2. BOILING WATER REACTOR AND **FUKUSHIMA DAIICHI NUCLEAR DISASTER**

The Development of
and Lessons from
the Fukushima Daiichi
Nuclear Accident

Fukushima Daiichi Nuclear Disaster

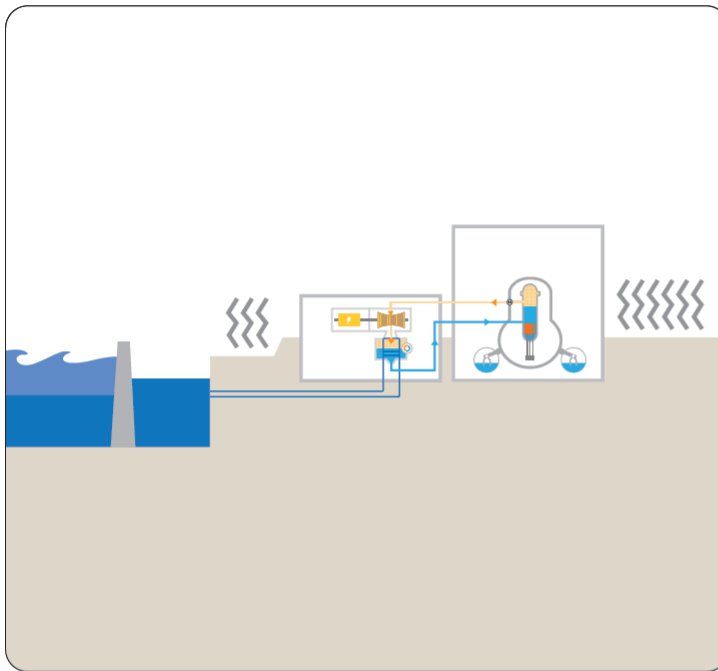
0. Protect

Design mindful of the height of tsunami and strength of earthquakes

Elements on the site of a power station are designed with provisions for the onslaught of conceivable earthquakes and tsunami.

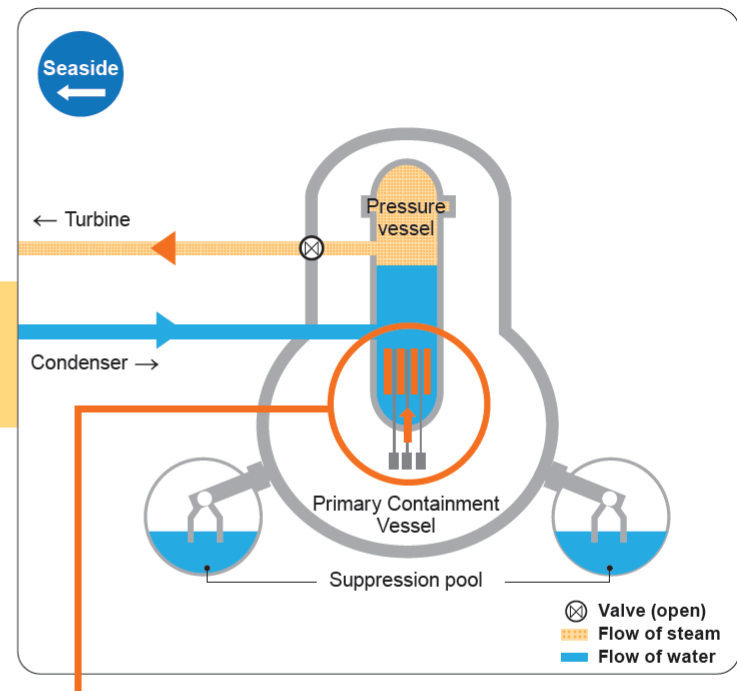
1. Shutting down

Emergency shutting down through insertion of control rods

Control rods are swiftly inserted in emergencies such as major earthquakes and the reactor undergoes an emergency shutting down.

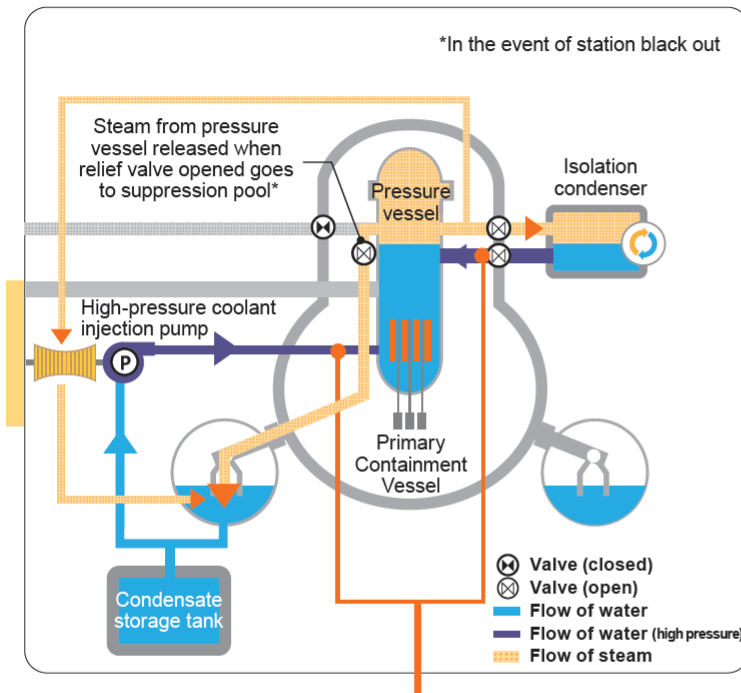
2. Cooling down

Cooling of the pressure vessel through injection and circulation of water

Equipment for sending a large amounts of water into the reactor is installed so that the fuel does not rise to high temperatures and the reactor core is not heating while empty.

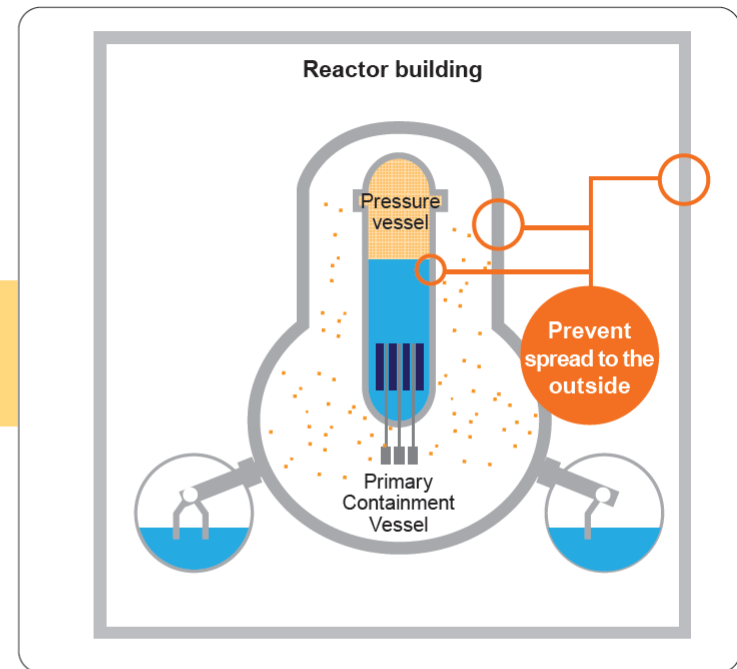
3. Confining inside

Radioactive materials are confined inside with pressure vessels, primary containment vessels, and the like

Protective walls are installed to confine inside radioactive materials so that they do not get outside even in an accident.

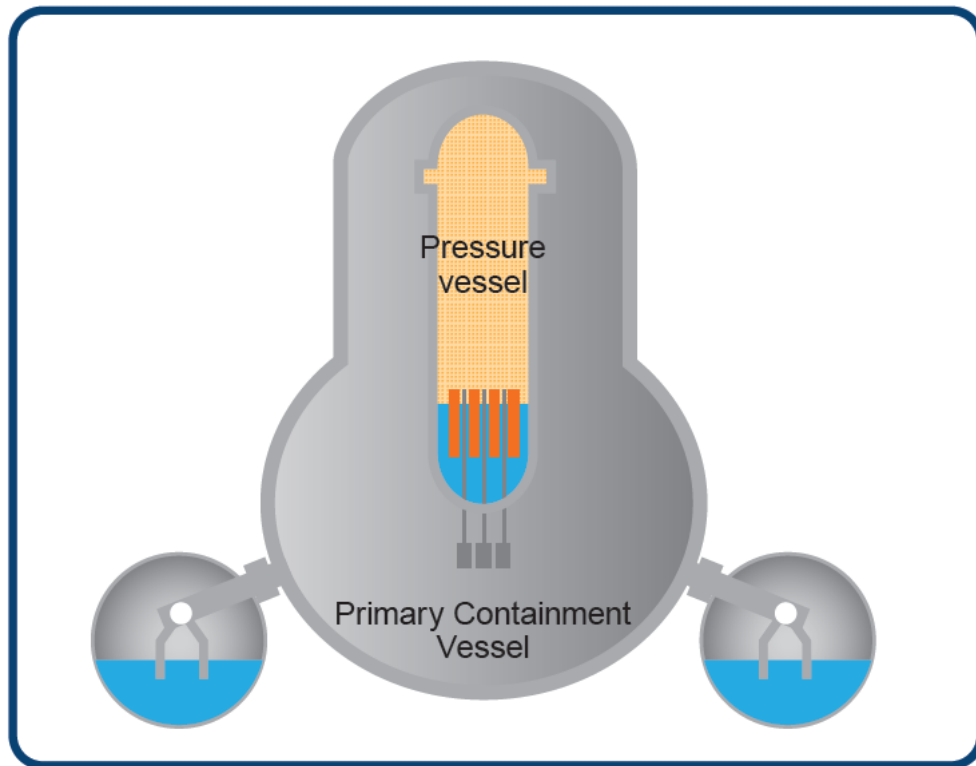
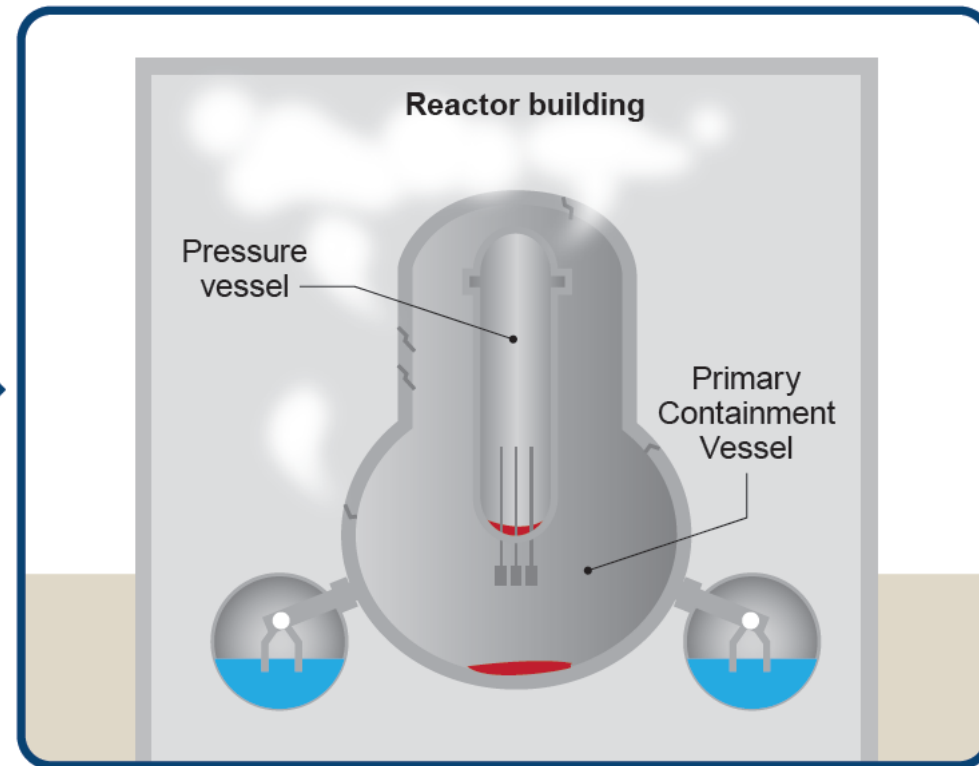
If cooling fails...

Water level in the pressure vessel falls, leading to core damage.

If cooling cannot be performed, it becomes difficult to continue keeping material confined inside. When confining inside fails, it leads to the release of hydrogen and radioactive materials to the outside.

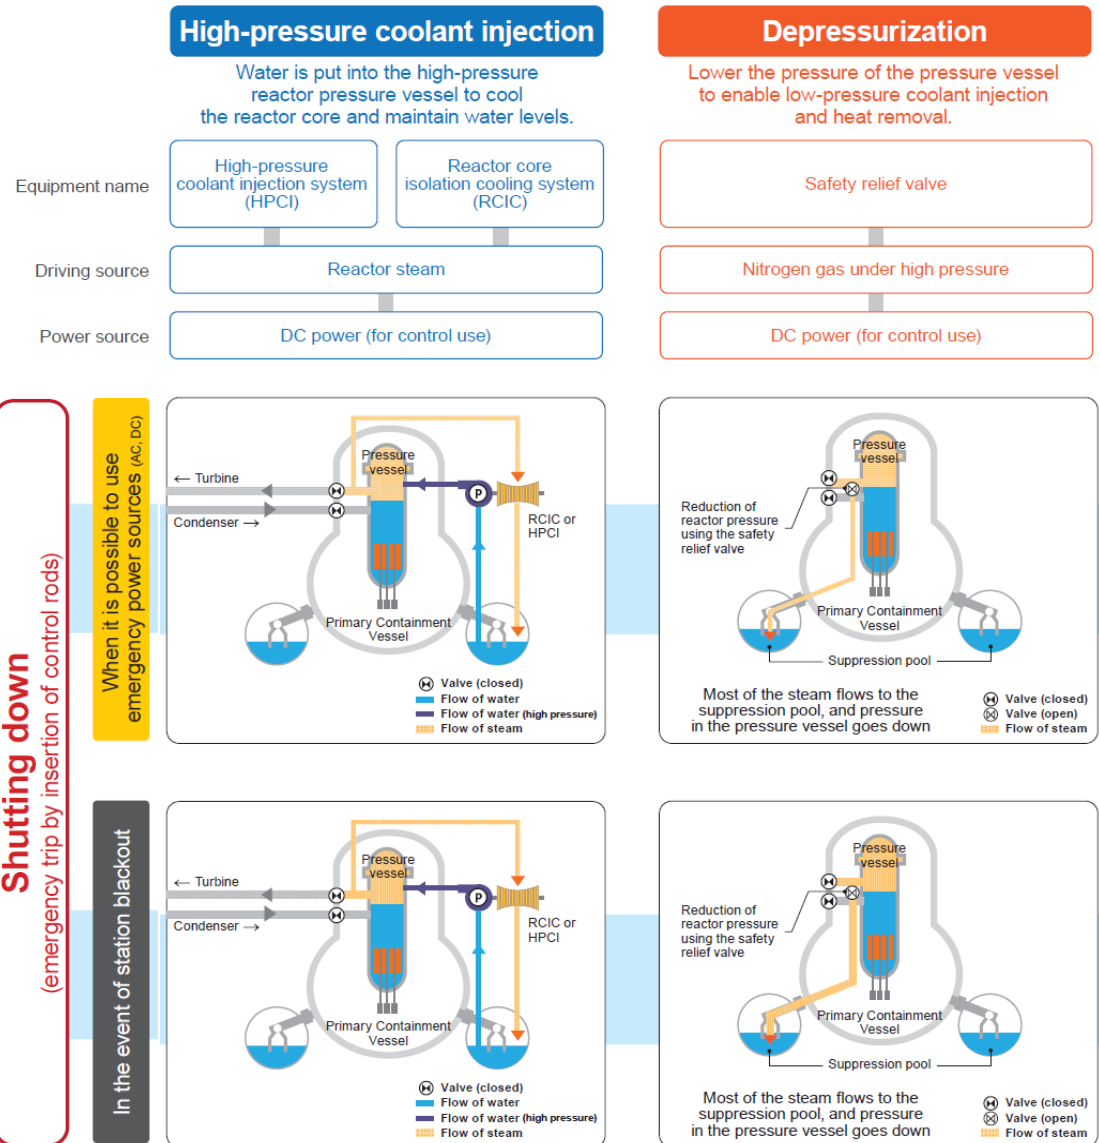
● HPCI/RCIC

- Passive cooling system
- Available in the event of SBO

● ADS

- Passive system
- Available in the event of SBO

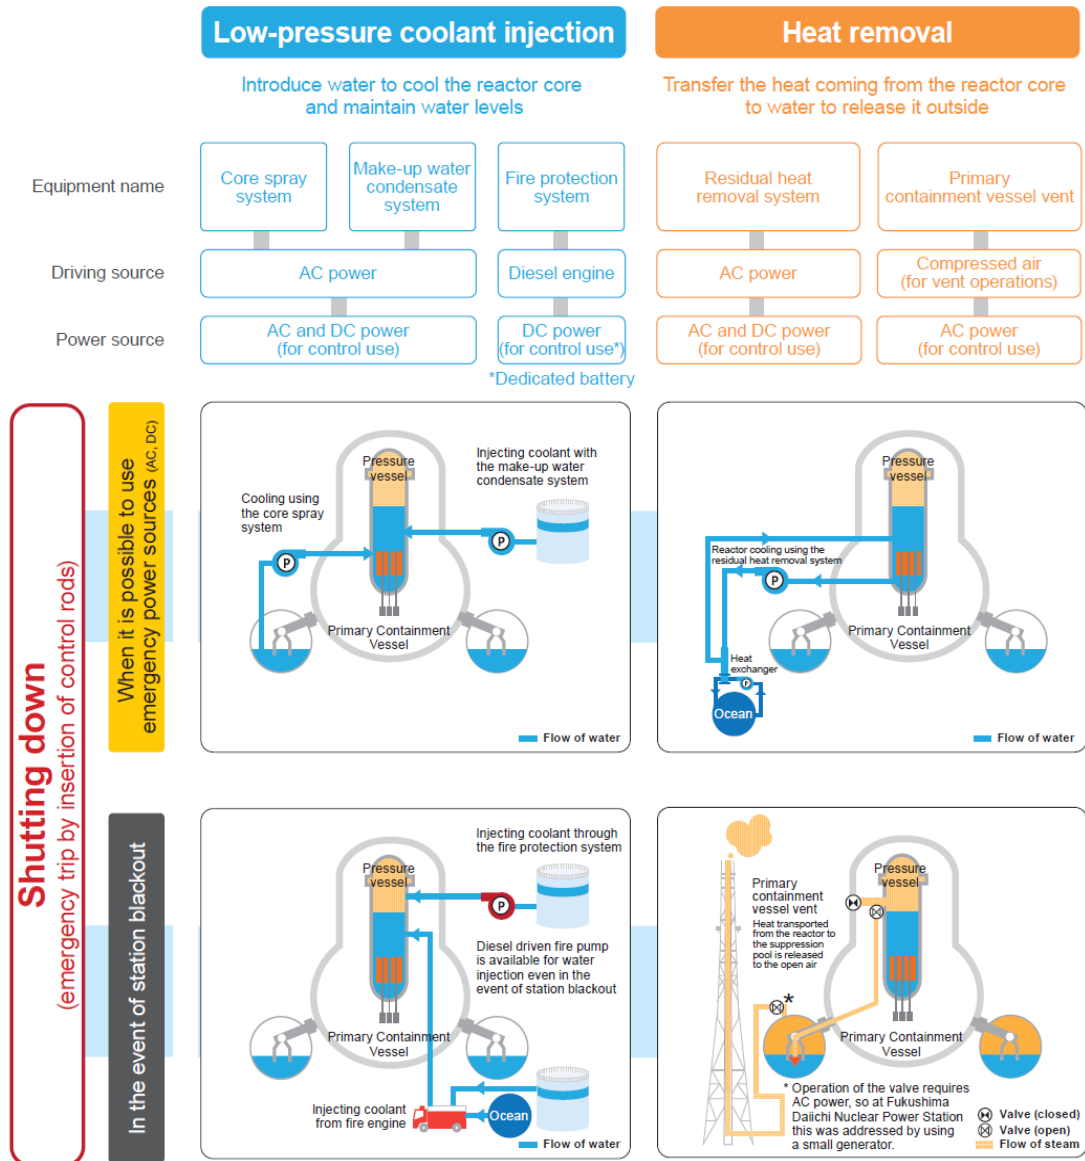
● LPCI/LPCS

- Active system
- Not available in the event of SBO
- Fire protection system was prepared.

● RHRS

- Active system
- Not available in the event of SBO

● PCV Vent

- AC power is required.

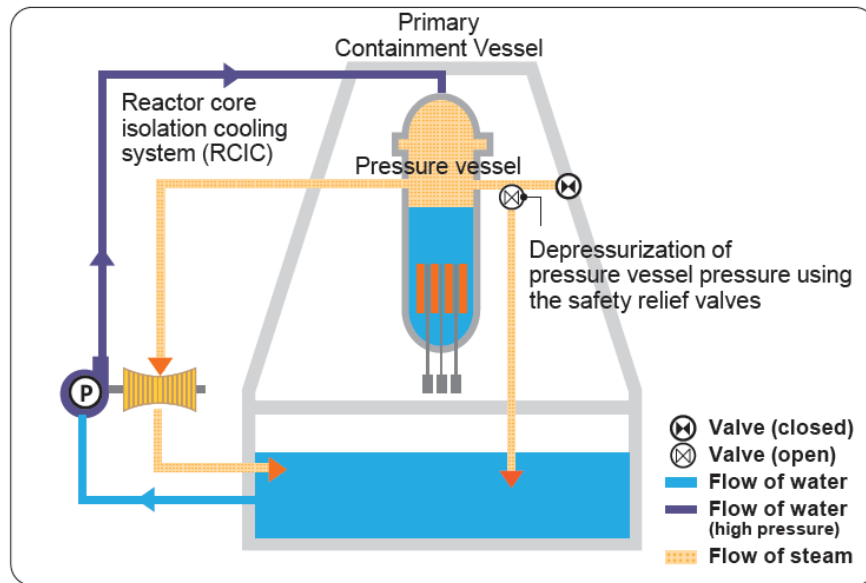
High-pressure coolant injection

Water level is maintained by the HPCI system (or RCIC system), and pressure in the pressure vessel is lowered using the safety relief valve.

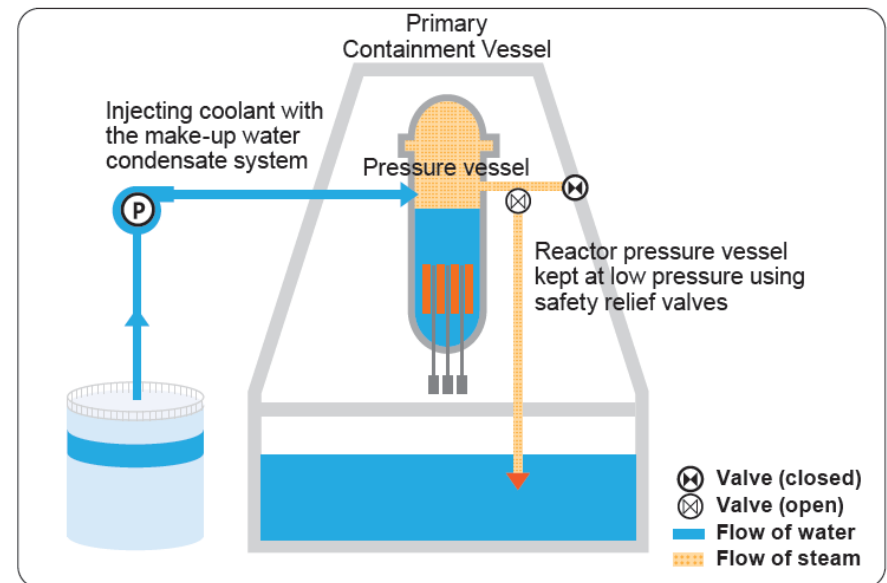
Low-pressure coolant injection

Water level is maintained through low-pressure coolant injection (make-up water condensate system), and pressure in the primary containment vessel is raised by transferring steam from the pressure vessel to the primary containment vessel.

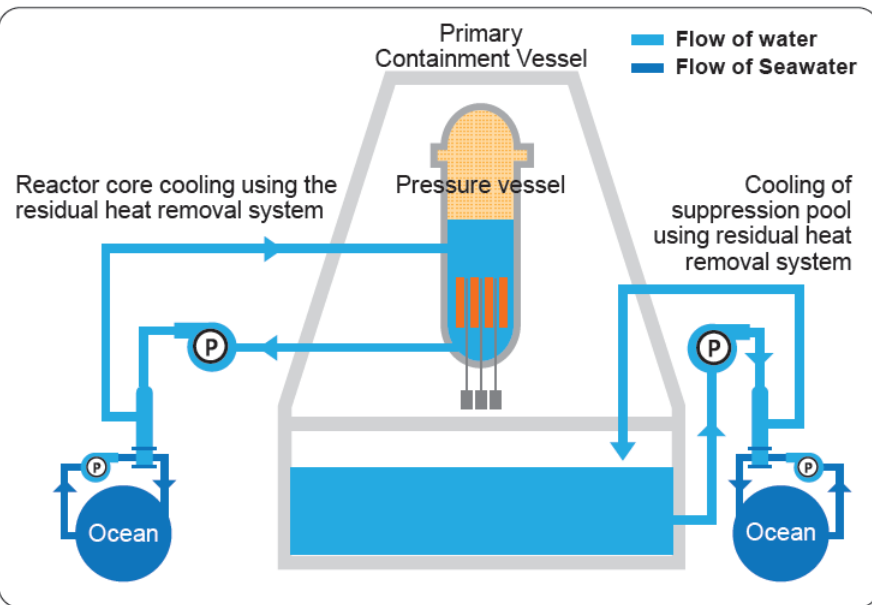
Heat removal

By starting heat removal, the flow of steam from the pressure vessel is halted while the primary containment vessel cools and its pressure gradually falls.

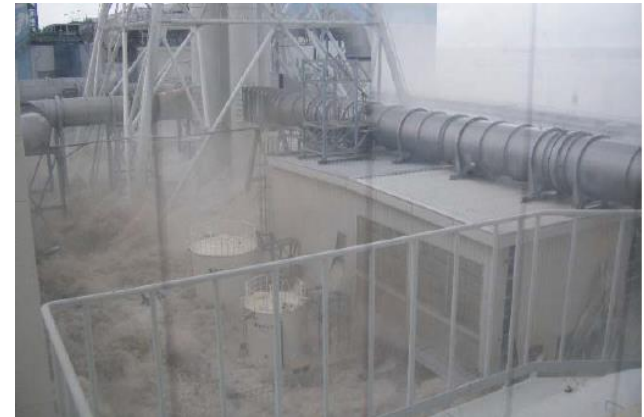
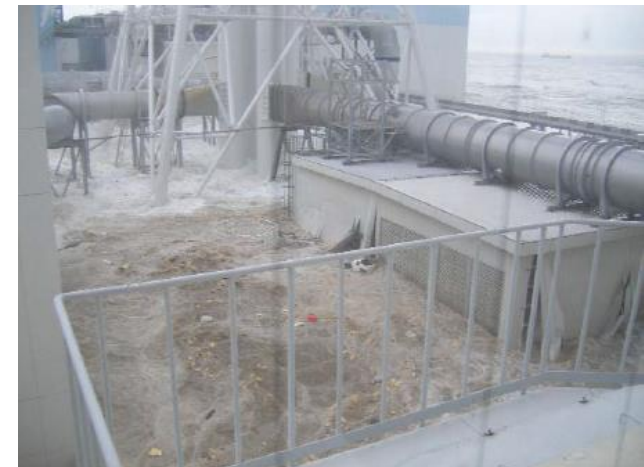
Tsunami waves

❖ Development of the accident

- Decay Heat produces steam in Reactor pressure Vessel
- Pressure increase

The wave flooded and damaged the unhoused seawater pumps and motors of all six units at the seawater intake locations on the shoreline, resulting in loss of ultimate heat sink events for all units. This meant that essential plant systems and components, including the water cooled EDGs¹⁴, could not be cooled to ensure their continuous operation.

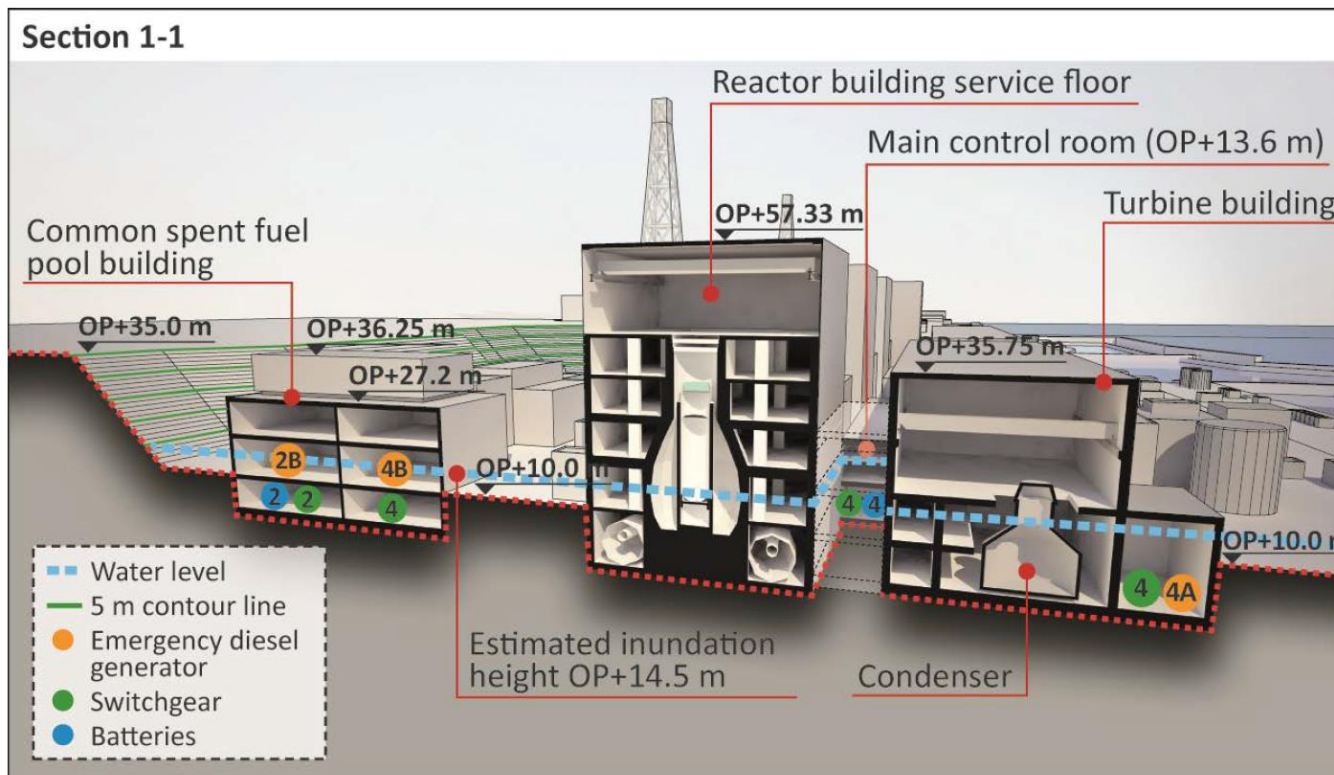
Each unit had a pair of EDGs, and Unit 6 had an additional generator. Of those 13 EDGs, Units 2, 4 and 6 each had one that was air cooled. Since they were air cooled, operability of these generators was not directly affected by the loss of cooling water caused by the damage to the seawater pumps.

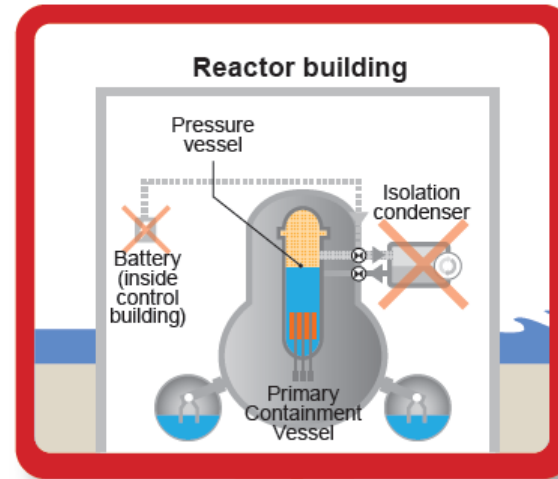
15:35 Tsunami hits

Isolation condenser became unusable due to the tsunami

The isolation condenser can perform cooling just by opening and closing a valve. The valve on the isolation condenser was opened and closed to slowly cool the reactor core after the earthquake. However, this valve was closed when all power was lost due to the tsunami. It could not be reopened for that reason, and the isolation condenser lost its cooling function.

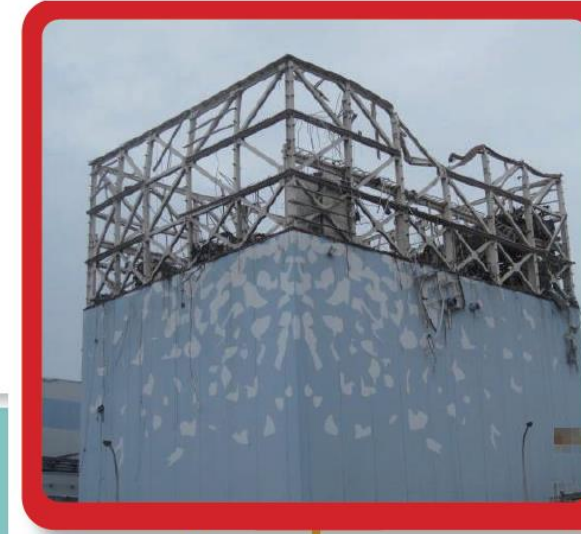
15:36 Hydrogen explosion in the Unit 1 reactor building

Water vapor reacted chemically with zirconium on the exterior of the fuel rods and hydrogen was generated in a large massive amounts

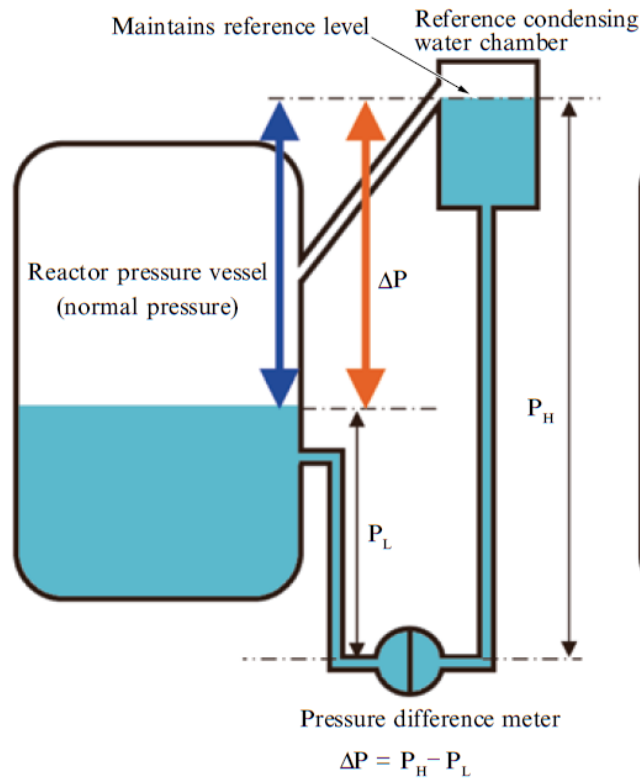
A. Normal operation

Measured water level matches with actual water level

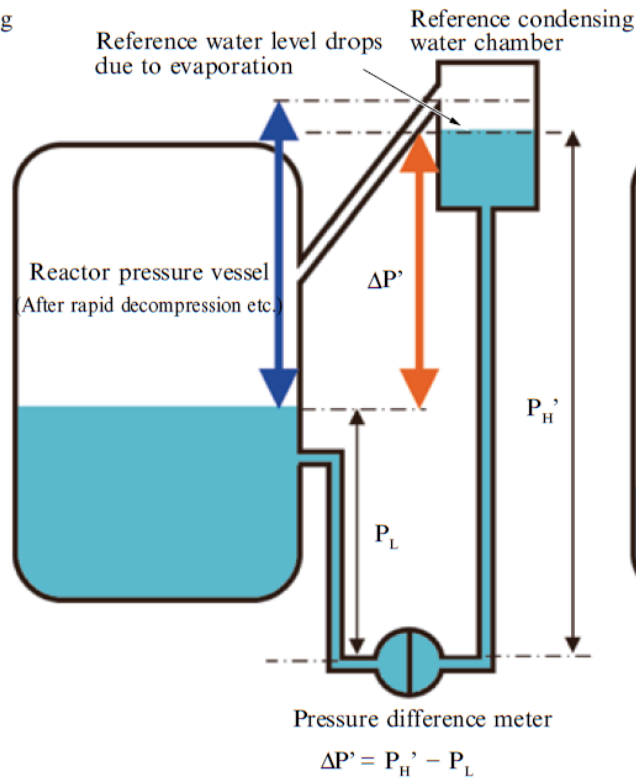
B. After decompression boiling

Measured water level appears higher than actual water level due to drop of reference water level

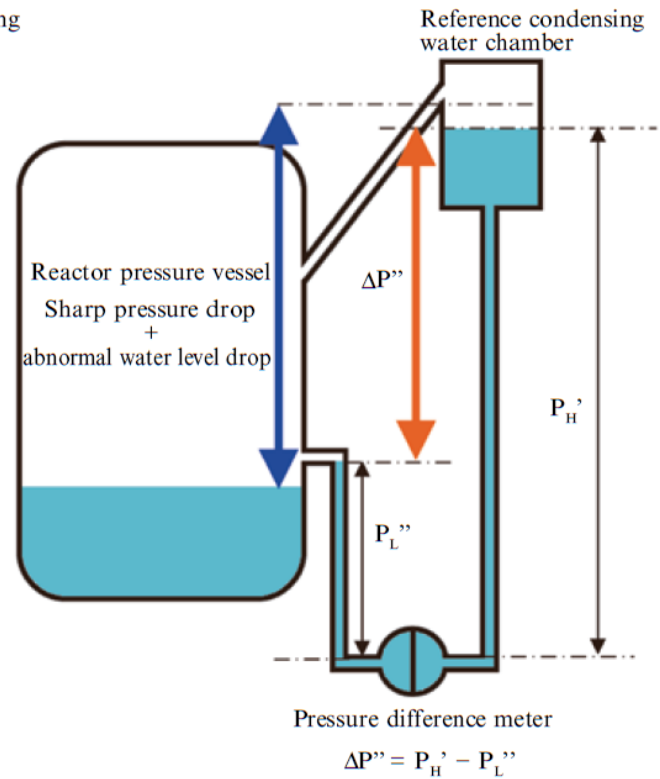
C. Decompression boiling + water level is below lower piping

Measured water level always appear higher than actual water level without being affected by actual changes in water level

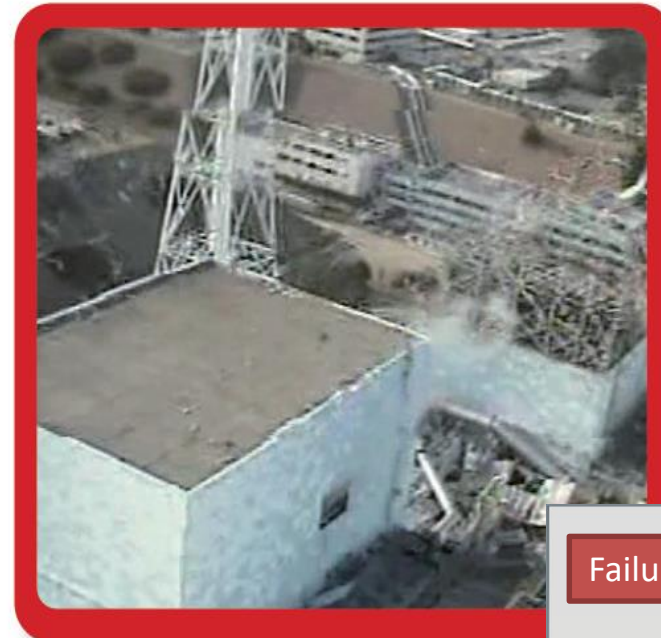
19:54 Start coolant injection

Depressurization
Succeeded!

Coolant injection
was delayed.

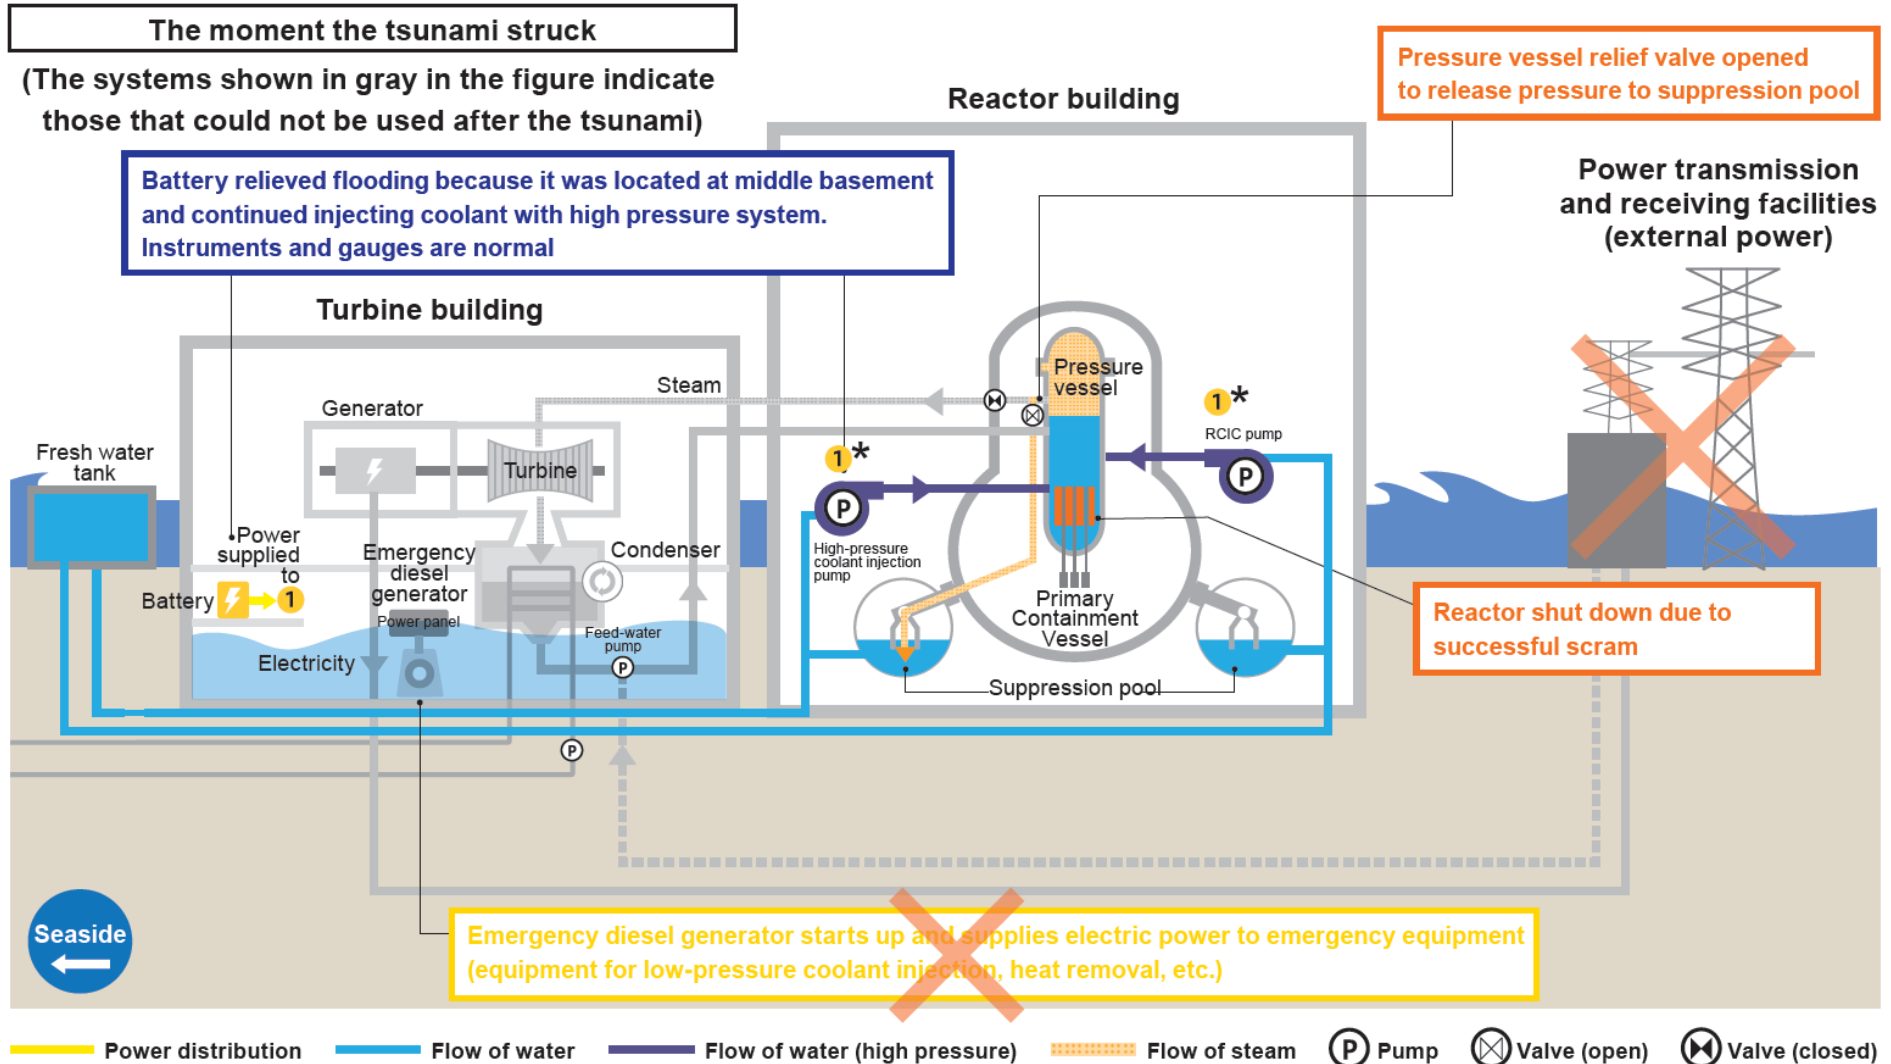
- Battery relieved flooding!

*Used for opening and closing valves in the system

- Battery relieved flooding!
- Operation and control of the RCIC and HPCI could be maintained.
- It was also possible to continue monitoring reactor status using meters and gauges.
- Coolant injection continued for approximately a day and a half, after which the HPCI system was tripped to change over to injecting coolant at low pressure (with a diesel driven fire pump).
 - RPV pressure was 0.58 MPa.
 - Safety relief valve did not work due to battery run-out.
- However, depressurization after this took time, the water level dropped, and the result was the generation of hydrogen and damage to the core.

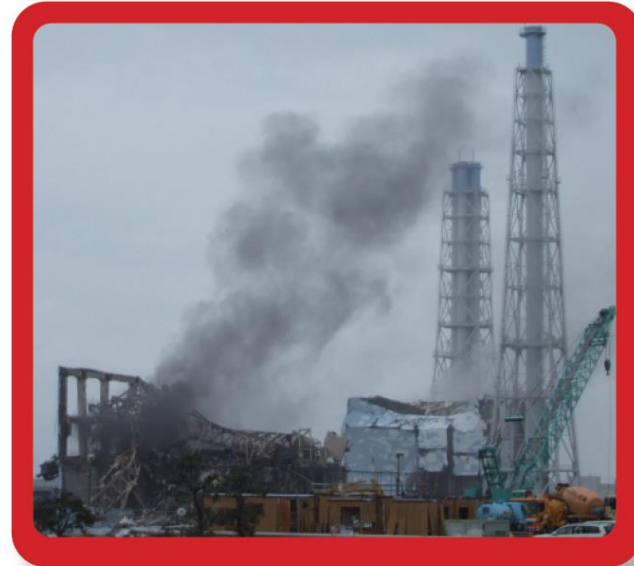
❖ Severe accident at Unit-3

About 9:25 Start coolant injection

Fuel exposure and
damage (heating while
empty conditions)

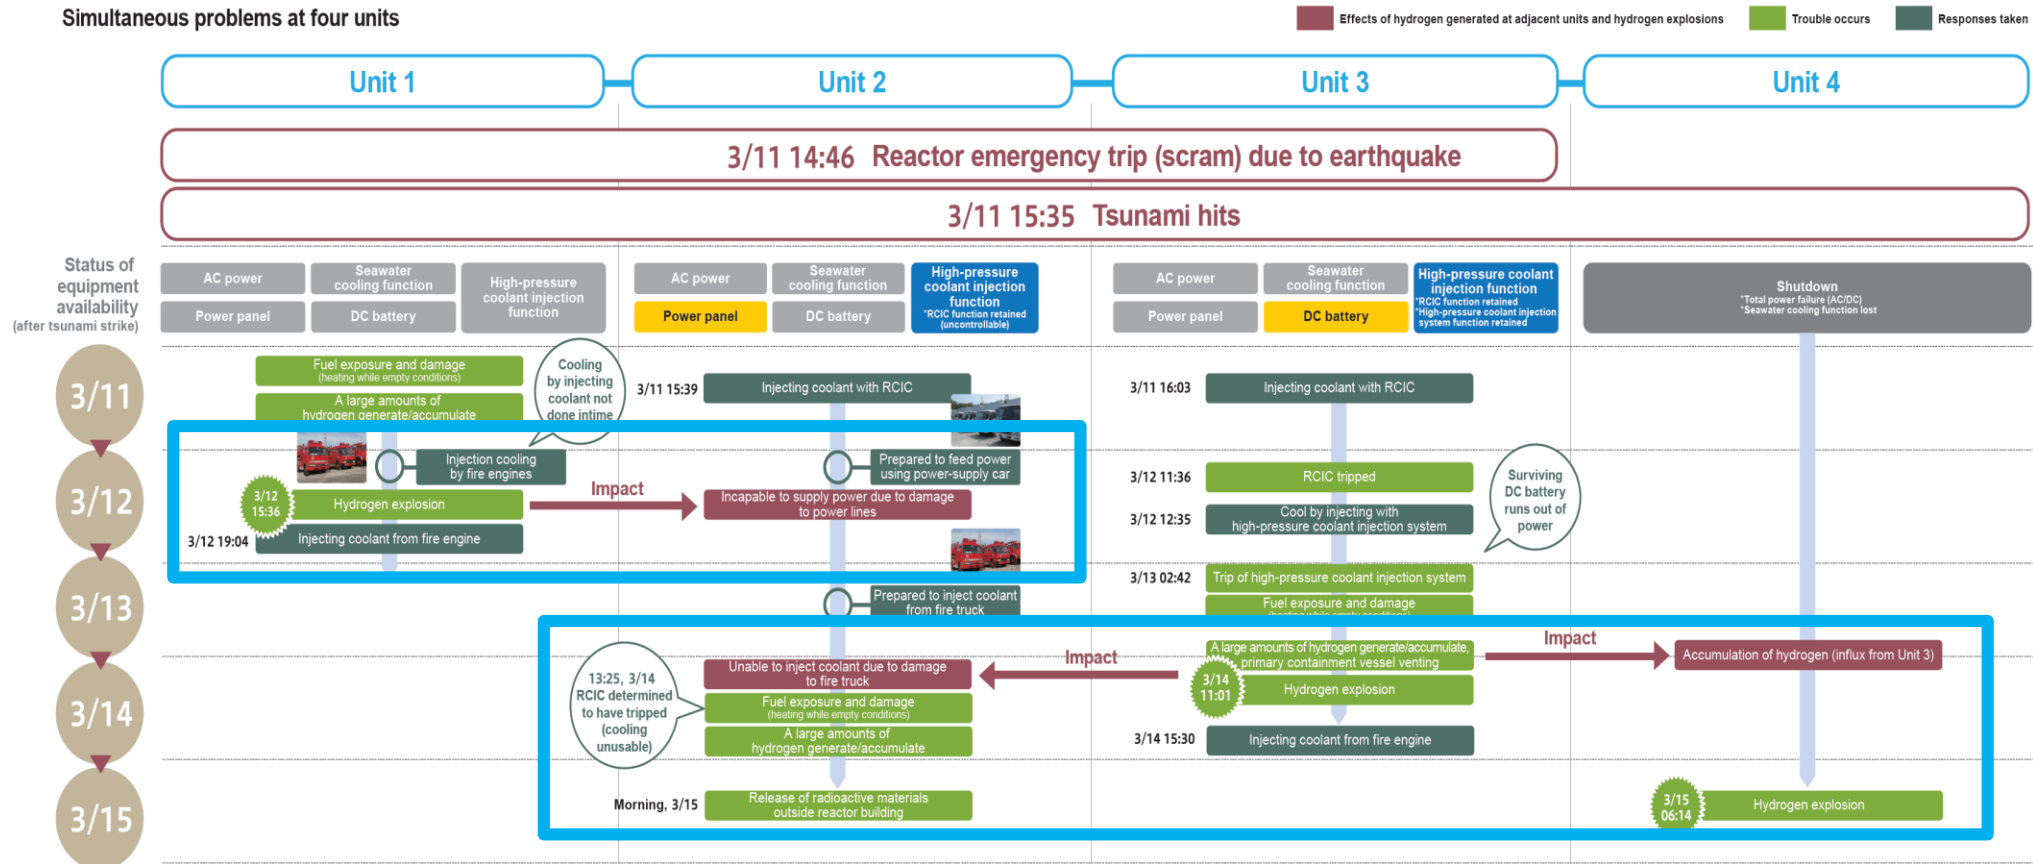
Simultaneous problems at four units

In this way, one of the lessons learned from the events is that the progression of the accident at one unit had a big impact on restoration work at the other units.

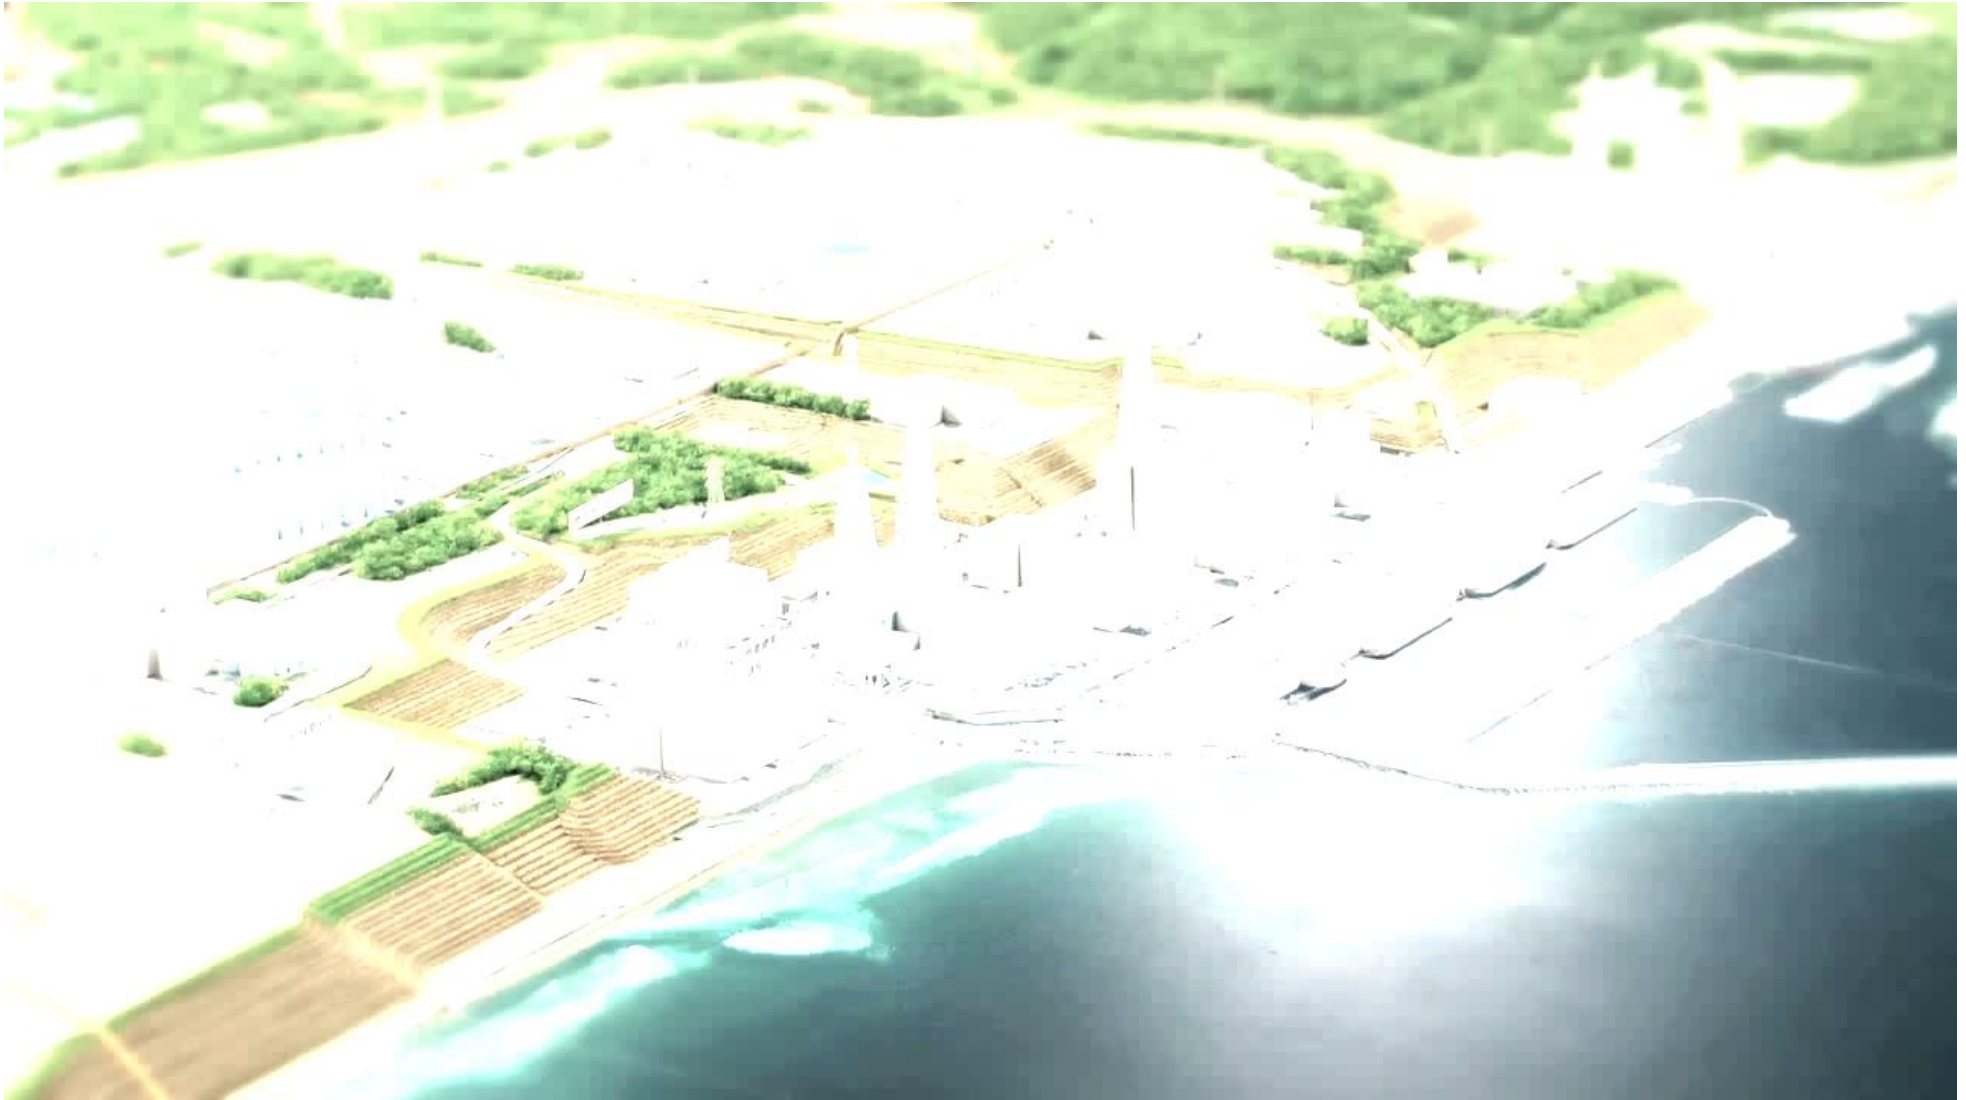
❖ Reactor Circulation Cooling <https://www.youtube.com/watch?v=o0cwp-d5BSU>
