# **Overview of Earthquake Engineering**

**Hong-Gun Park**  
**Seoul National University**

1. Causes and damages
2. Principles of earthquake design
3. Design considerations
4. Earthquakes in Korean Peninsular

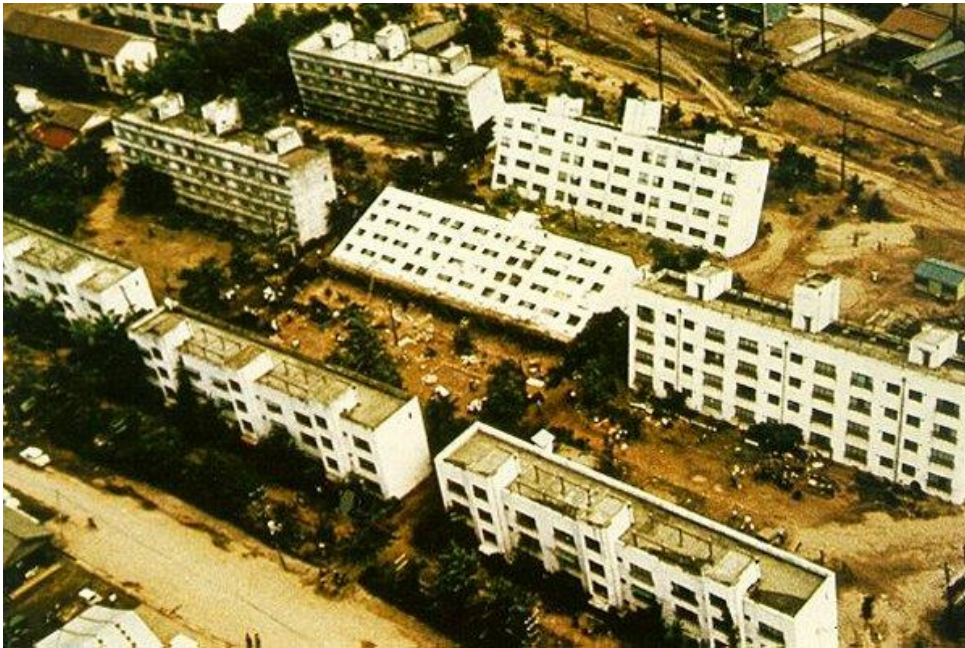
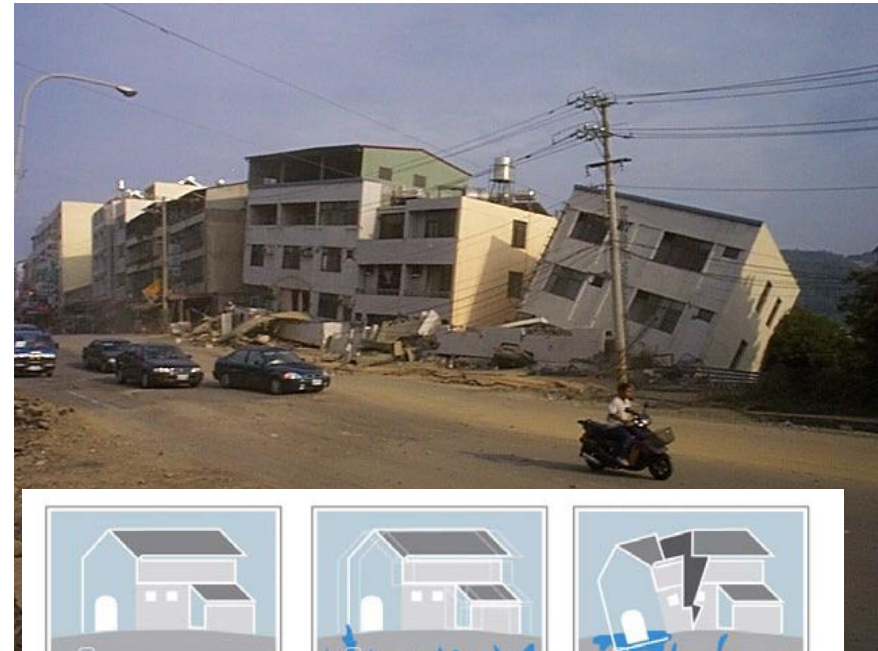
지반의 액상화(liquefaction)  
Liquefaction occurs when  $M > 6.0$

Fig. 4. Soil liquefaction process

Fig. 4. Soil liquefaction process

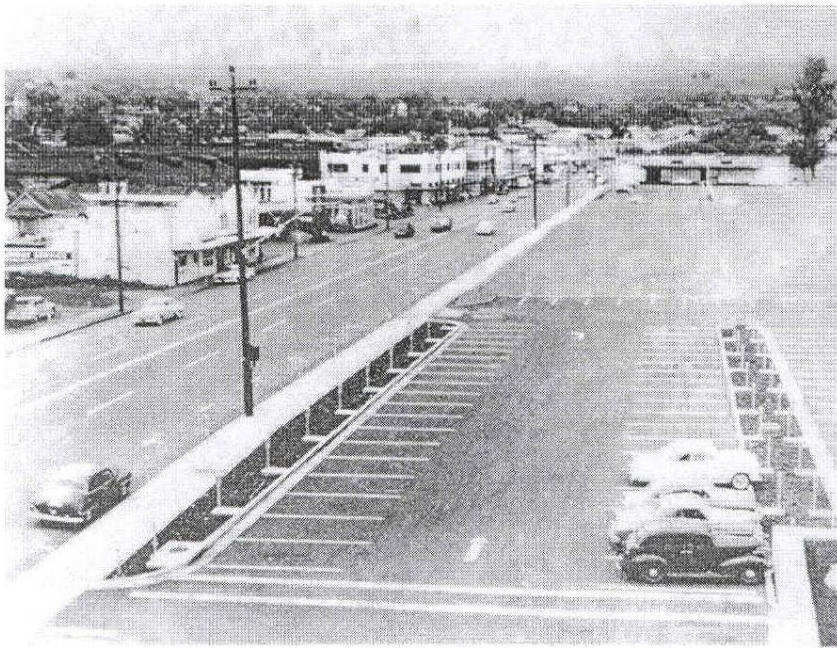
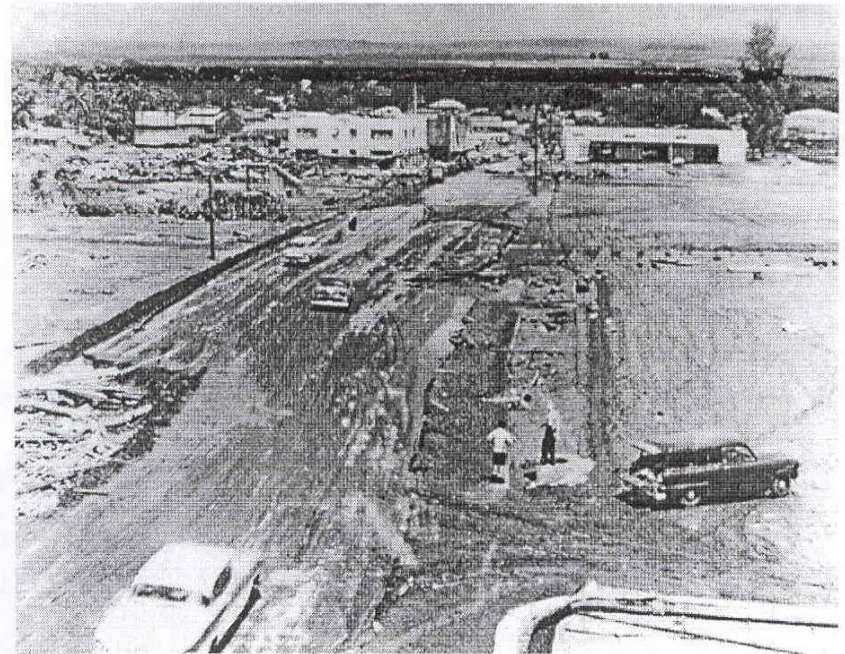
Before tsunami

After tsunami

*Figure 1-21* Damage at Hilo, Hawaii, due to tsunami of May 23, 1960. (Photos courtesy of R. L. Wiegel.)

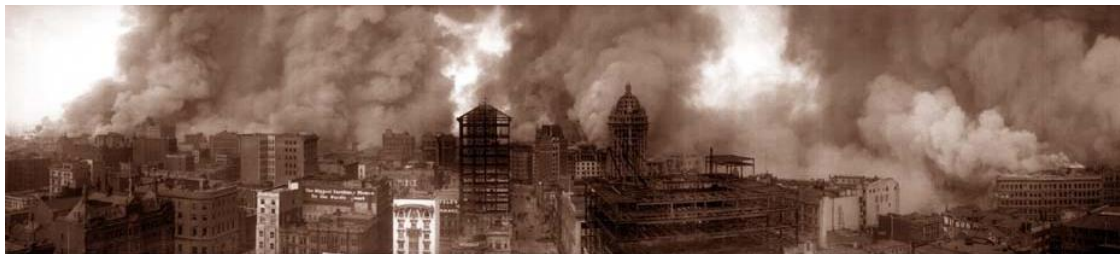
breakdown of Gas pipes, Electric lines, and water lines

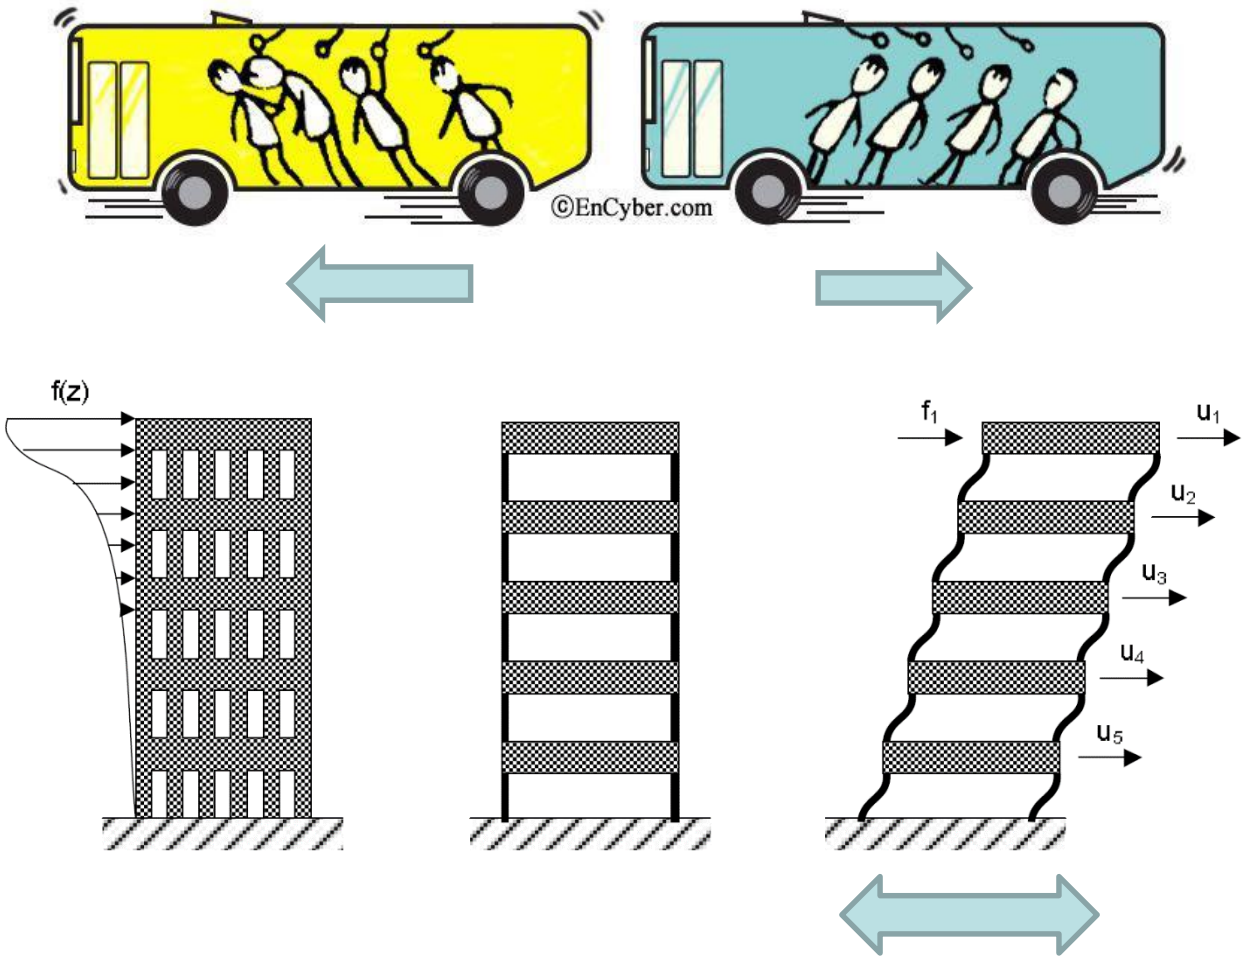
Variation of maximum accelerations of structures according to the dynamic period : 응답스펙트럼 (elastic response Spectrum)

Response spectrum – key feature of modern earthquake design codes

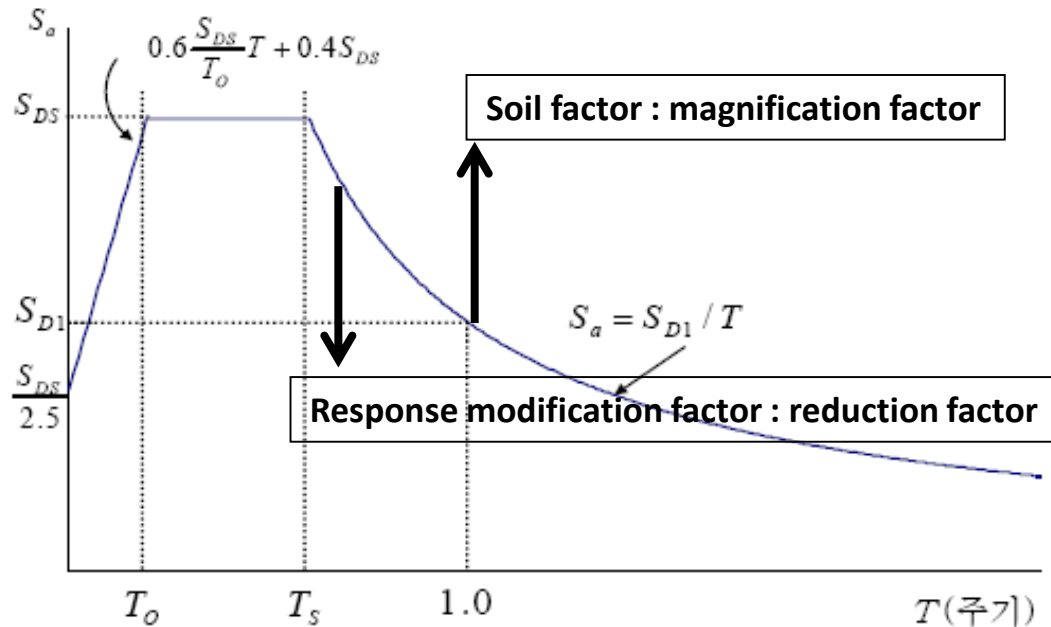
## 설계스펙트럼 (Design Response Spectrum)

Response modification factor (반응수정계수) : decrease of earthquake load when ductility (inelastic deformation) of the structure is good. A reduction factor

Soil factor : increase of earthquake load for soft soil deposit

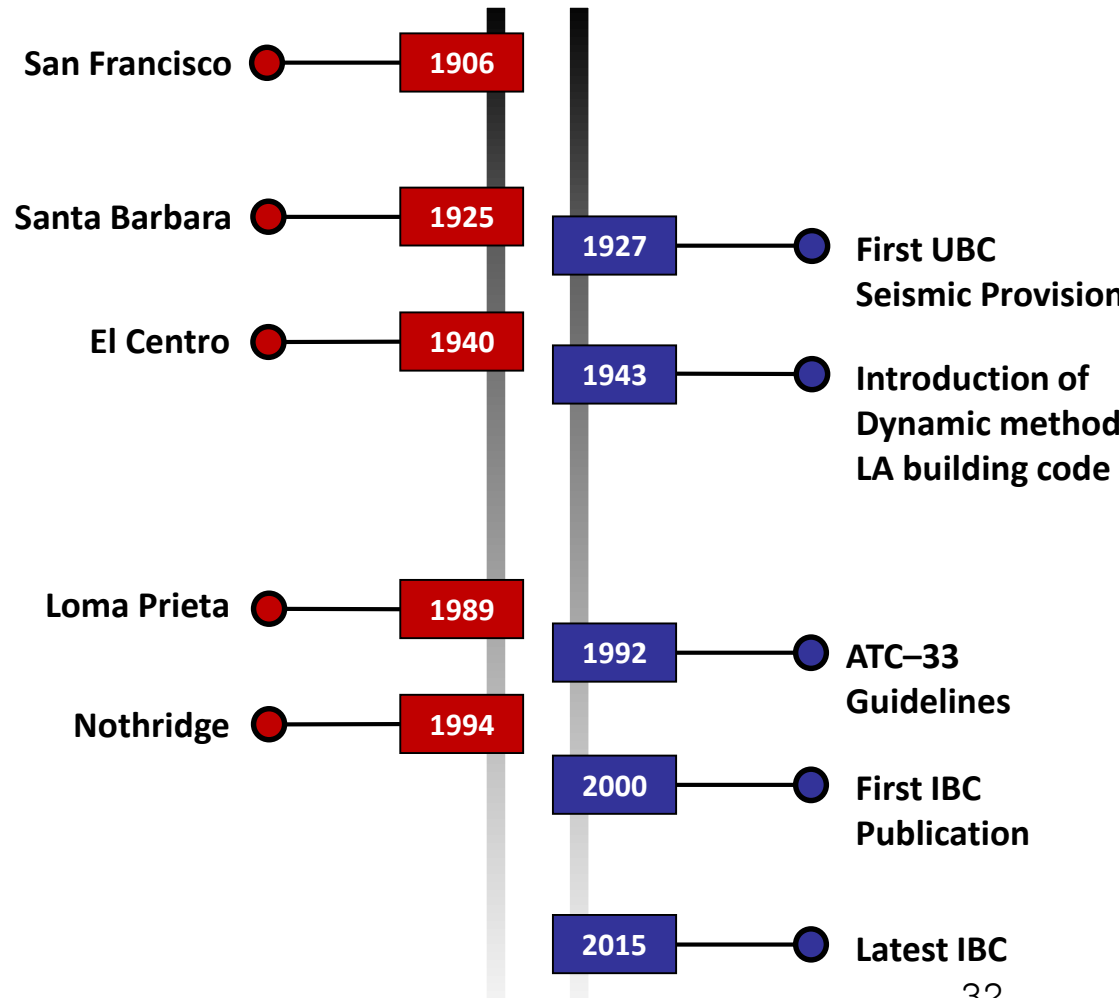
- Lessons from significant earthquakes led to the incorporation of more advanced codes for the construction of new buildings
- Big change in design codes
  - Old design codes : focused on increasing strength of structures
  - New design codes : increasing ductility capacity of structures

Earthquake occurrence and design codes in US

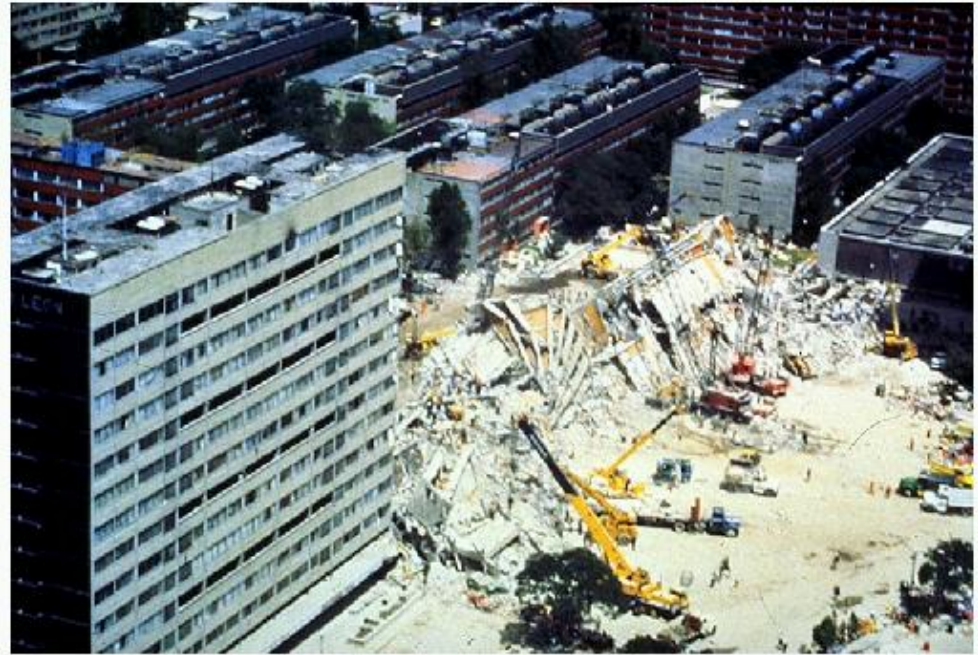
**Aerial view of Nuevo Leon Looking Northwest**

Aerial view looking northwest of the collapsed Nuevo Leon Building. Hundreds died in the collapse.

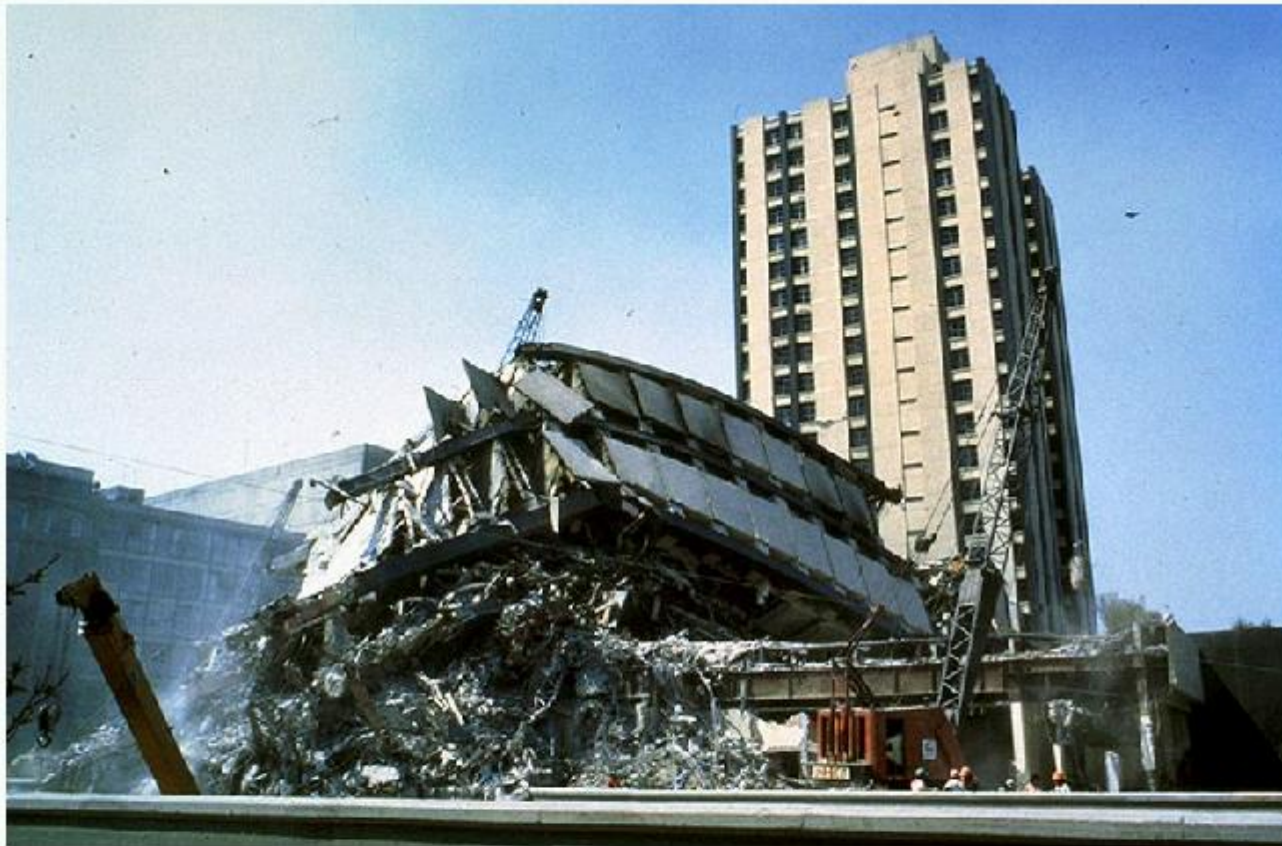
## **Pino Suarez Towers Looking North**

View looking north of the Pino Suarez Towers. Originally there were five structures at this site. Three central 21-story buildings and two flanking 14-story buildings. These government office towers were one of the few steel frame

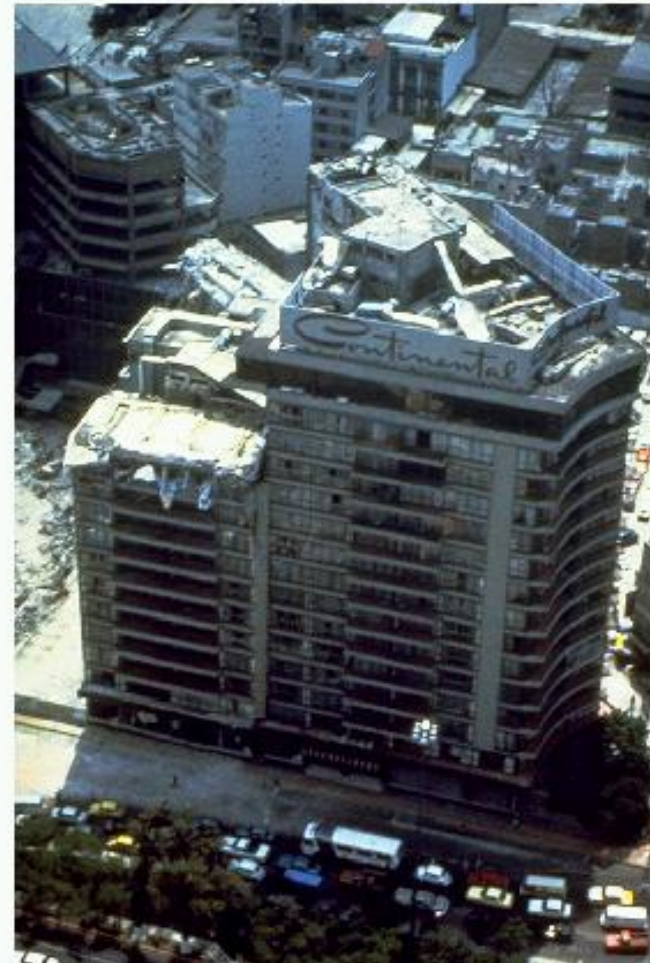
## Aerial View of Continental Hotel

Aerial view of the Continental Hotel, where different sections of the building collapsed when pounding or hammering occurred at nonstructural Joints. .

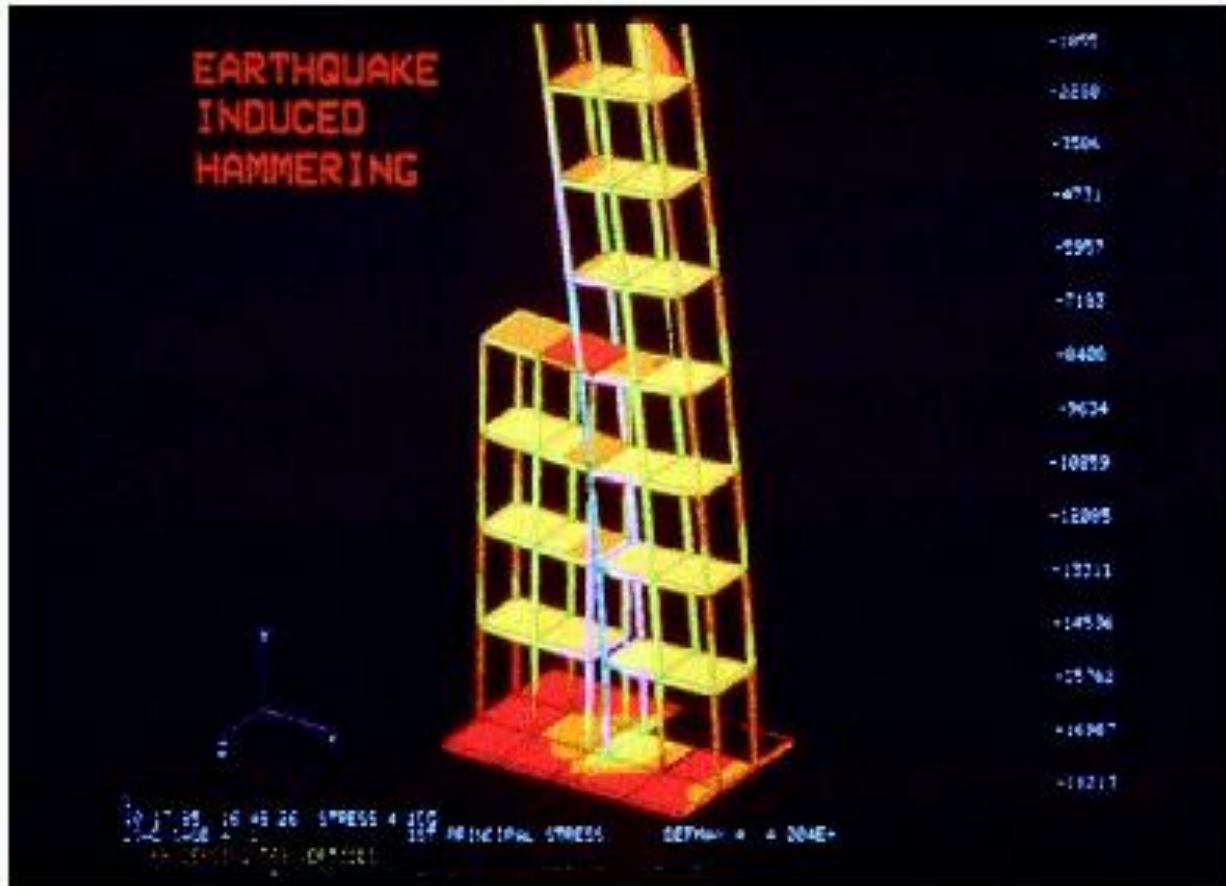
## Hammering of Unequal Height Buildings

Building hammering was widespread in Mexico City. This slide depicts collision between two buildings of unequal height.

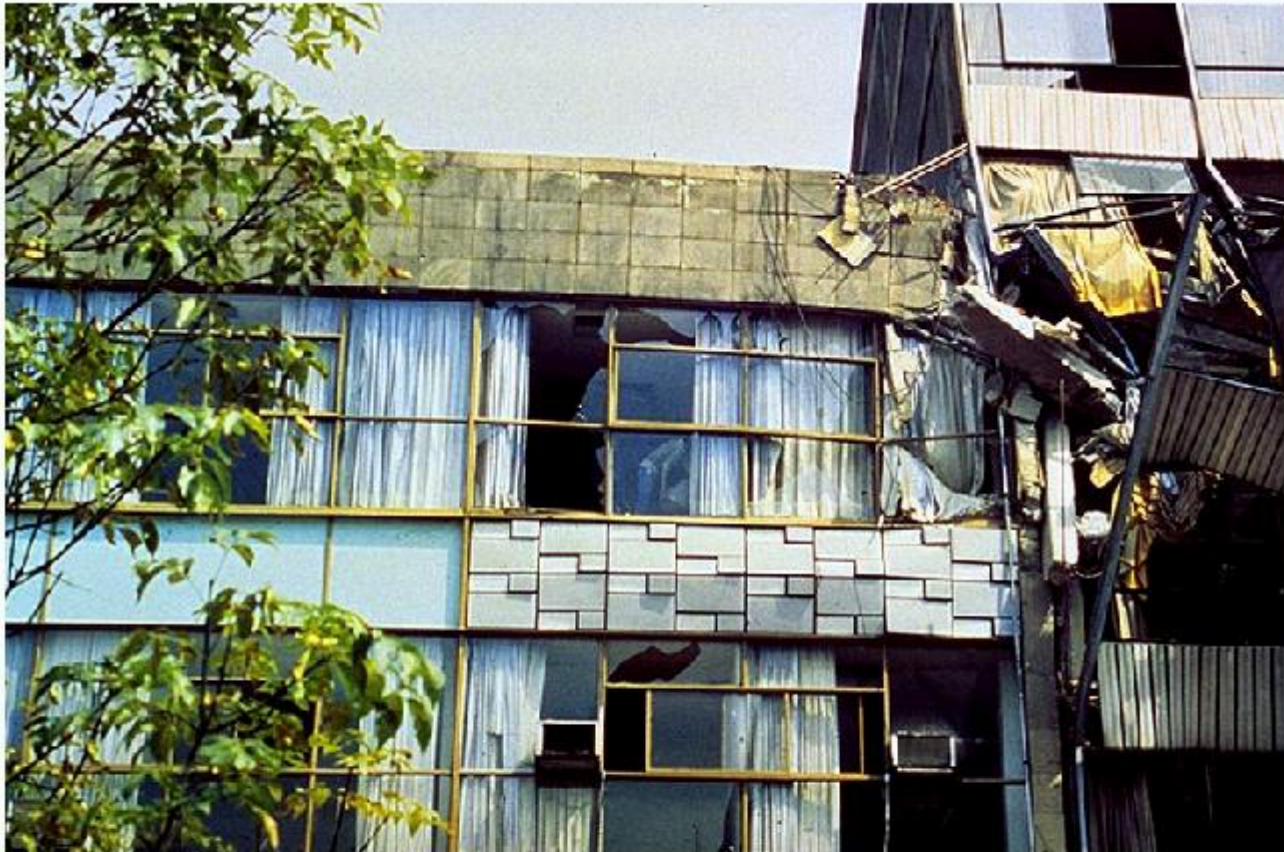
## **Pounding Damage**

Damage caused by pounding results in intermediate floor collapse. Note that in spite of severe structural distortion, much glass is unbroken.

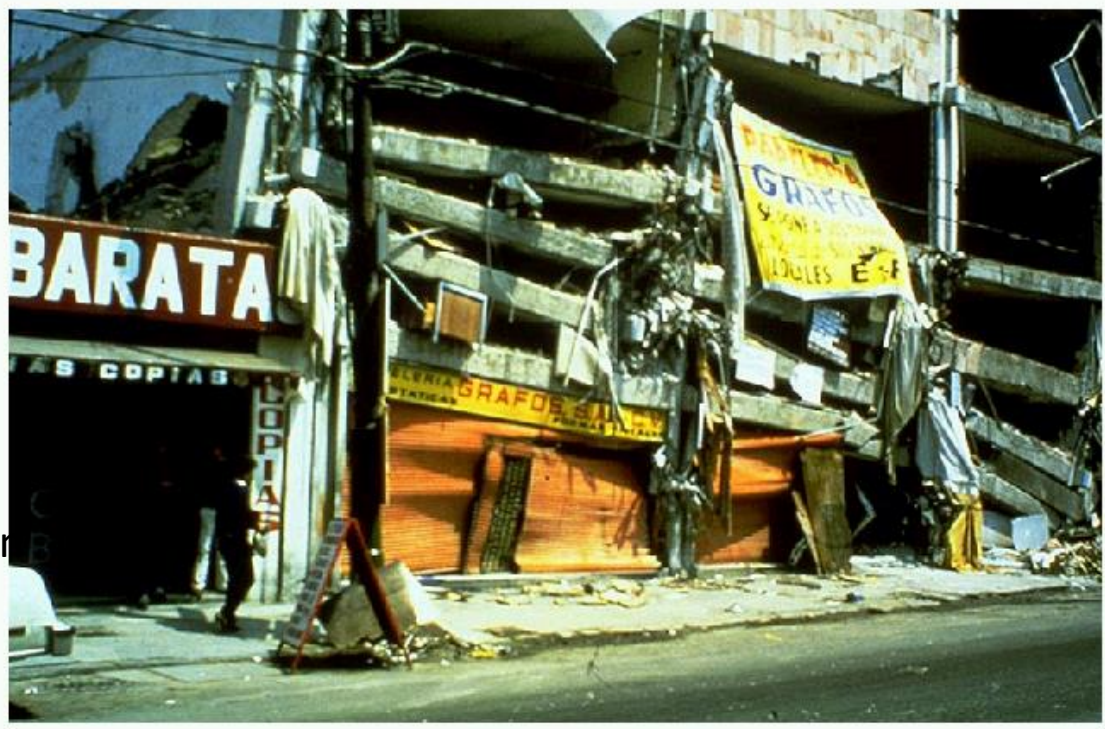
## Lower Floor Collapse

*Time and Location of Slide: Downtown Mexico City, October 1, 1985*

Collapse of a number of lower floors of a commercial building. Upper floors remain intact. Note open first floors contrasted to upper floor with the consequent stiffness differential probably leading to the failure.

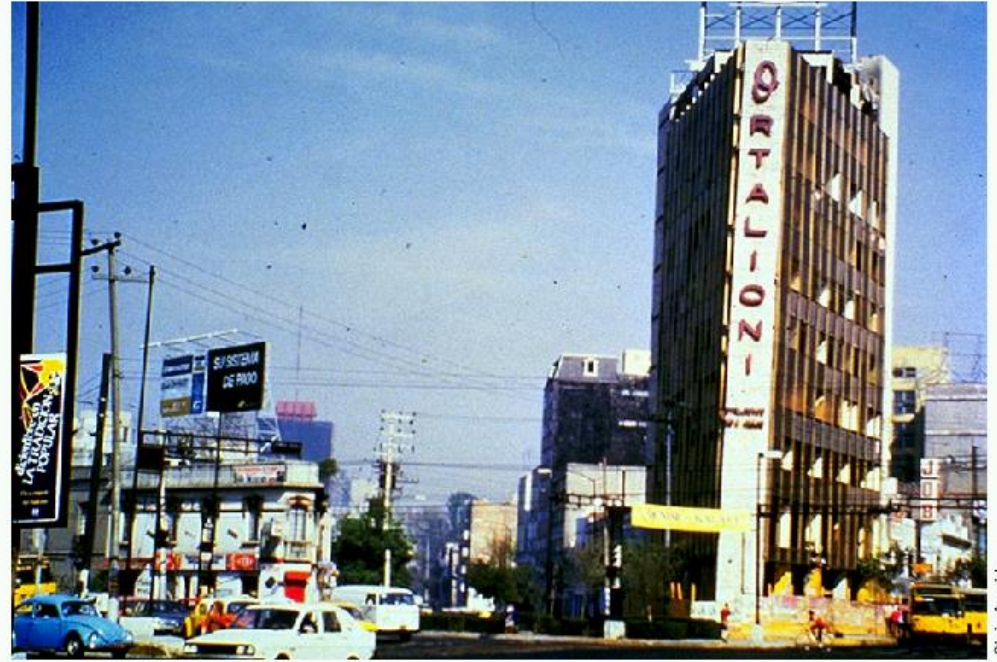
## Building Distortion

*Time and Location of Slide: Downtown Mexico City, December 15, 1985*

Severe distortion of building that is triangular in plan to fit the site requirement at a multiple street intersection. Form of building results in the torsional behavior shown.

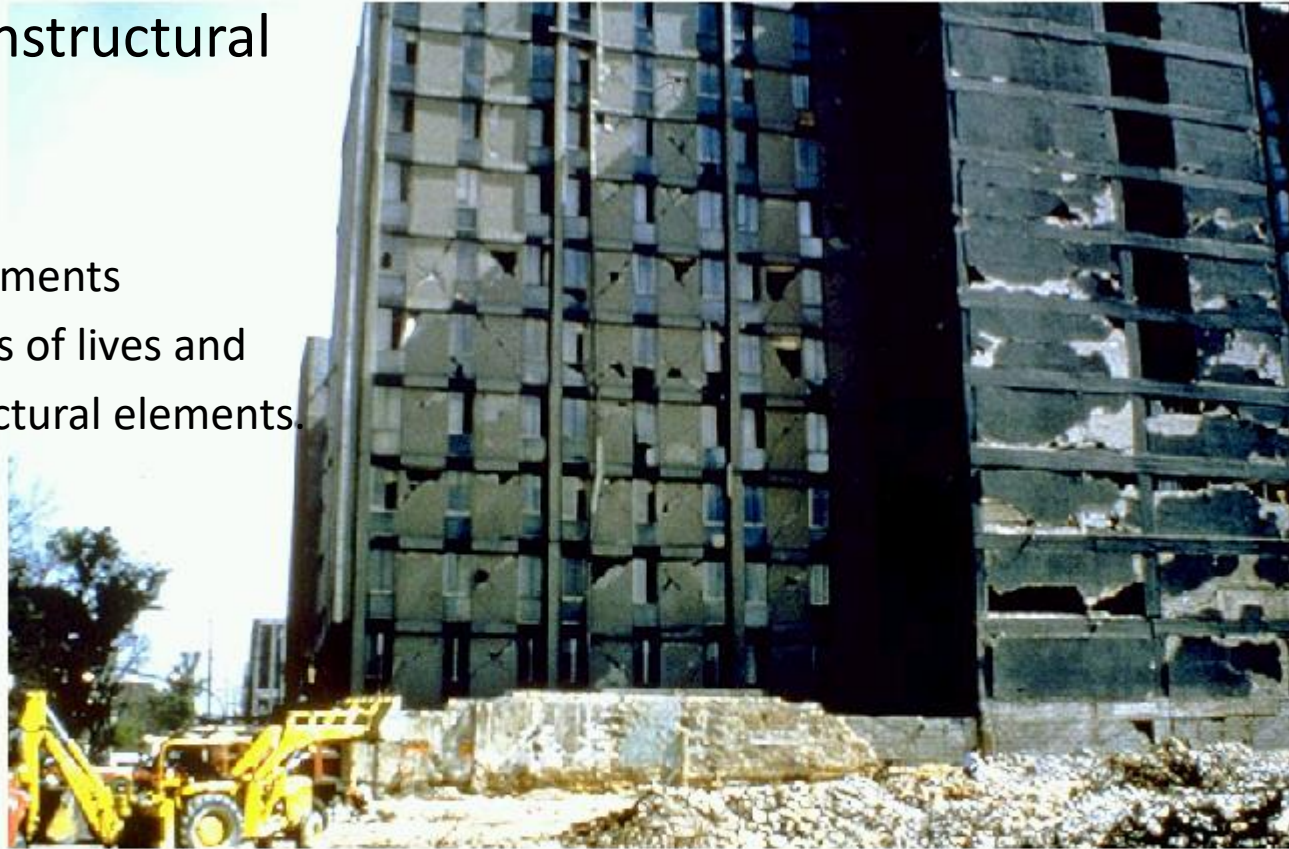
### **Infill Wall Damage**

*Time and Location of Slide: Downtown Mexico City, December 15, 1985*

Typical patterns of damage in unreinforced masonry infill wall. Note damage concentration towards bottom of walls.

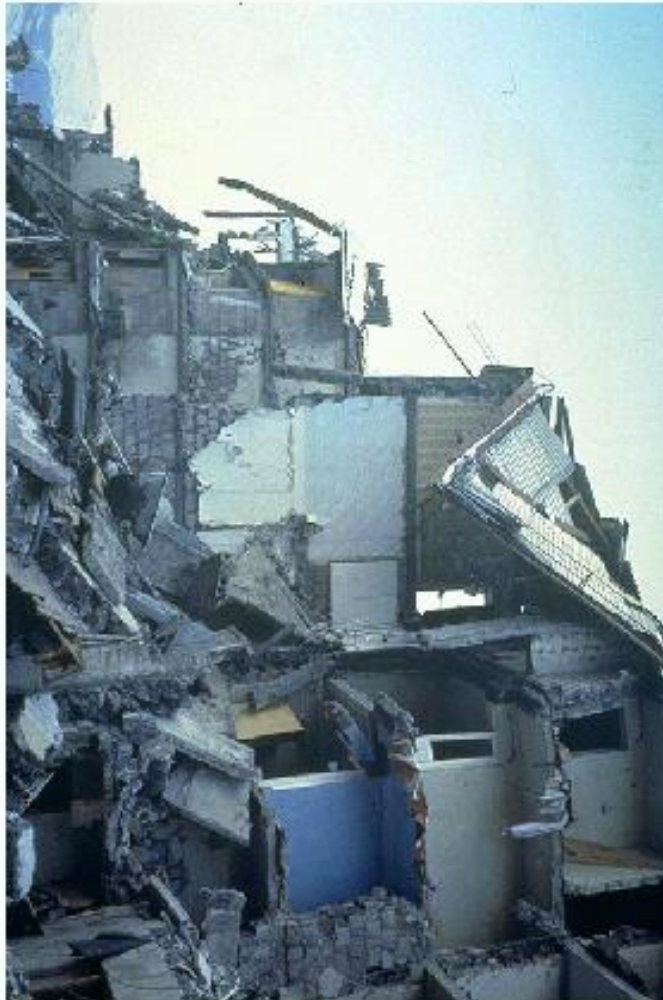
### **DAMAGE TO LOAD BEARING STONE MASONRY WALL BUILDING IN SPITAK**

There are no ties between the floor planks and the wall. The ground shaking in the epicentral region was too great for this ineffective lateral force resisting system.

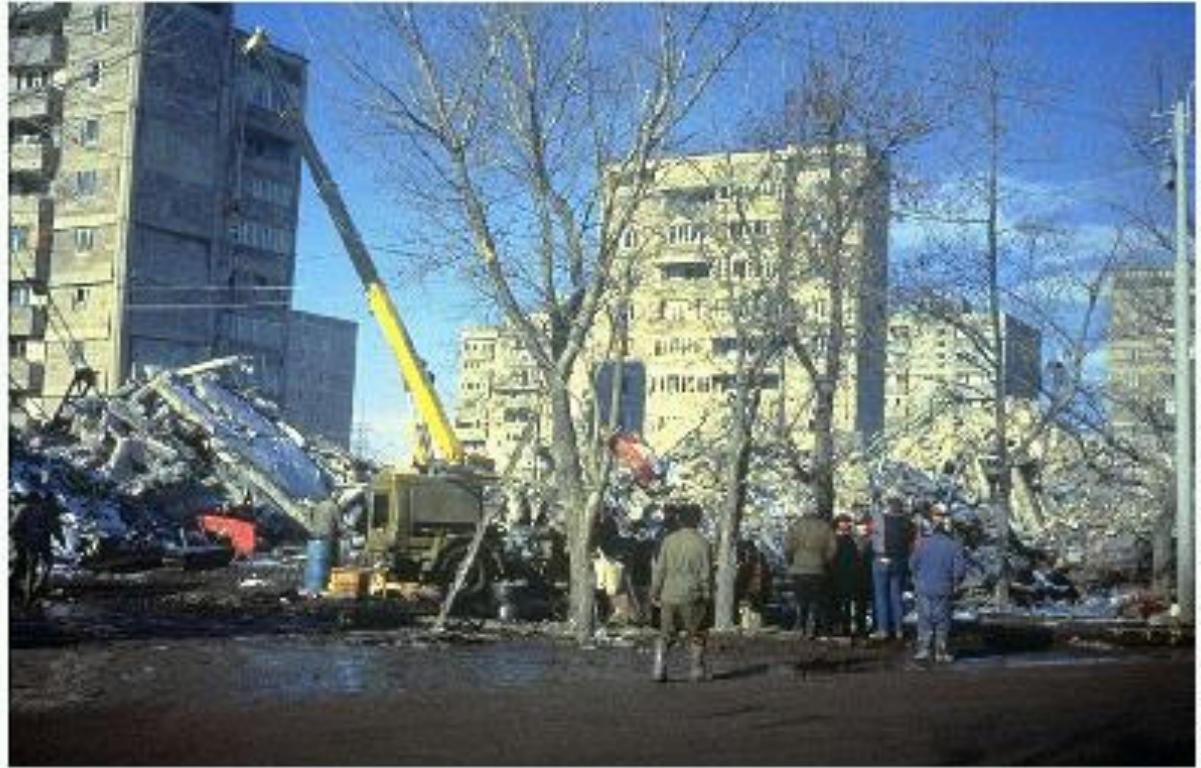
### **DAMAGE TO 9-STORY PRECAST CONCRETE FRAME BUILDINGS IN LENINAKAN**

This slide shows collapsed and damaged nine-story precast concrete frame buildings in Leninakan. Poor diaphragm action due to lack of connections between the floor planks (flexicore precast floor panels) contributed to the failures.

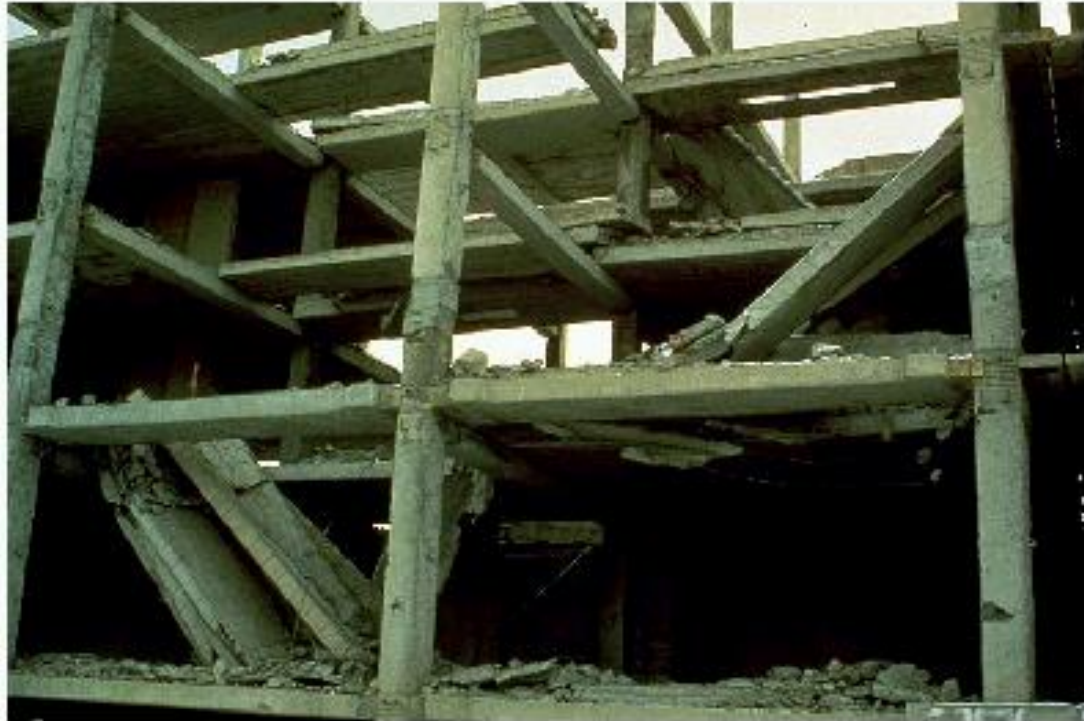
## **FAILURE MECHANISMS OF PRECAST CONCRETE FRAME-PANEL BUILDINGS**

*Taken at 10:00 a.m. on December 24 in Leninakan*

shows the failure of floor planks of a building under construction which was to become the new building of the Polytechnic Institute. The floor planks, of lightweight concrete, hollow-core, and approximately 4 ft x 6 ft x 8 inches are simply supported on the beams over a 2 to 3 inch seat. There are no ties between the planks or between the planks and the beam reinforcement.

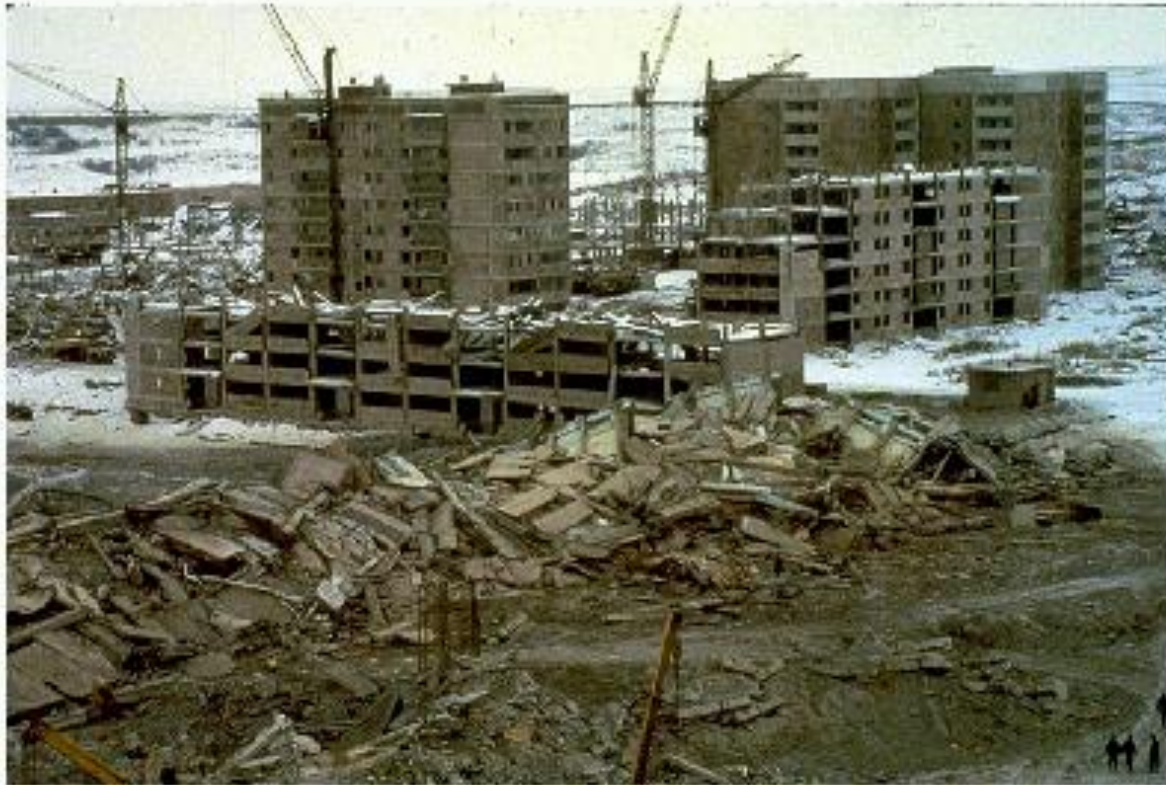
## PRECAST CONCRETE PANEL BUILDINGS

In the Soviet design of precast concrete panel buildings, virtually every precast interior wall is used as a load-bearing element having shear capacity. This design gives a stiff, redundant structure. Floors and roofs are precast concrete planks, but with positive infrastructural connections between the various elements.

In this slide, taken at noon in Leninakan on December 27, the performance of precast frame-panel and precast panel buildings can be compared. Many precast frame-panel buildings in Leninakan collapsed and are shown in the foreground, including one under construction. Precast panel buildings, in contrast, performed very well and are shown standing in the background. The difference in performance is due to the basic differences in their design as well as possibly to specific characteristics of the ground motion. Site amplification in the 1.0 to 2.5 second band was found in the strong motion records of the aftershock sequence recorded in Leninakan may have generated a greater load on the concrete frame-panel buildings.

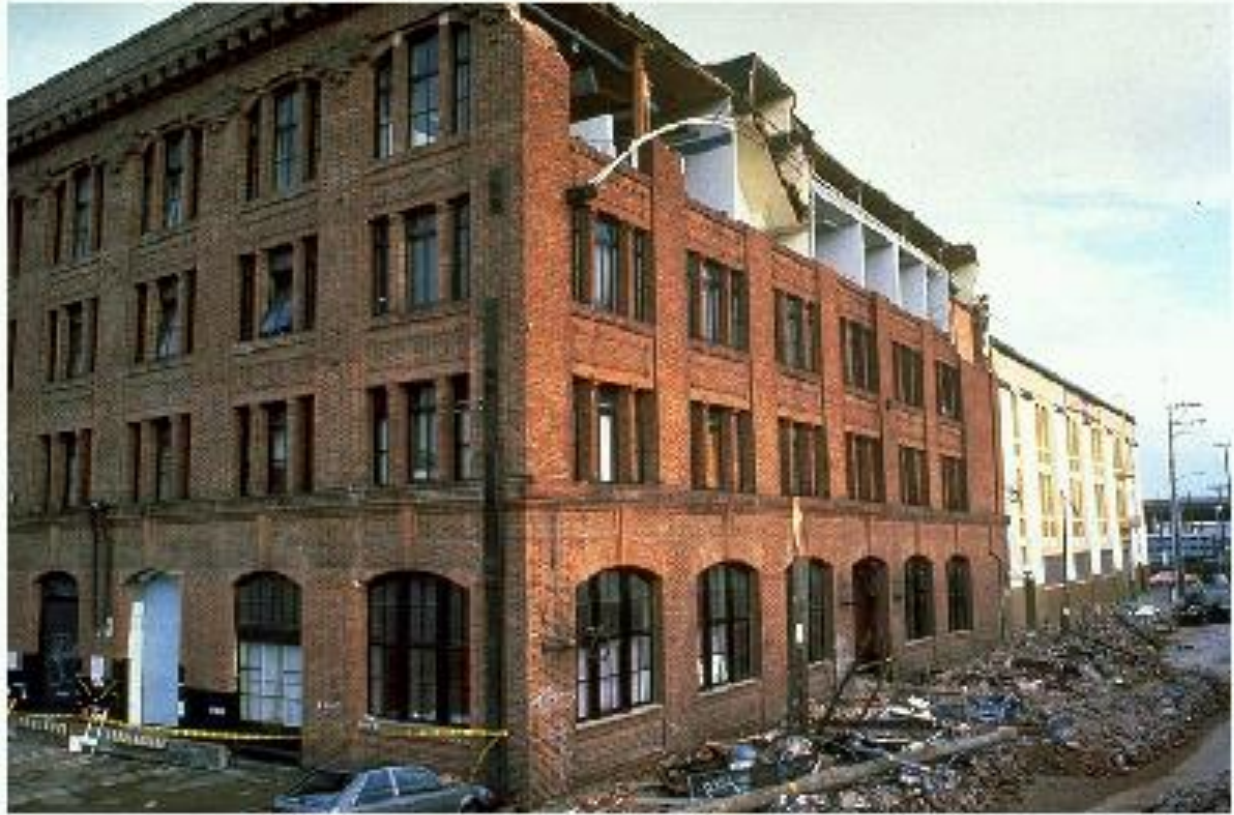
## **San Francisco**

118 km (70 miles) from the Epicenter

Building officials and volunteers inspected more than 8,500 buildings; 260 were rated as "unsafe" and 1,400 as "limited entry." This slide shows the classic failure of an end wall of an unreinforced masonry building at Bluxome and Sixth Street. Six people were killed in a car outside of the building by the falling masonry.

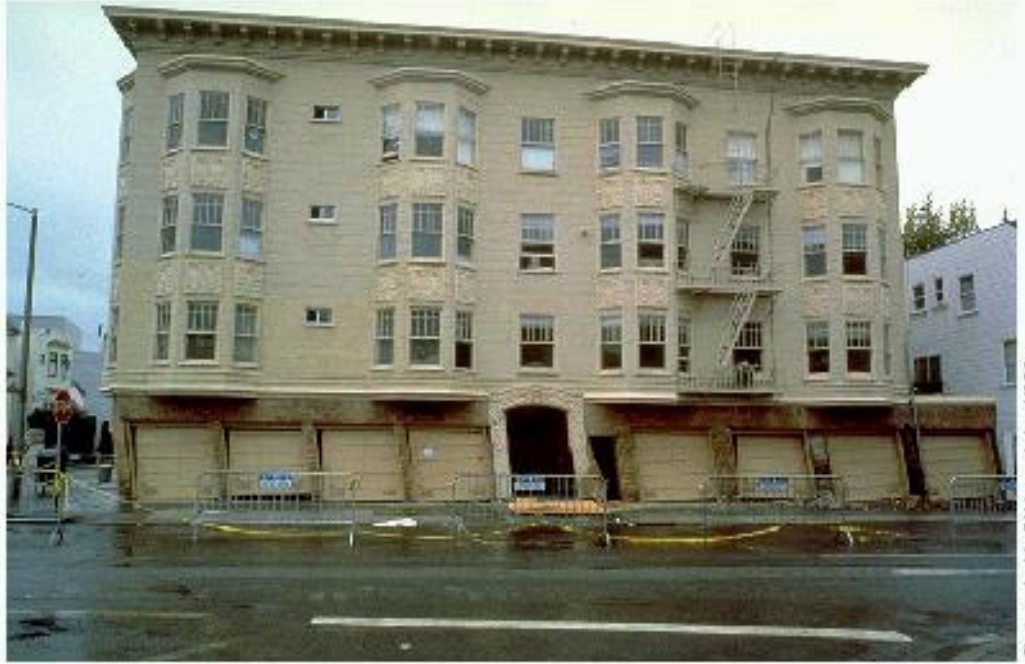
## Marina District of San Francisco

The soft story weakened this structure. The level of ground shaking and the influence of the land fill on liquefaction and/or ground motion amplification were factors that also contributed to the damage.

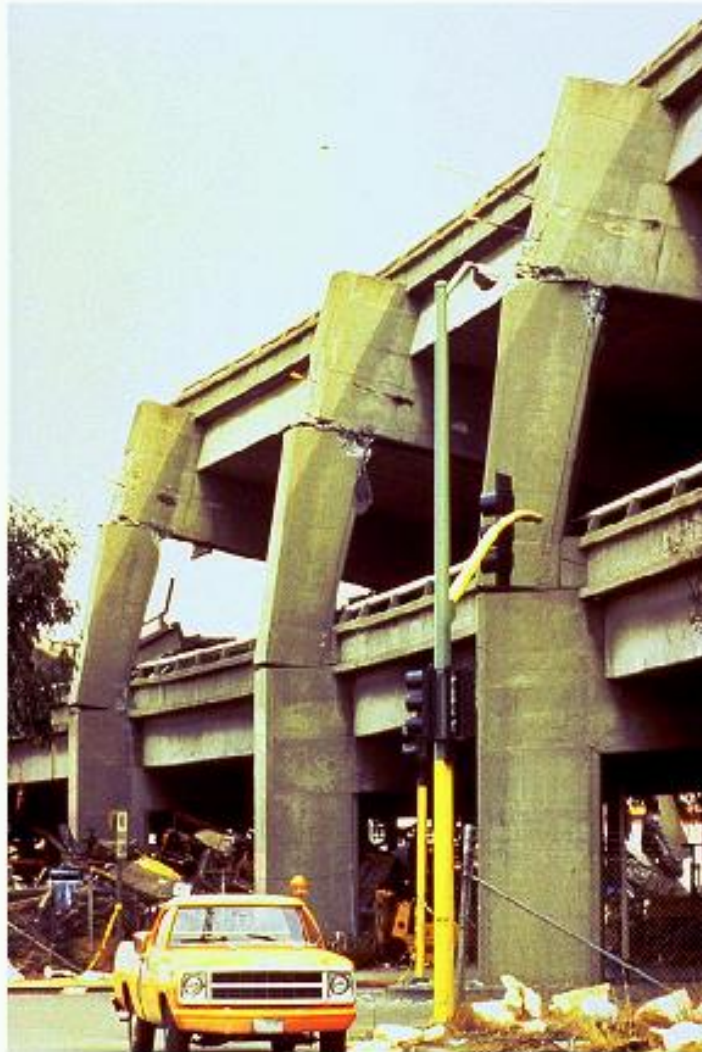
### **Detail of Failure: 1-880**

A view looking north at the west side of three type 2 bents. These bents included prestressing of the upper girders. In this particular mode of failure, only the east columns of the upper frames failed.

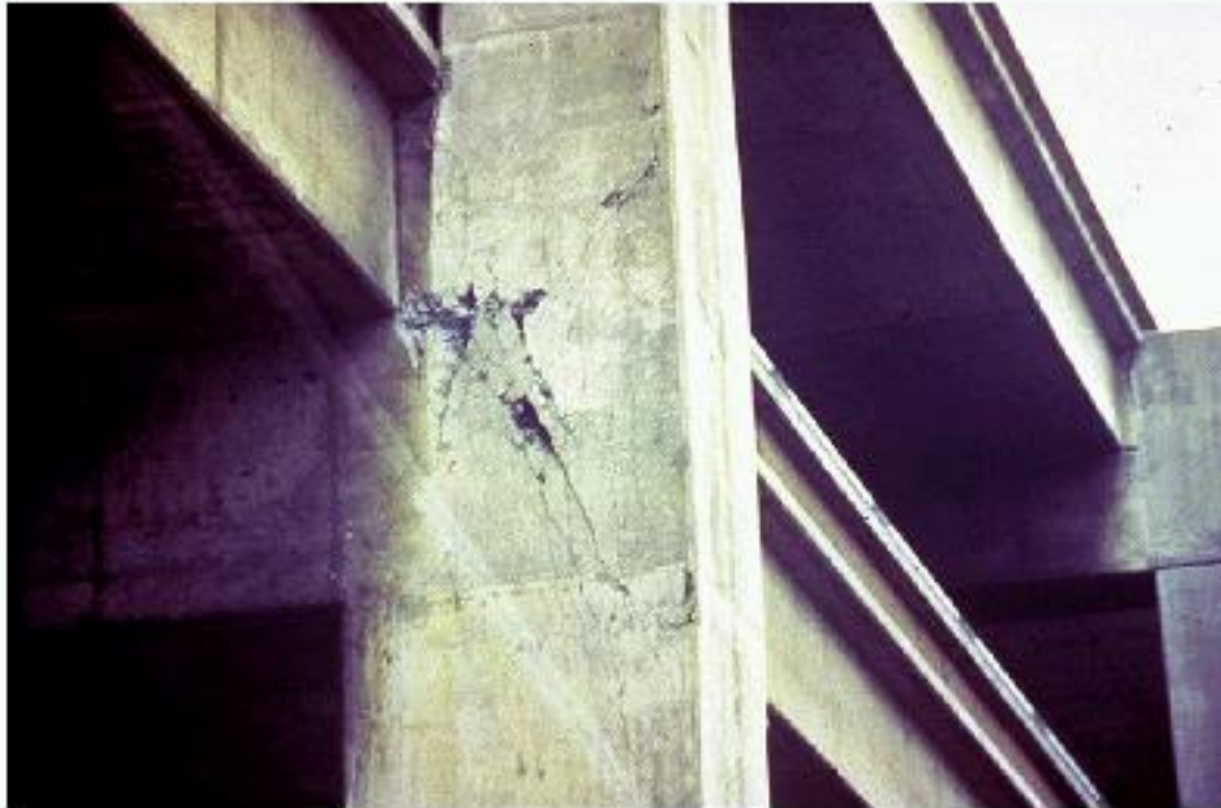
### **Close Up of Joint Failure: Embarcadero Freeway**

The reasons for damage to the Embarcadero Freeway are likely the same as the reasons for the damage to I-880, namely: 1) the structure was built prior to the adoption of modern seismic design criteria, and 2) both locations experienced large ground displacements. The damage correlated with that portion of the Embarcadero Freeway where a transition in the bent configuration occurred.

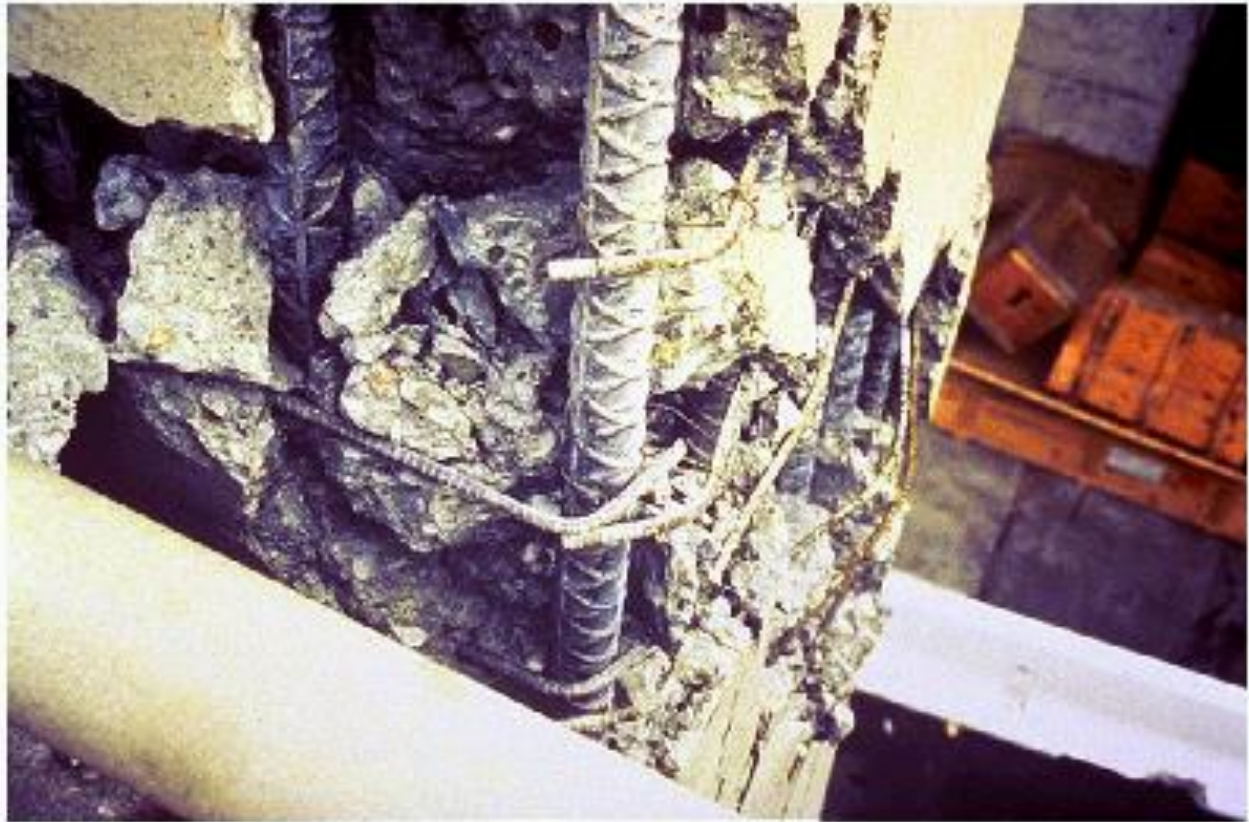
## Reinforcing Details: I-280

A close-up view of reinforcing details of failure zone in bent 51. Note anchorage failure of ties.

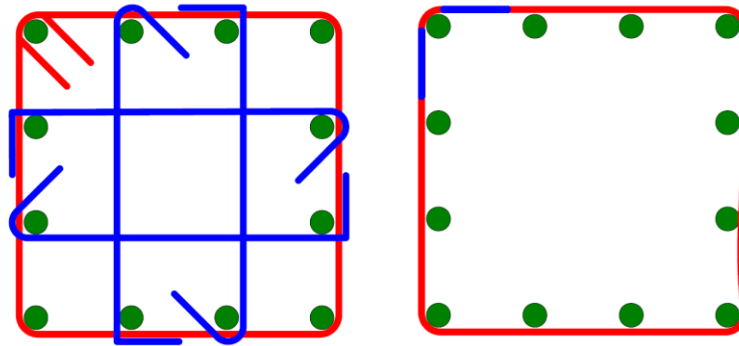
Fig. 15. Comparison on standard detail (left) and bad detail (right) regarding to hoops and tie bars.
