# **Overview of Earthquake Engineering**

**Hong-Gun Park**  
**Seoul National University**

1. Causes and damages
2. Principles of earthquake design
3. Design considerations
4. Earthquakes in Korean Peninsular

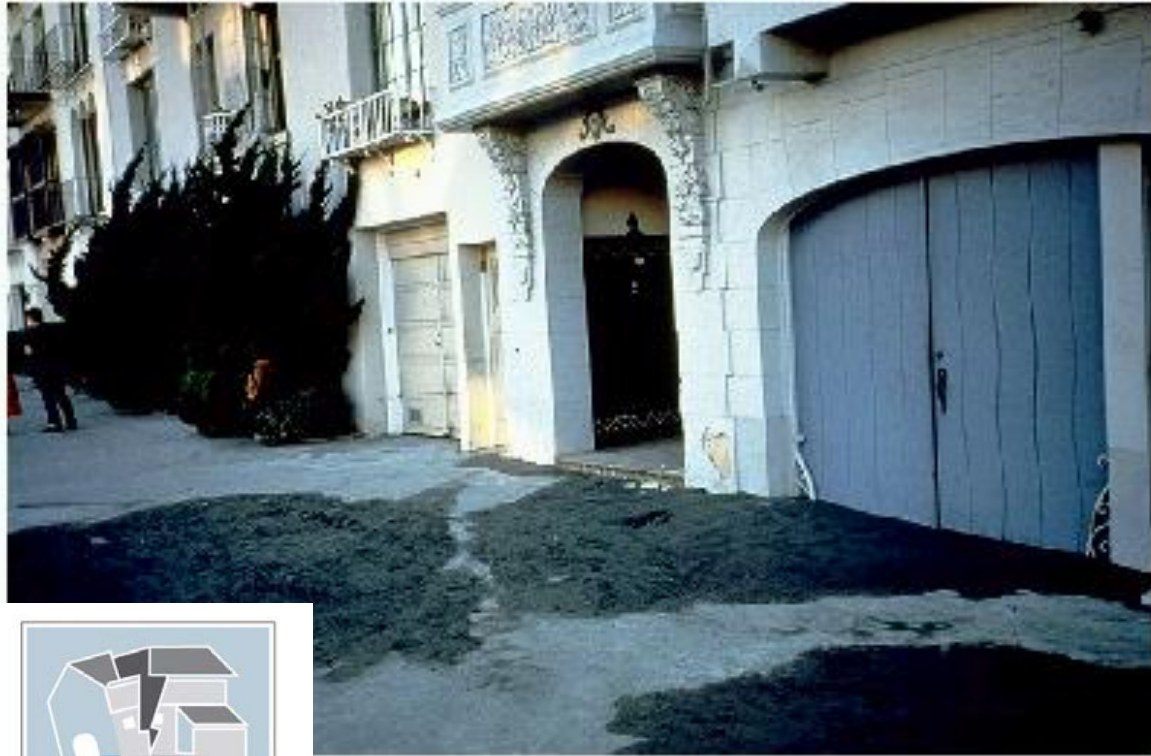
out the ground failure zone - erupting onto the Marina Green (Slide 12) and s, through cracks in garage and basement floors, and next to buildings (Slide it near Cervantes). At most locations, ejected sand was dark gray in color, edged from the Bay bottom; however, at a few locations, ejected material was characteristics of nearby dune sand (Slide 14, taken at Scott and North Point

Fig. 4. Soil liquefaction process

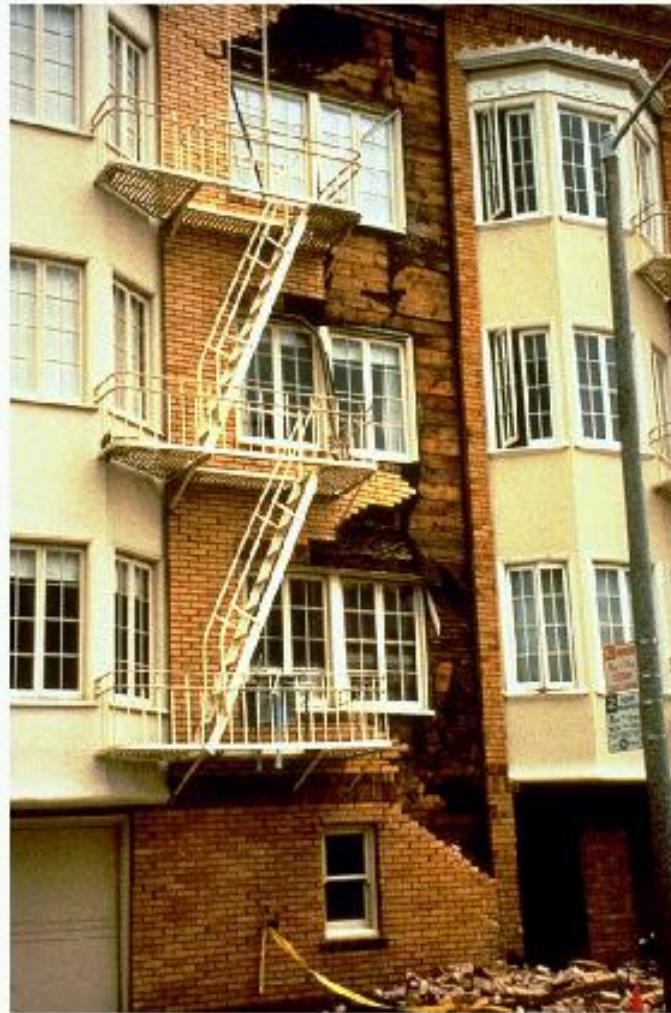
### **Brick Facade Collapse**

While most of the buildings in the Marina district are wood-frame structures, many have an ornamental brick facade. During the strong ground shaking, quite a number of these facades became unattached from the building and crashed down onto the sidewalk or street.

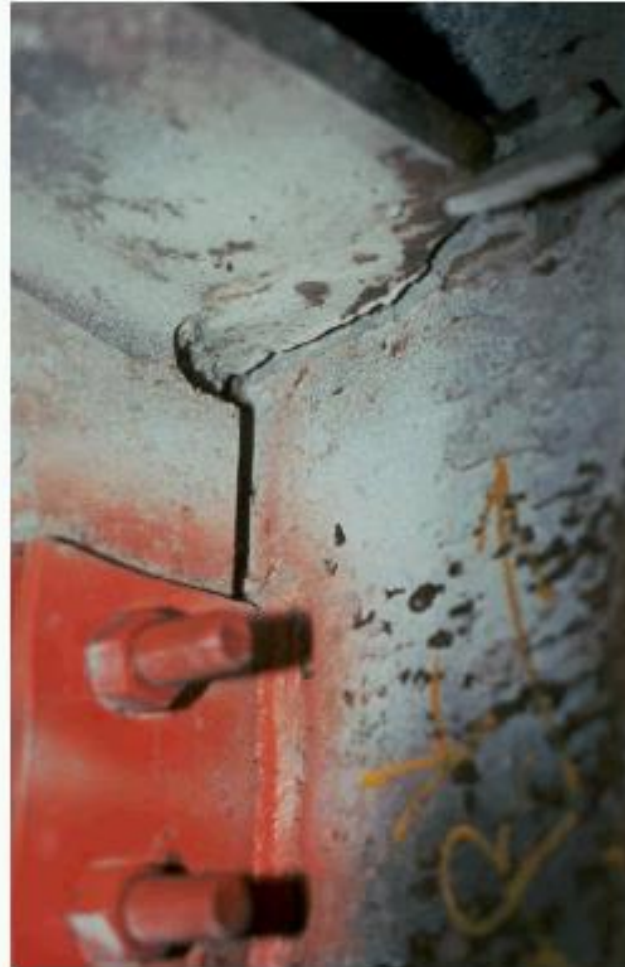
## Fracture of steel in welded connection

- 재료적으로 연성인 강 구조의 취약한 부분은 접합부. 특히 용접접합

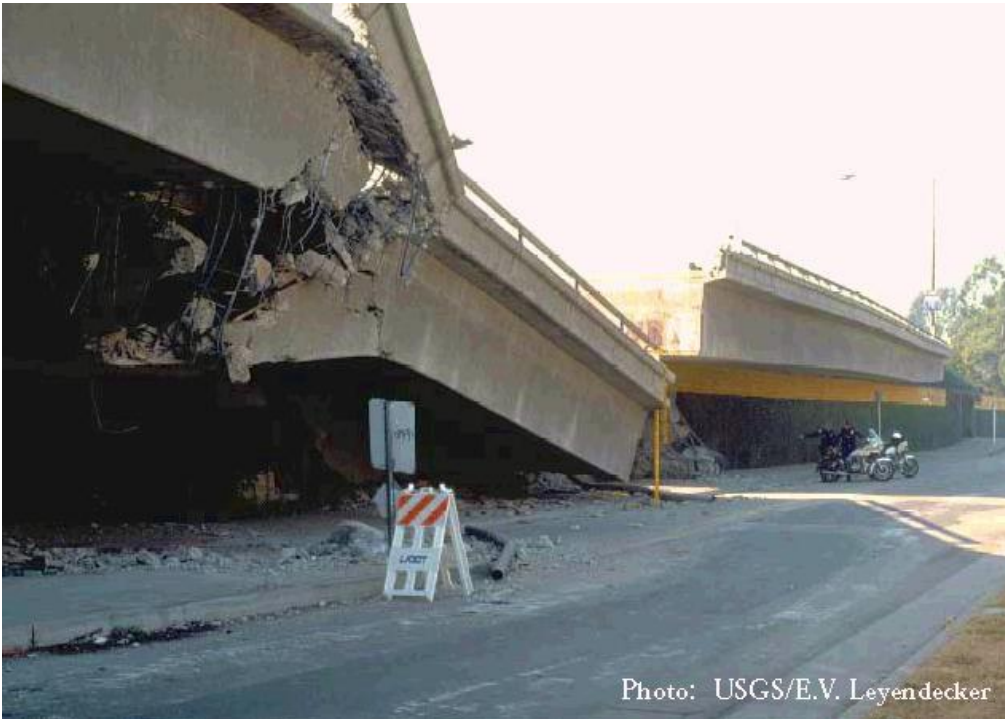
Failure of bridge columns caused by the lack of lateral reinforcement

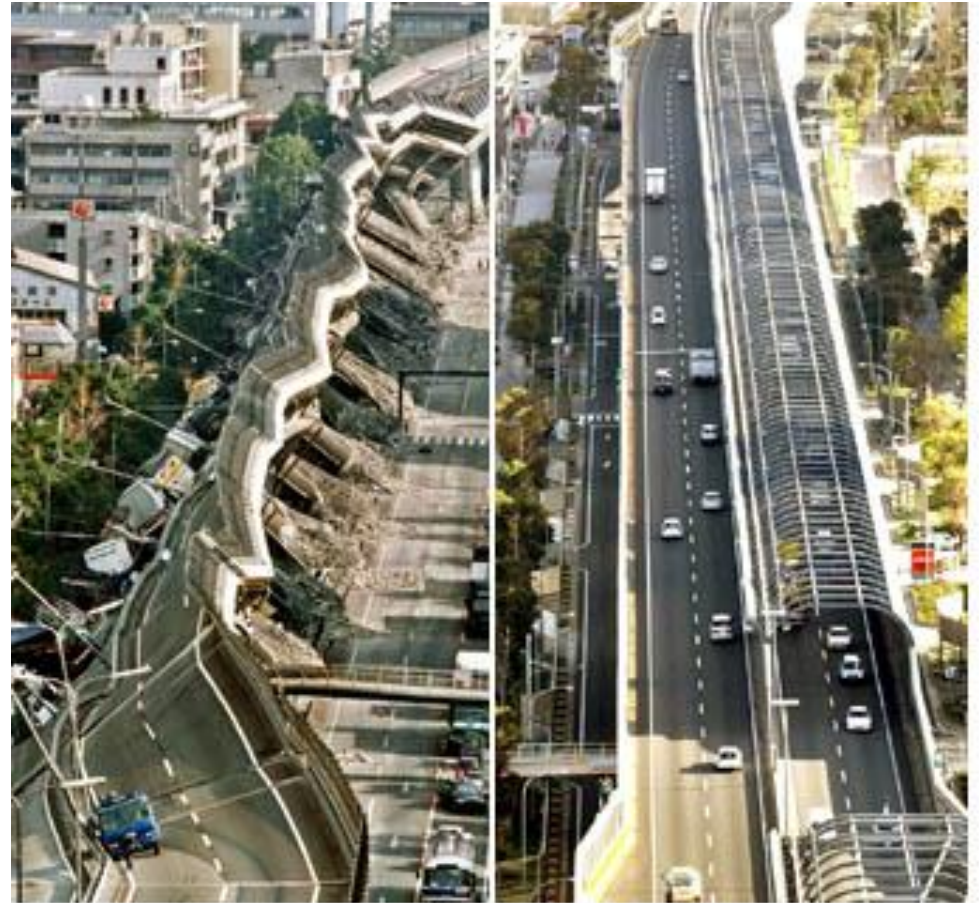
10년전인 1995년 1월 17일 엇가락처럼 휘어진 한신고속도로 (왼쪽)가 새로운 내진 공법으로 1년 8개월여의 공사끝에 말끔히 복구돼 차량들이 오가고 있다. /일본 산케이신문제공

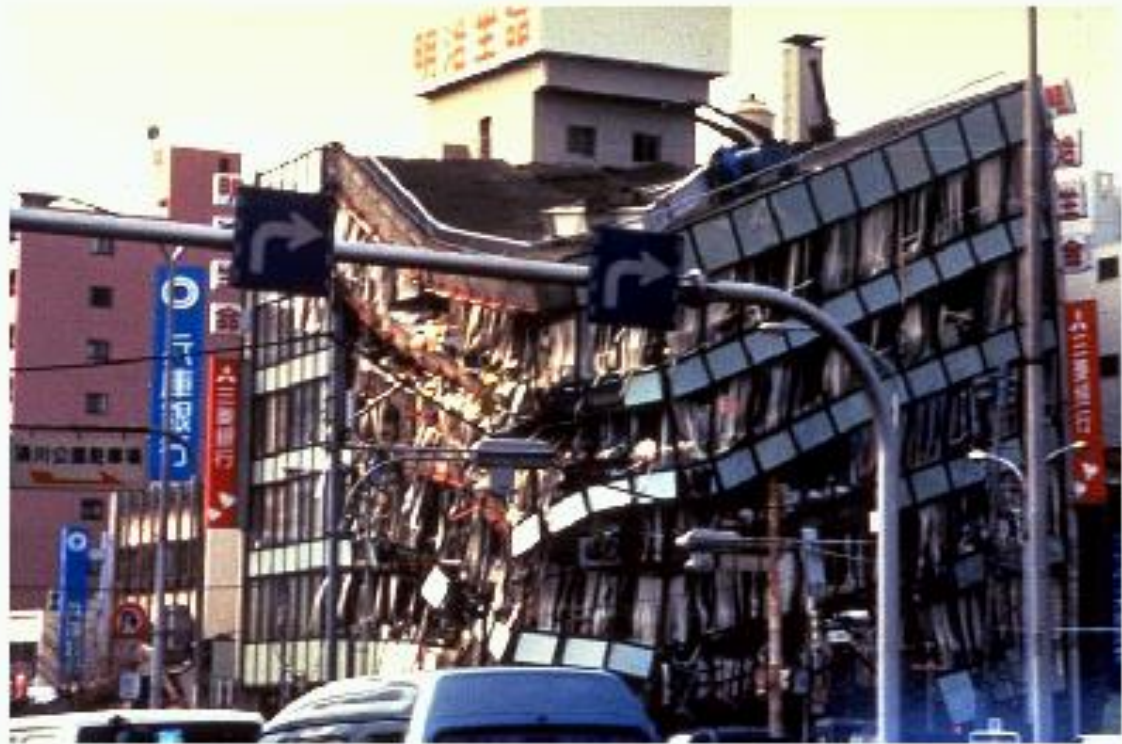
### **Slide 16-17:**

A number of buildings built on city-block corners sustained partial collapse at the corner of the building, or failed completely.

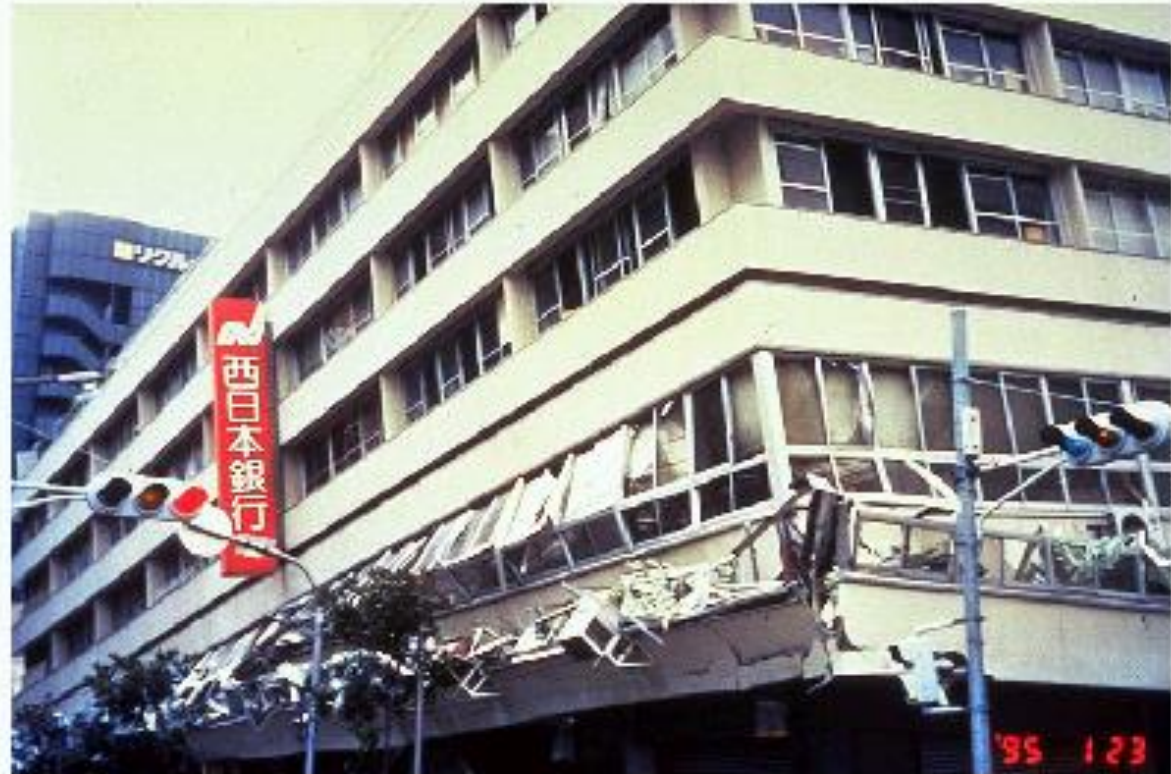
### Slide 18-20:

Partial or full collapse of a single story in buildings was the common failure for most of the larger buildings. The particular story that sustained partial or full collapse varied from building to building. First-story failure was more common than mid-level or upper-story collapse.

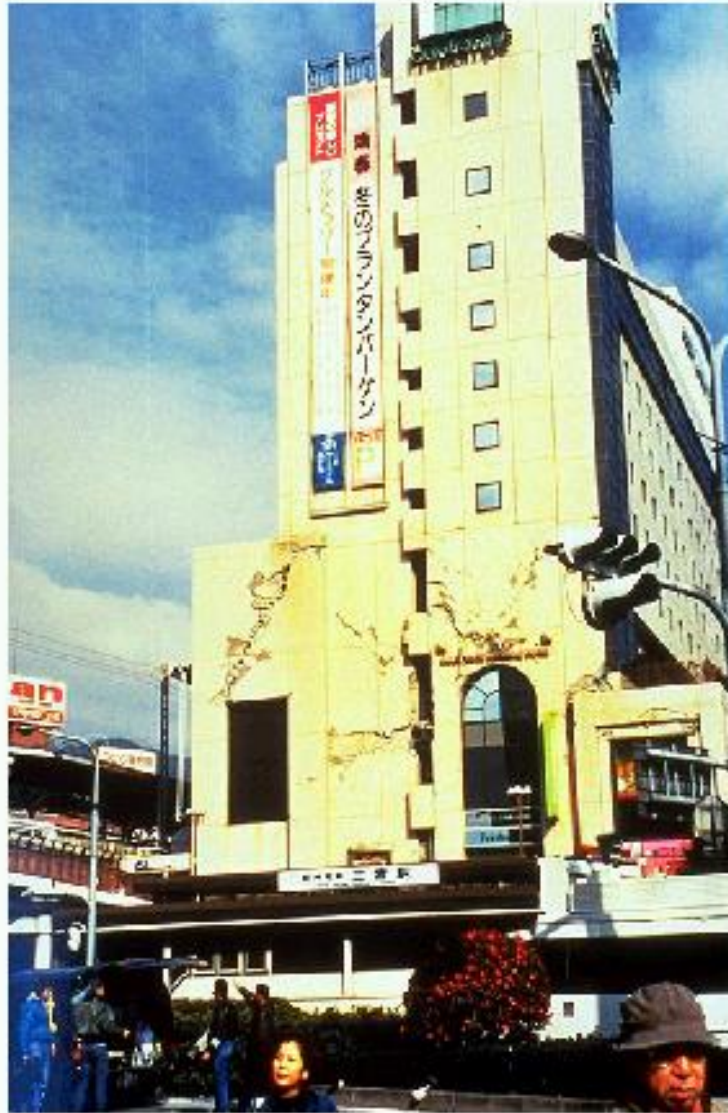
Severe damage to relatively modern hotel structure in downtown Kobe. While the majority of partial or complete collapses appear to be older, reinforced-concrete buildings (pre-1975), severe structural damage was also observed for buildings of steel or composite construction.

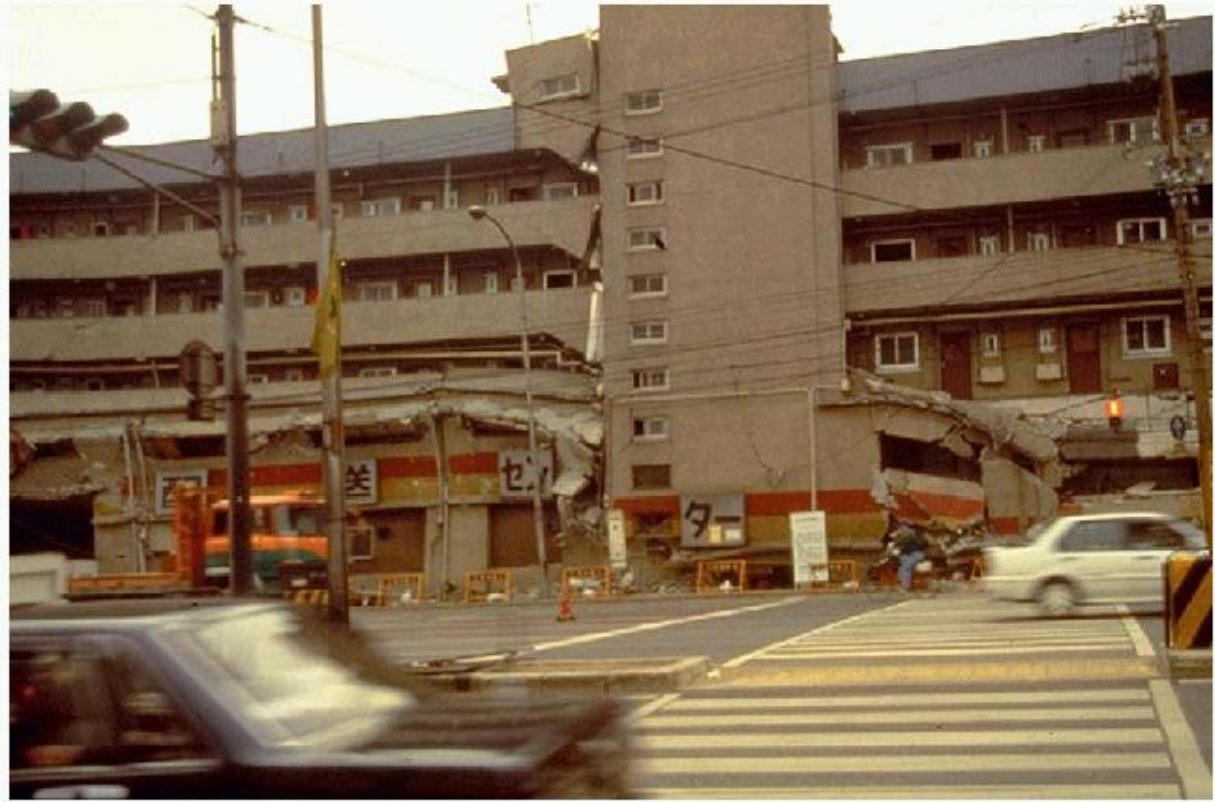
### **Pre-1971 Concrete Frame Buildings**

First story collapse of non-ductile concrete frame building. Collapse of soft first story concrete frame buildings were common.

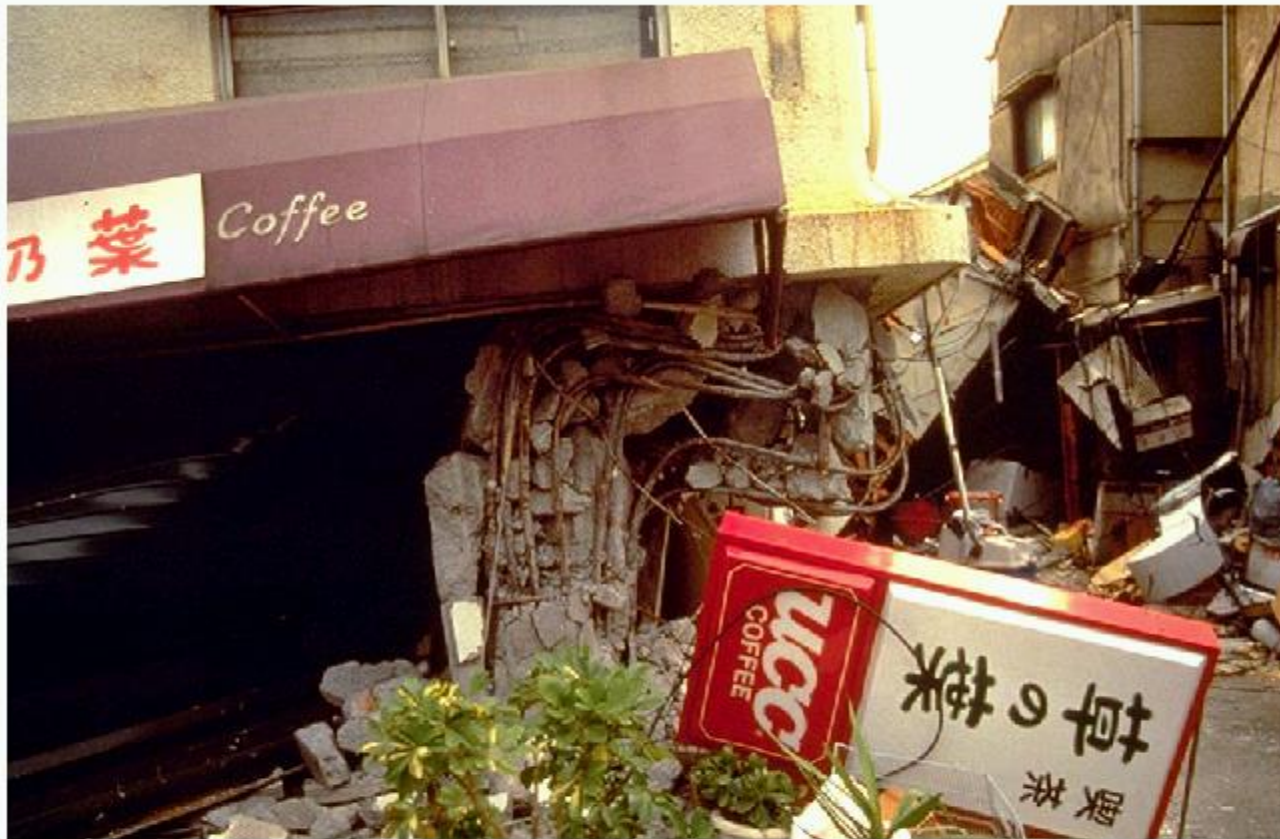
## Pre-1971 Concrete Frame Buildings

Collapse of another soft first story non-ductile concrete frame.

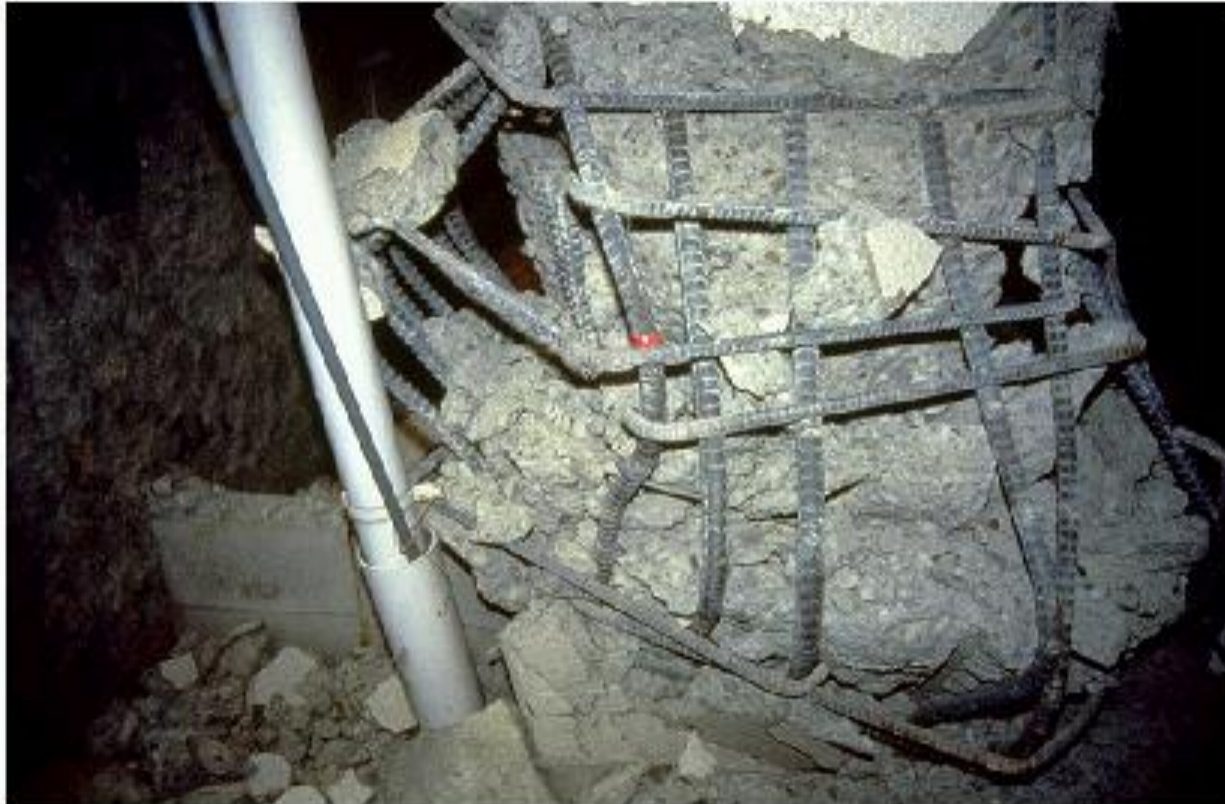
### **Newer Concrete Frames**

Five-year-old 6-story concrete frame with garage level collapse. This was an exception to the rule of good performance of newer concrete buildings. Note, however, that there were ductile detailing problems in the columns and the building had a severe vertical (soft-story) irregularity as well as a plan irregularity causing torsion.

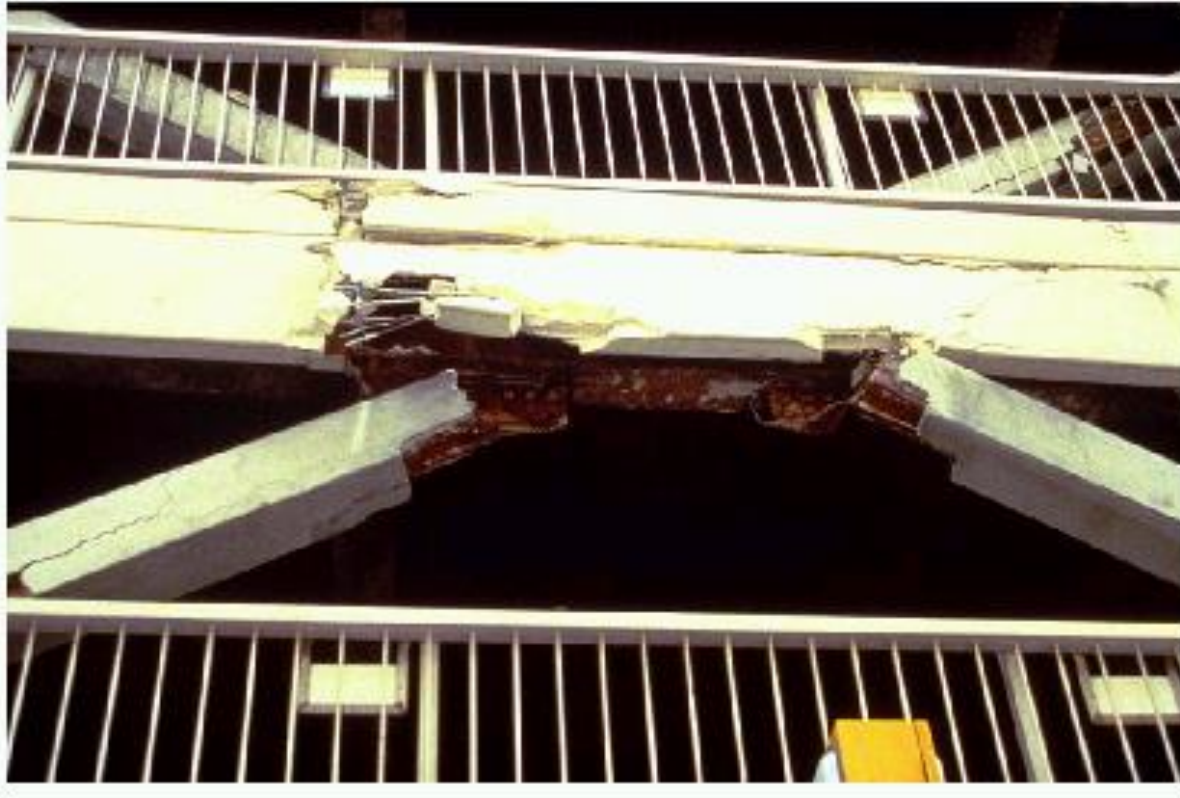
## **Steel Frame Buildings**

Mid-rise steel braced frame parking garages. There were many similarly damaged garages utilizing this construction type, common in Japan. As in the U.S., braced frames such as these suffered damage due to lack of connection strength and ductility. However, collapses were rare.

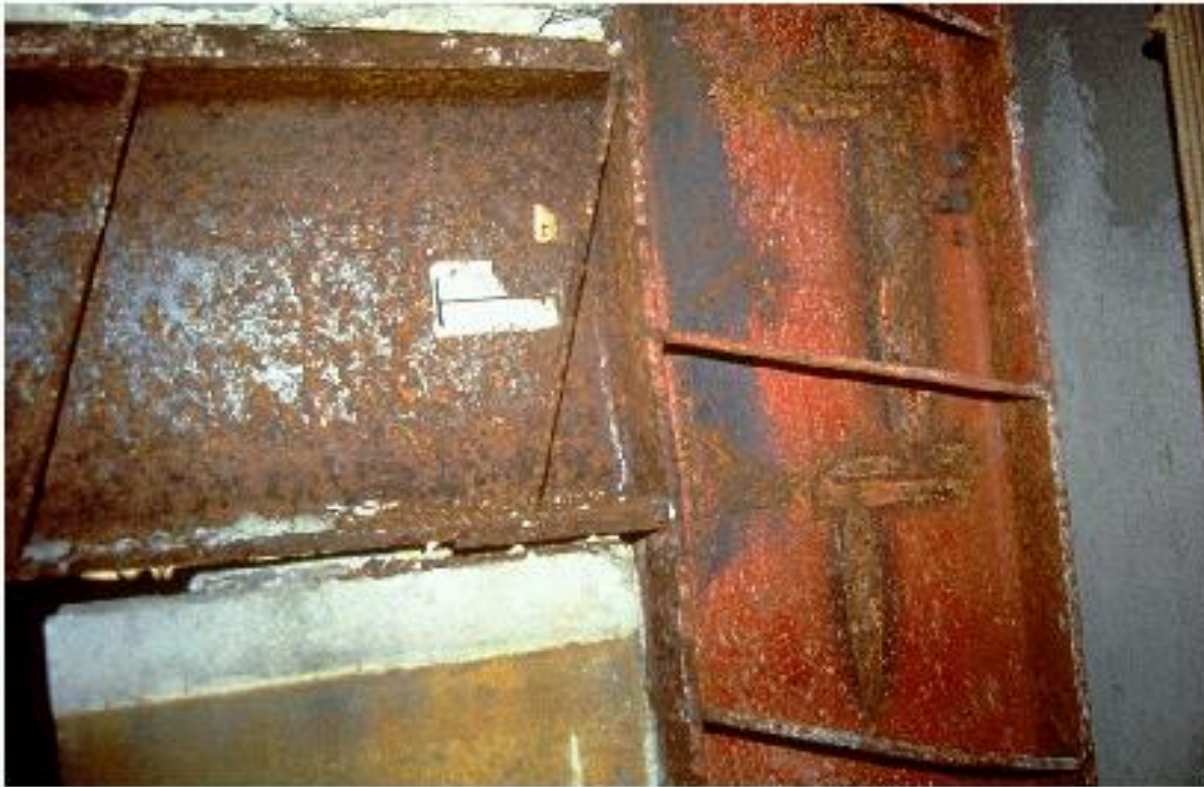
## **Steel Frame Buildings**

Older steel frame parking garage with bracing in one direction and moment frames in the other. The moment frames experienced fracture at the welded flange connections with cracking extending into the web.

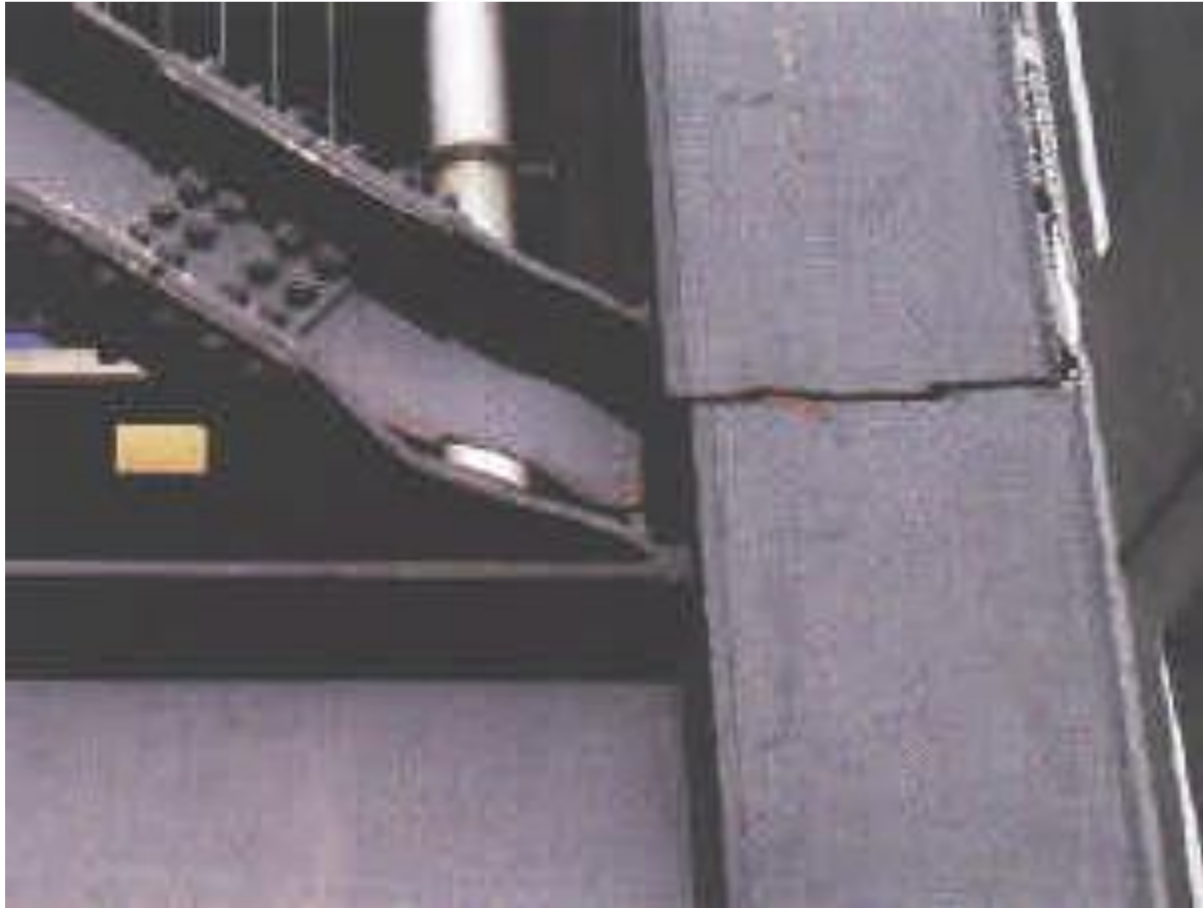
Fracture of steel tube column with thick plates

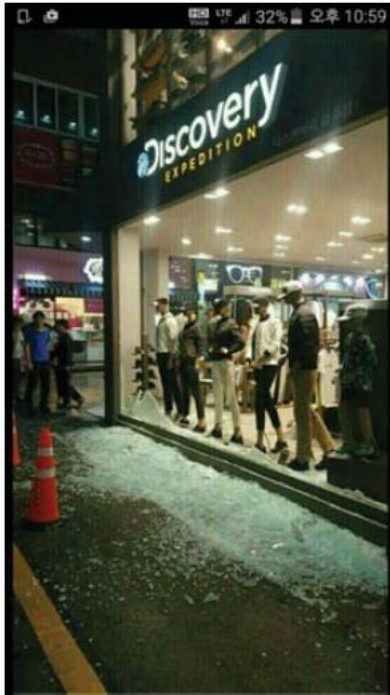
Show window shattered

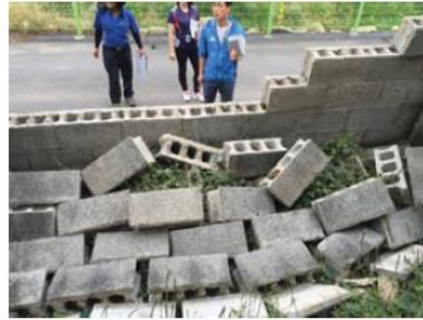
Unreinforced block wall fallen down

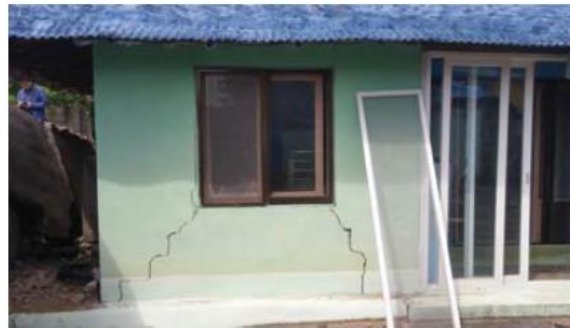
Typical corner cracking at opening

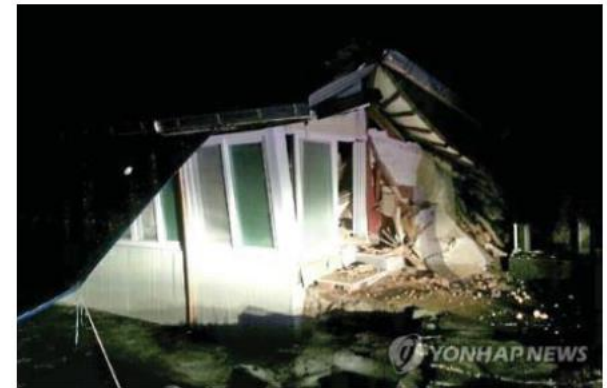
Failure in an already poor (non-engineered) construction

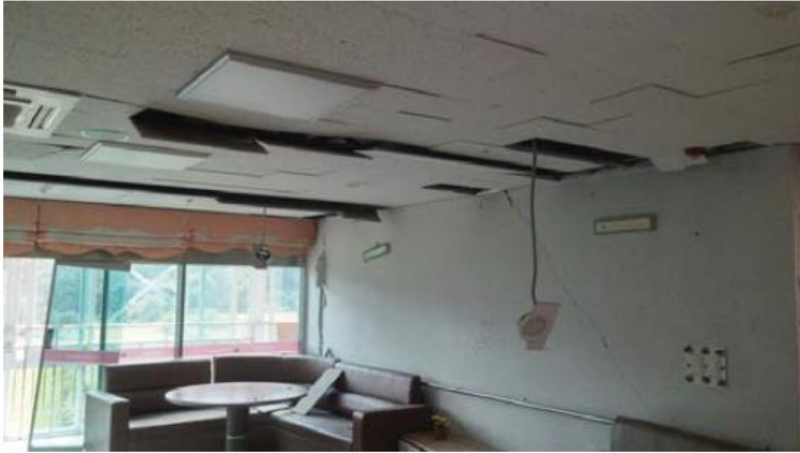
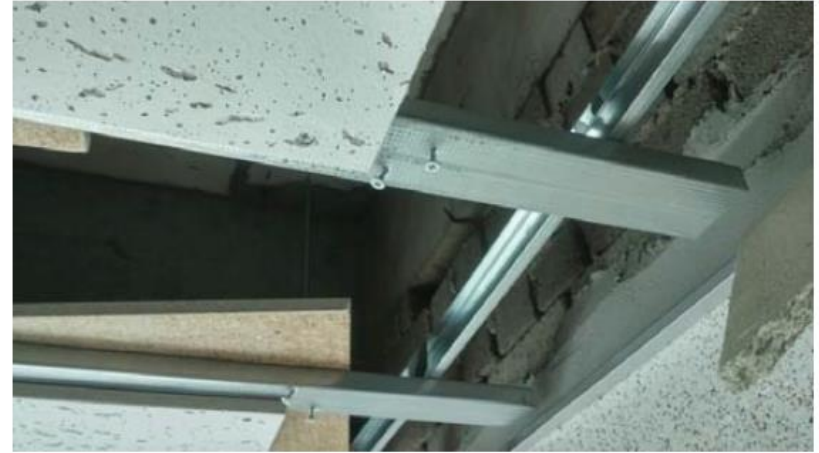
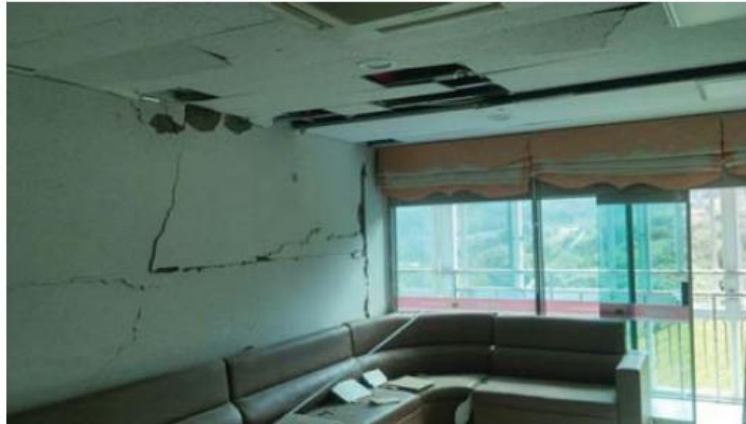
Damage observed in a 3-story RC Building (Ulju, Ulsan)\_ ceiling and brick wall failure

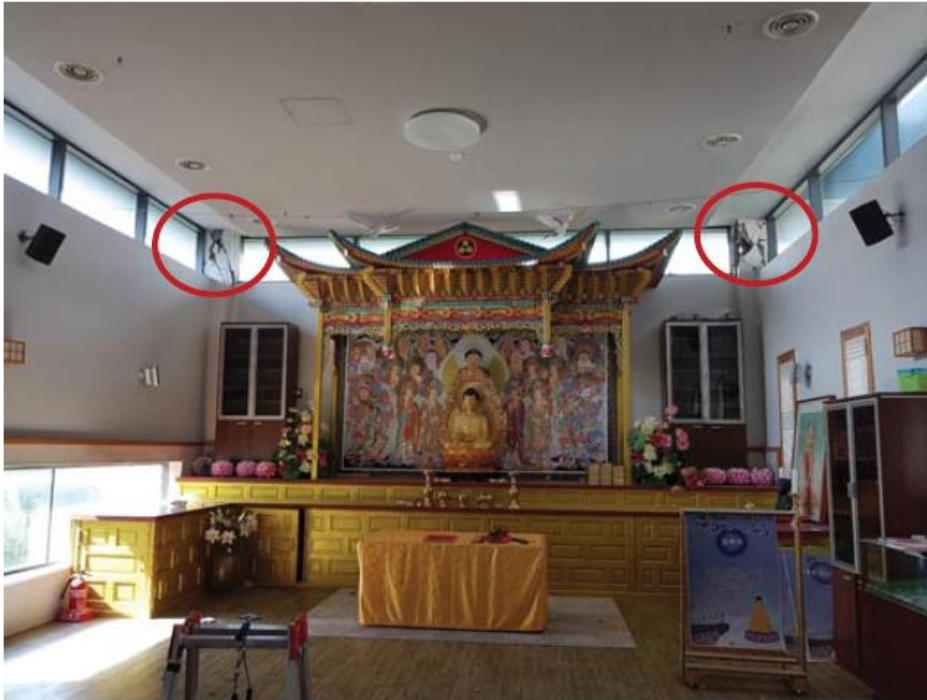
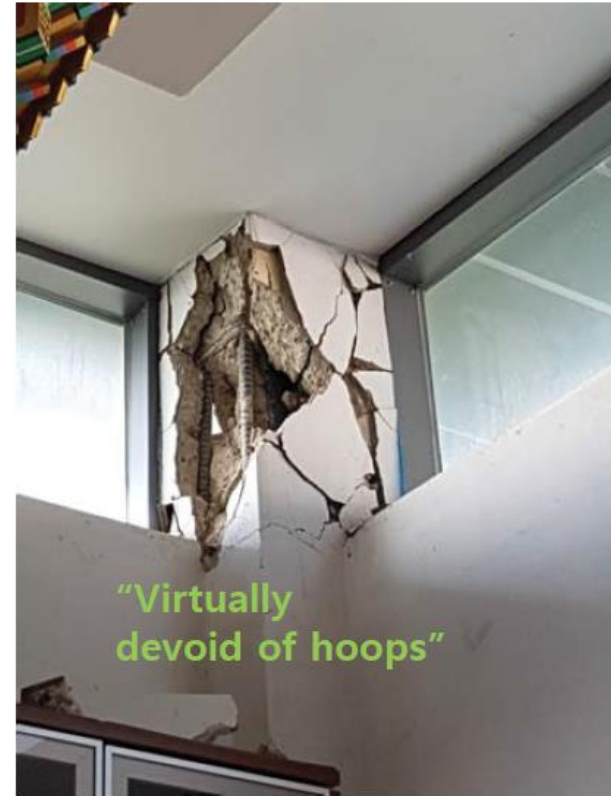
## The most impressive failure mode\_ “short-column” shear failure

One of the well-known seismic failure modes observed in a Buddhist temple: so called “short-column” shear failure  
Never imagined to see....

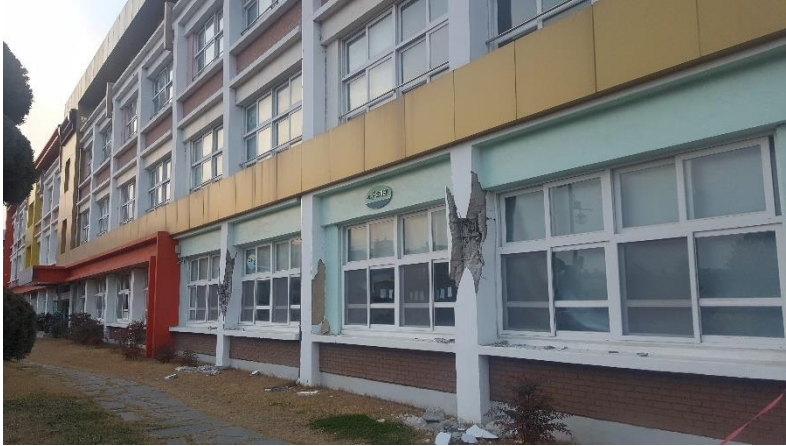
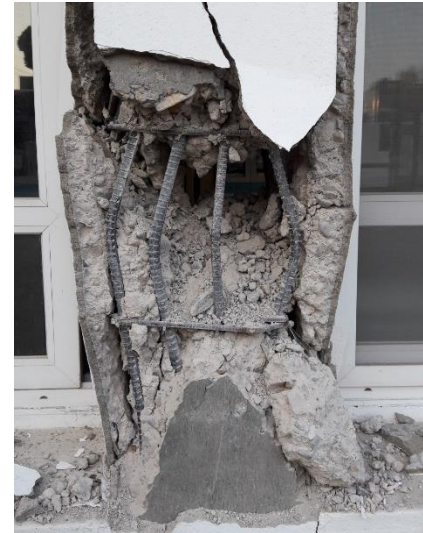
**Heunghae Elementary School**

**Short column effect  
By masonry wall**

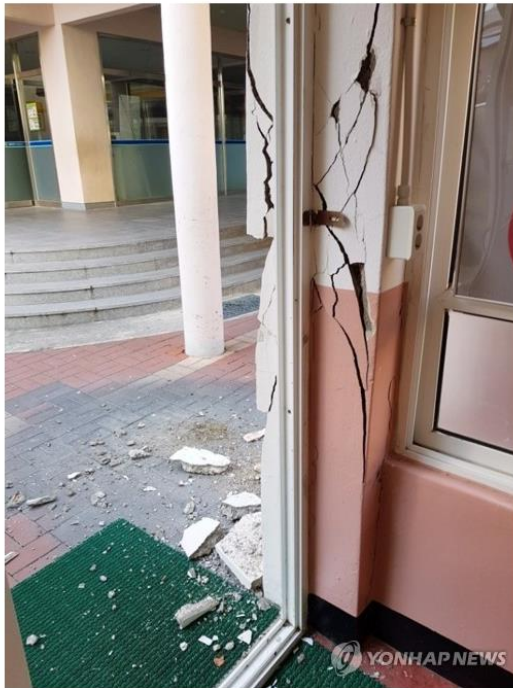
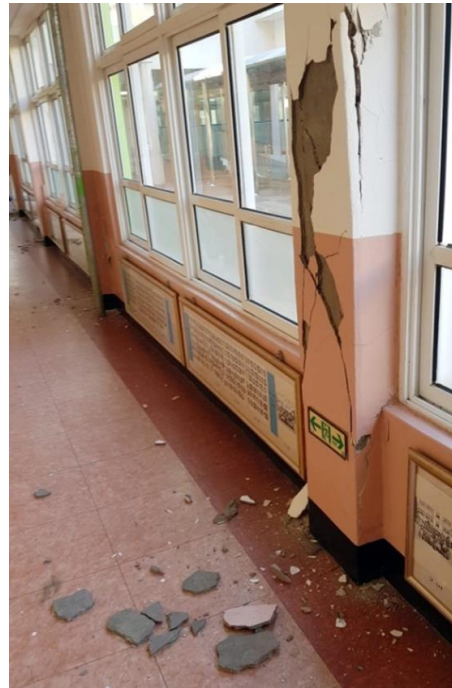
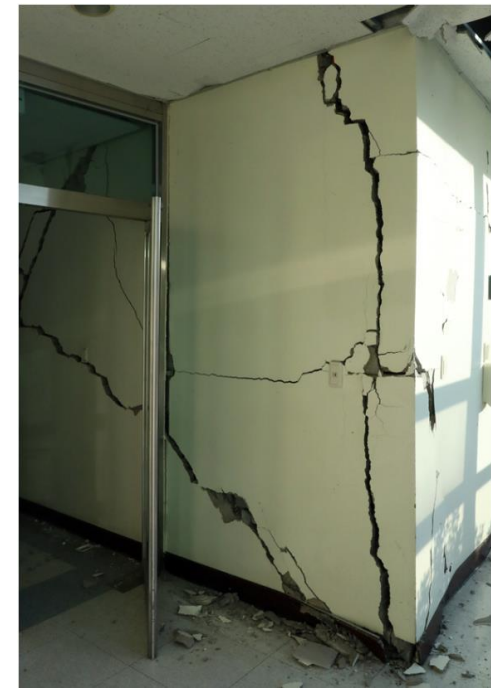
경북 포항 00초등학교

기둥, 내력벽 손상 / 피복탈락 및 균열

초등학교 지진 피해  
(포항=연합뉴스) 15일 발생한 지진으로 경북 포항 한 초등학교 건물 기둥과 벽 일부가 금이 가거나 부서졌다.  
2017.11.15 [독자 제공=연합뉴스]

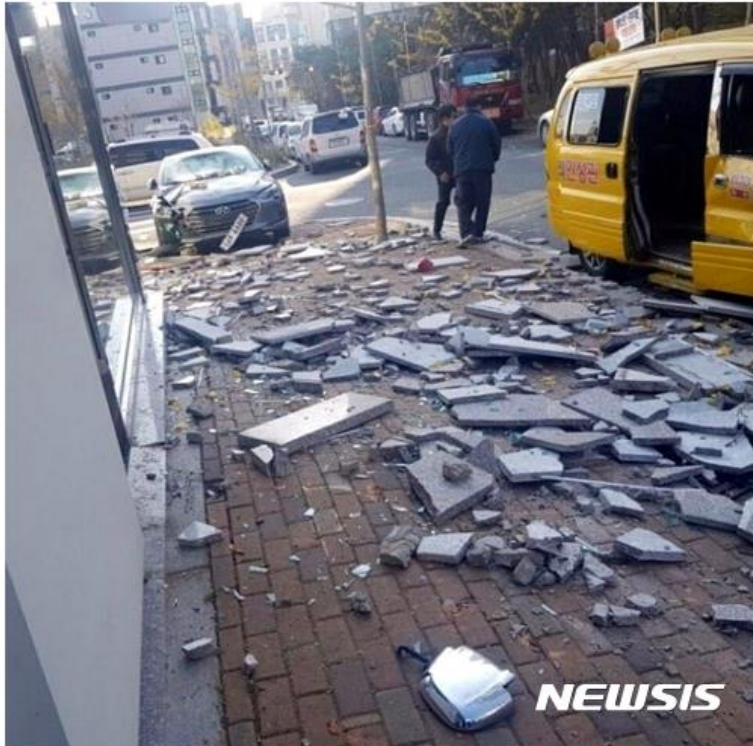
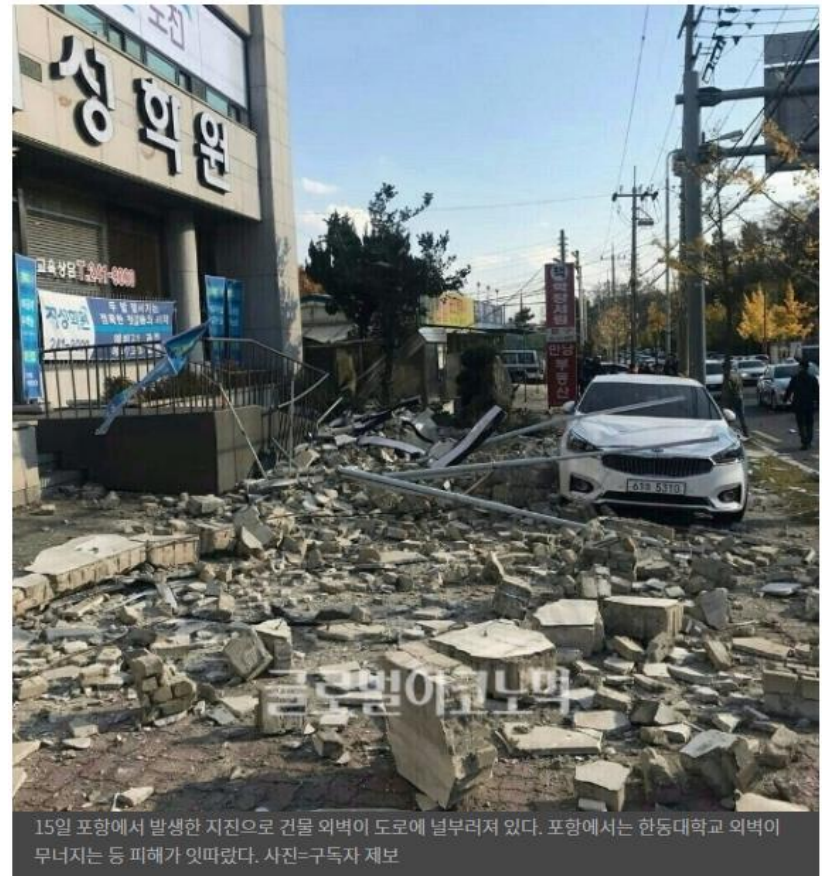
【포항=뉴스시스】박준 기자 = 15일 오후 2시29분께 경북 포항시 북구 북쪽 6km 지역에서 규모 5.5의 지진이 발생해 도로가 갈라지고 건물 외벽이 무너지는 등 피해가 속출했다. 2017.11.15june@newsis.com

15일 포항에서 발생한 지진으로 건물 외벽이 도로에 널부러져 있다. 포항에서는 한동대학교 외벽이 무너지는 등 피해가 잇따랐다. 사진=구독자 제보

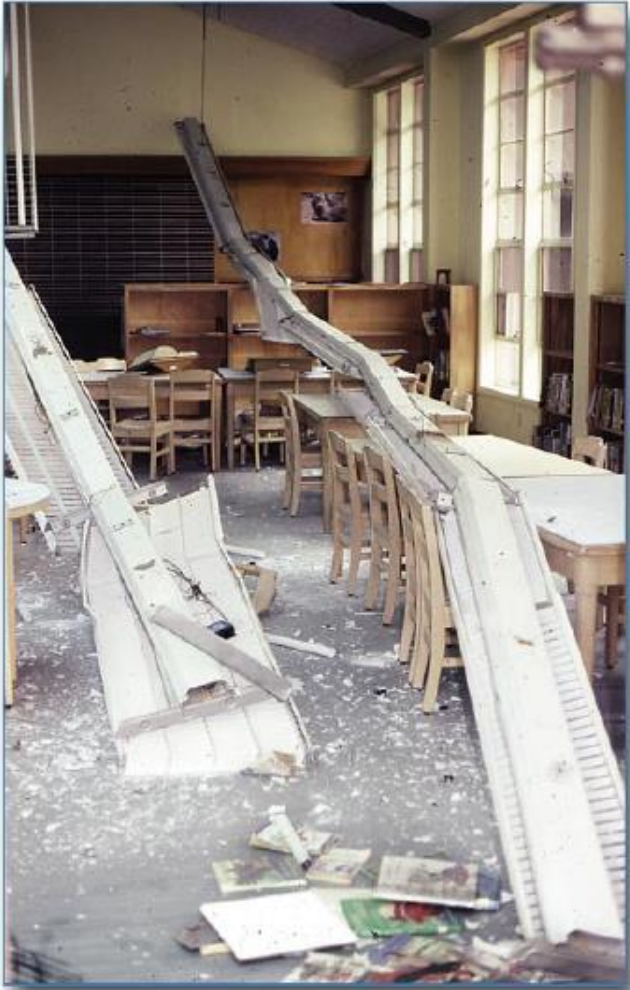
**Falling of ceiling**

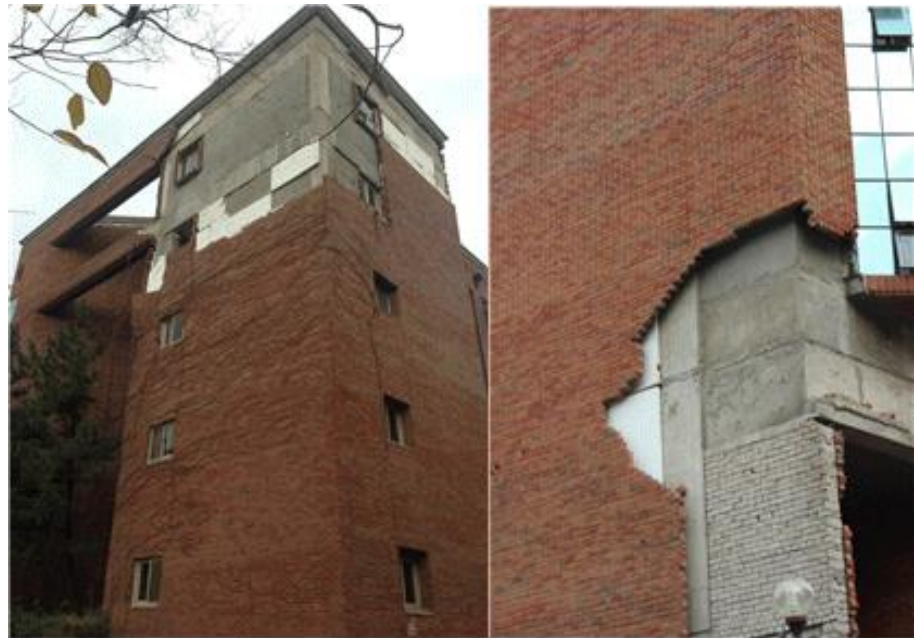
**Falling of masonry wall**
