Overview of Earthquake Engineering

**Hong-Gun Park
Seoul National University**

1. Causes and damages
2. Principles of earthquake design
3. Design considerations
4. Earthquakes in Korean Peninsular

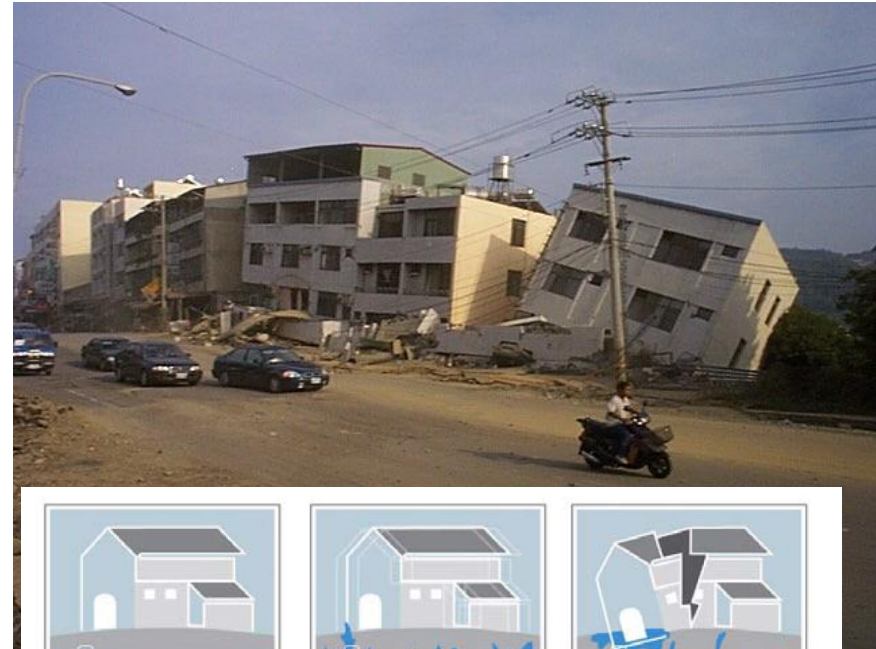
지반의 액상화(liquefaction)
Liquefaction occurs when $M > 6.0$

Fig. 4. Soil liquefaction process

Fig. 4. Soil liquefaction process

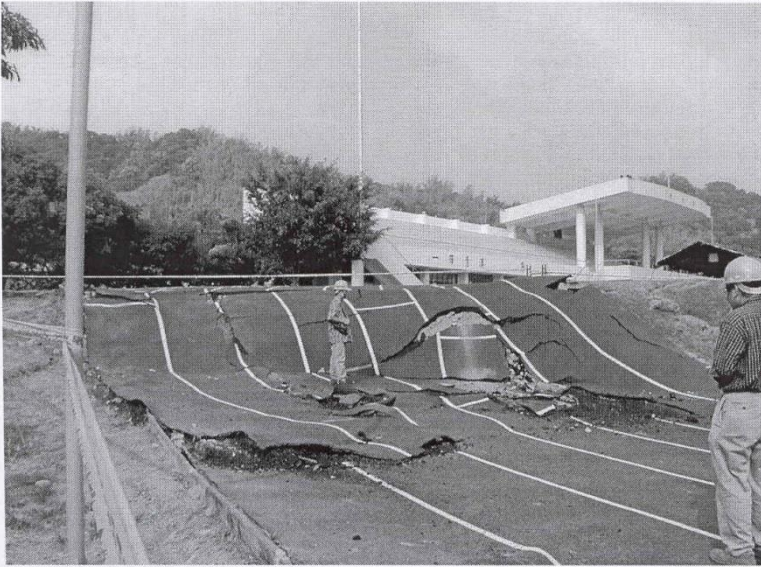
Figure. 1-20 Ground uplift along the fault in the 1999 Chi-Chi Earthquake (Photo by Dr. Farzad Naeim).

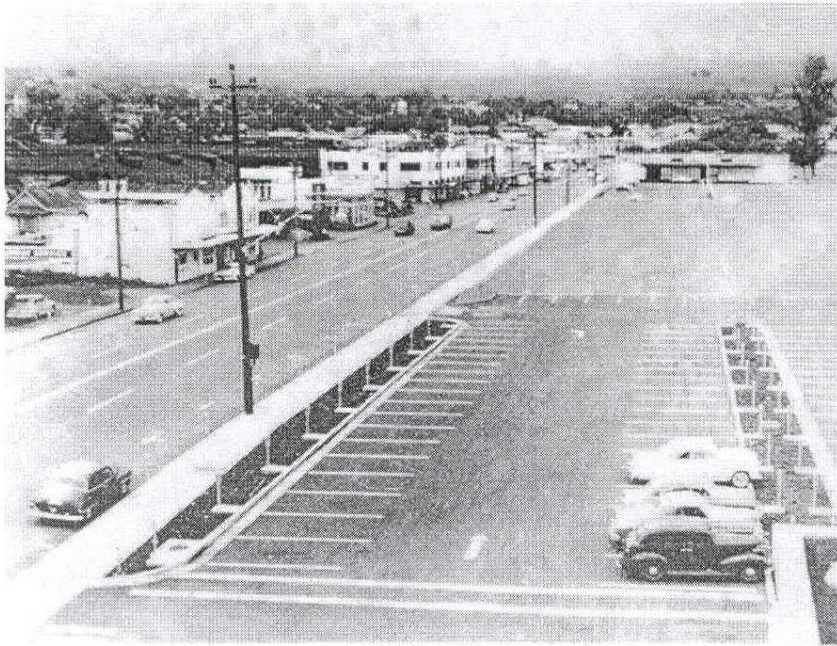
Before tsunami

Figure 1-21 Damage at Hilo, Hawaii, due to tsunami of May 23, 1960. (Photos courtesy of R. L. Wiegel.)

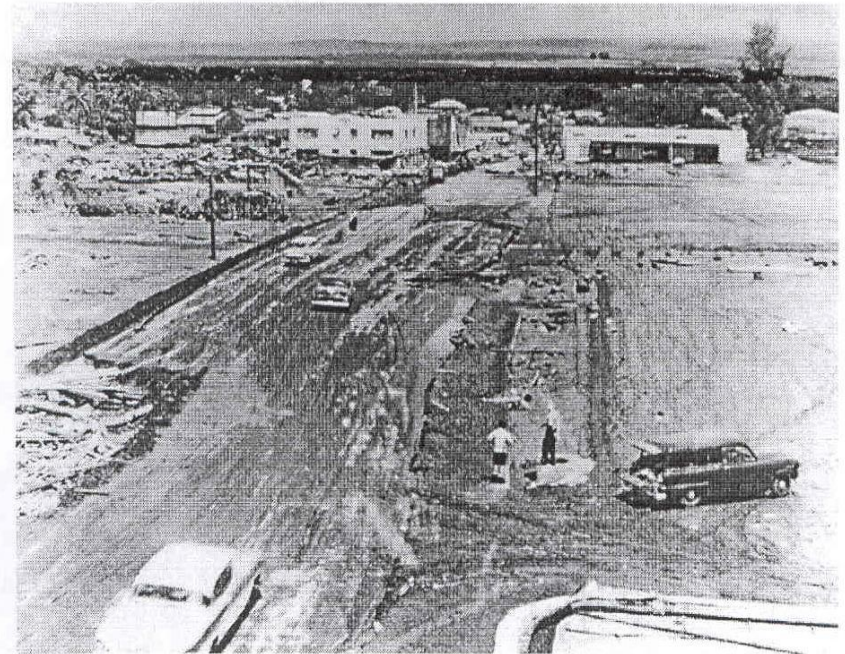
After tsunami

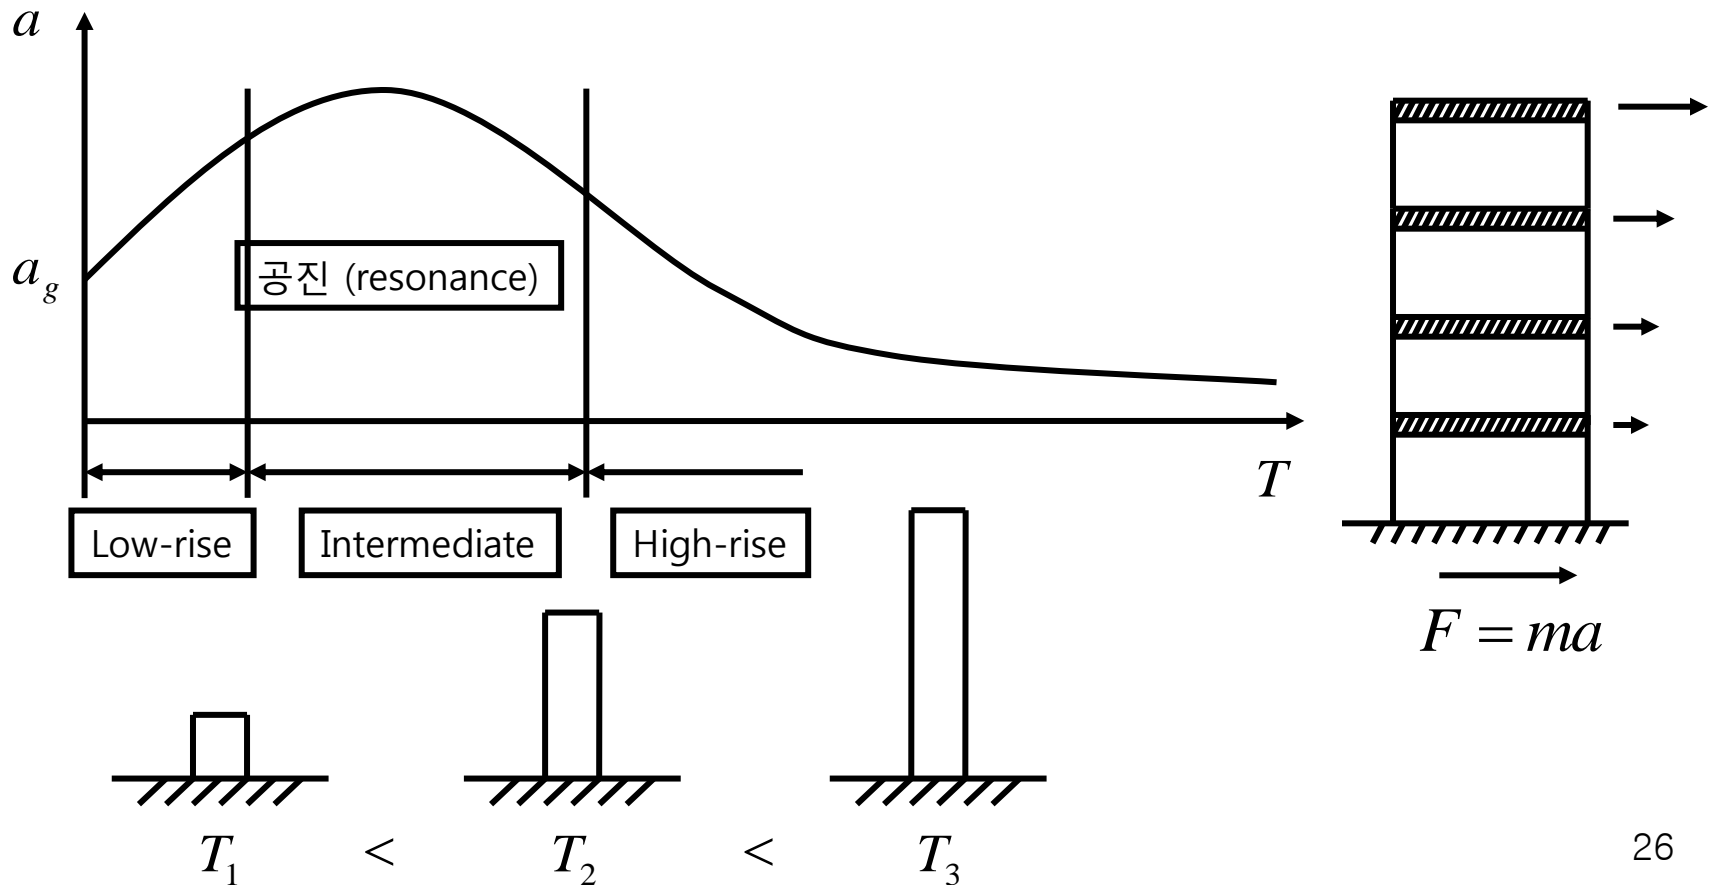
Response spectrum – key feature of modern earthquake design codes

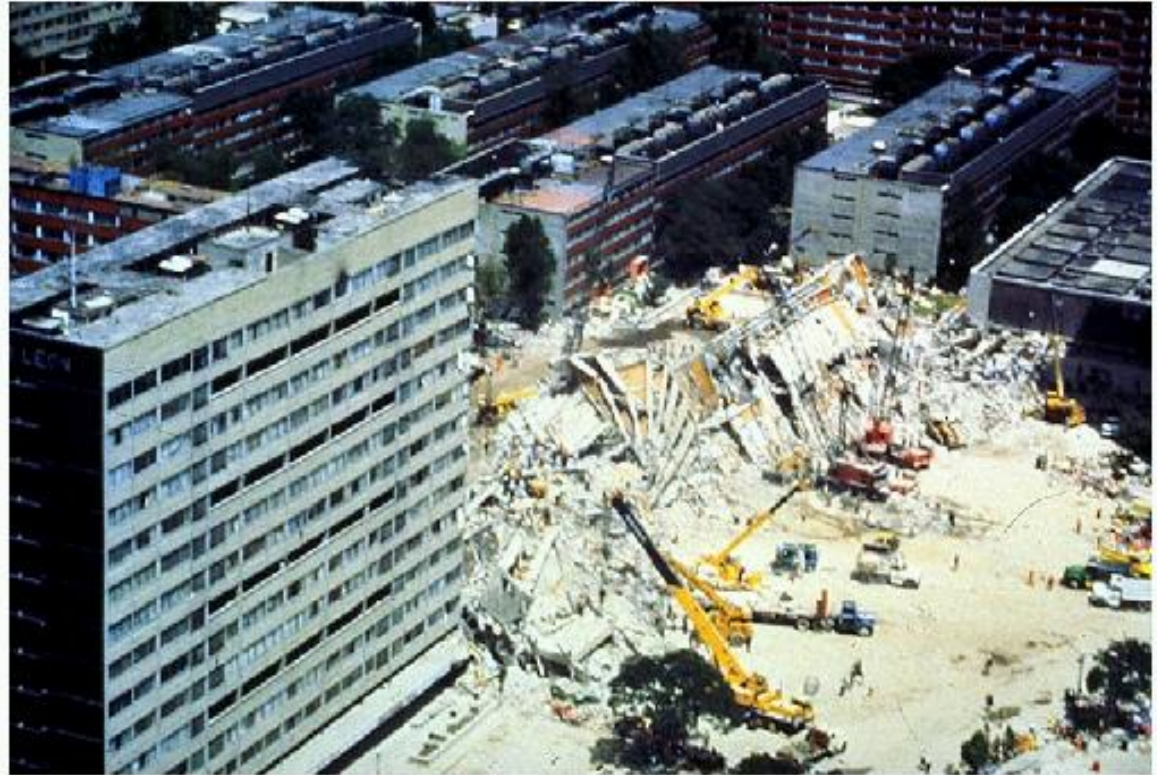
Aerial view of Nuevo Leon Looking Northwest

-Resonance between
soft soil deposit and
high-rise buildings with
long dynamic periods

Aerial view looking northwest of the collapsed Nuevo Leon Building. Hundreds died in the collapse. .

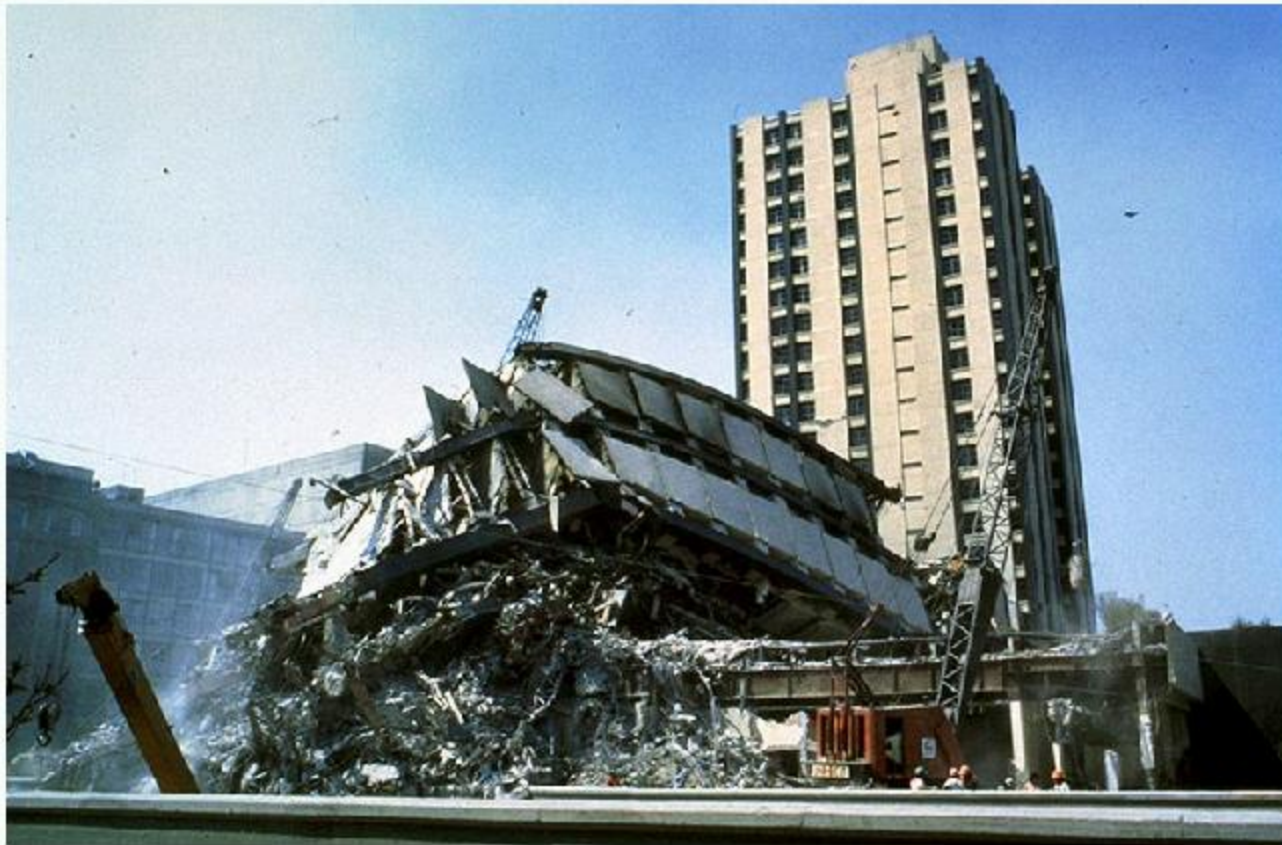
Pino Suarez Towers Looking North

View looking north of the Pino Suarez Towers. Originally there were five structures at this site. Three central 21-story buildings and two flanking 14-story buildings. These government office towers were one of the few steel frame

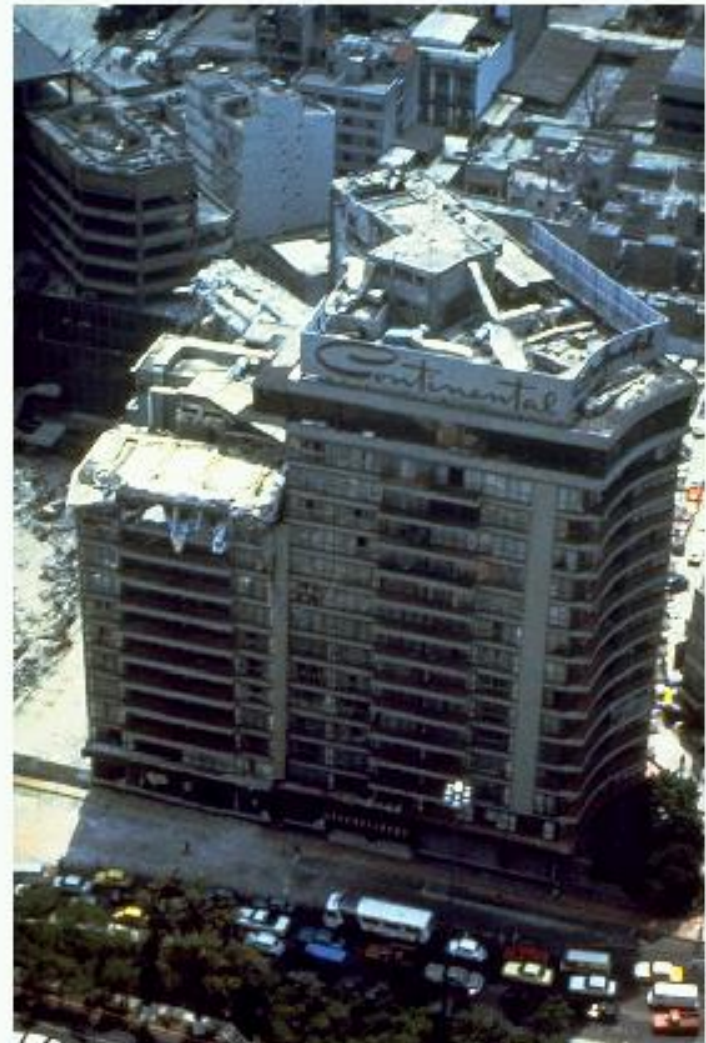
Aerial View of Continental Hotel

Aerial view of the Continental Hotel, where different sections of the building collapsed when pounding or hammering occurred at nonstructural Joints. .

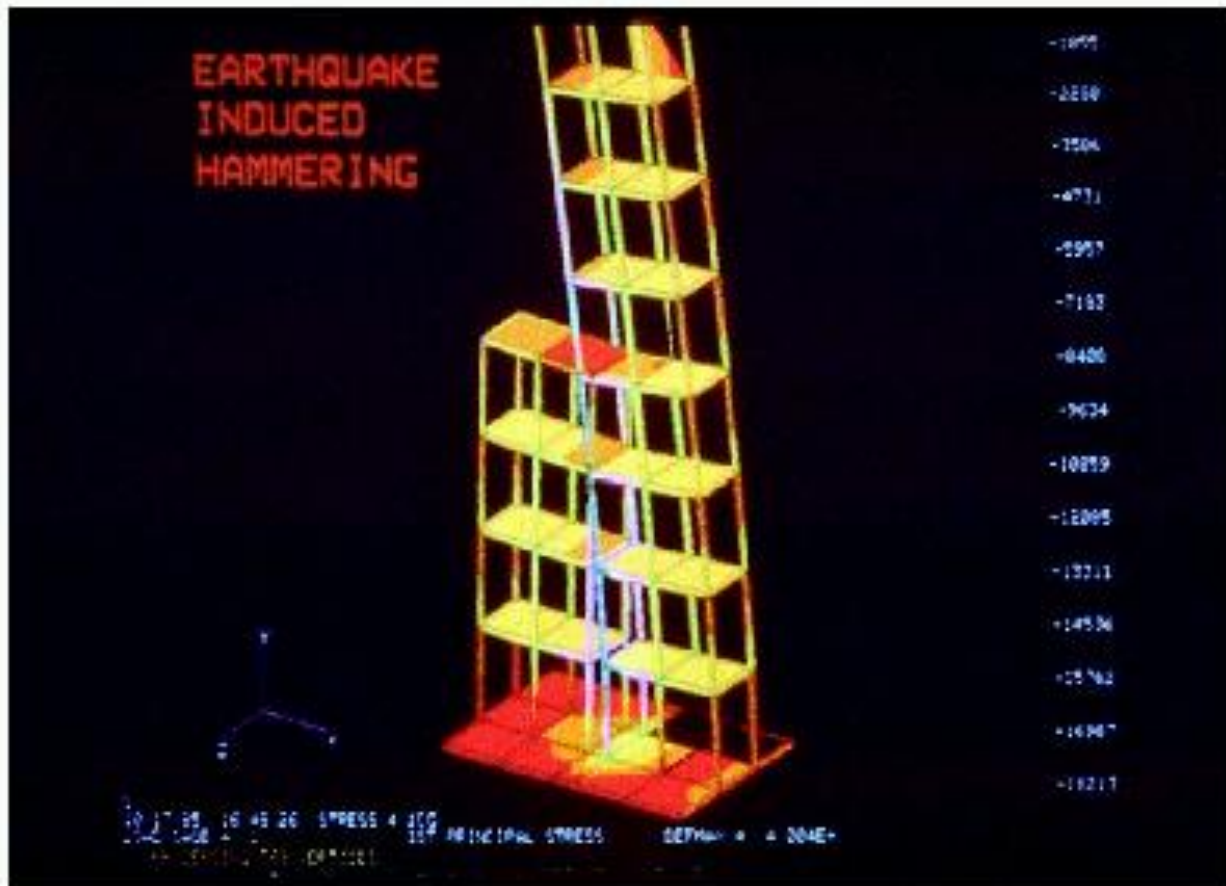
Hammering of Unequal Height Buildings

Building hammering was widespread in Mexico City. This slide depicts collision between two buildings of unequal height.

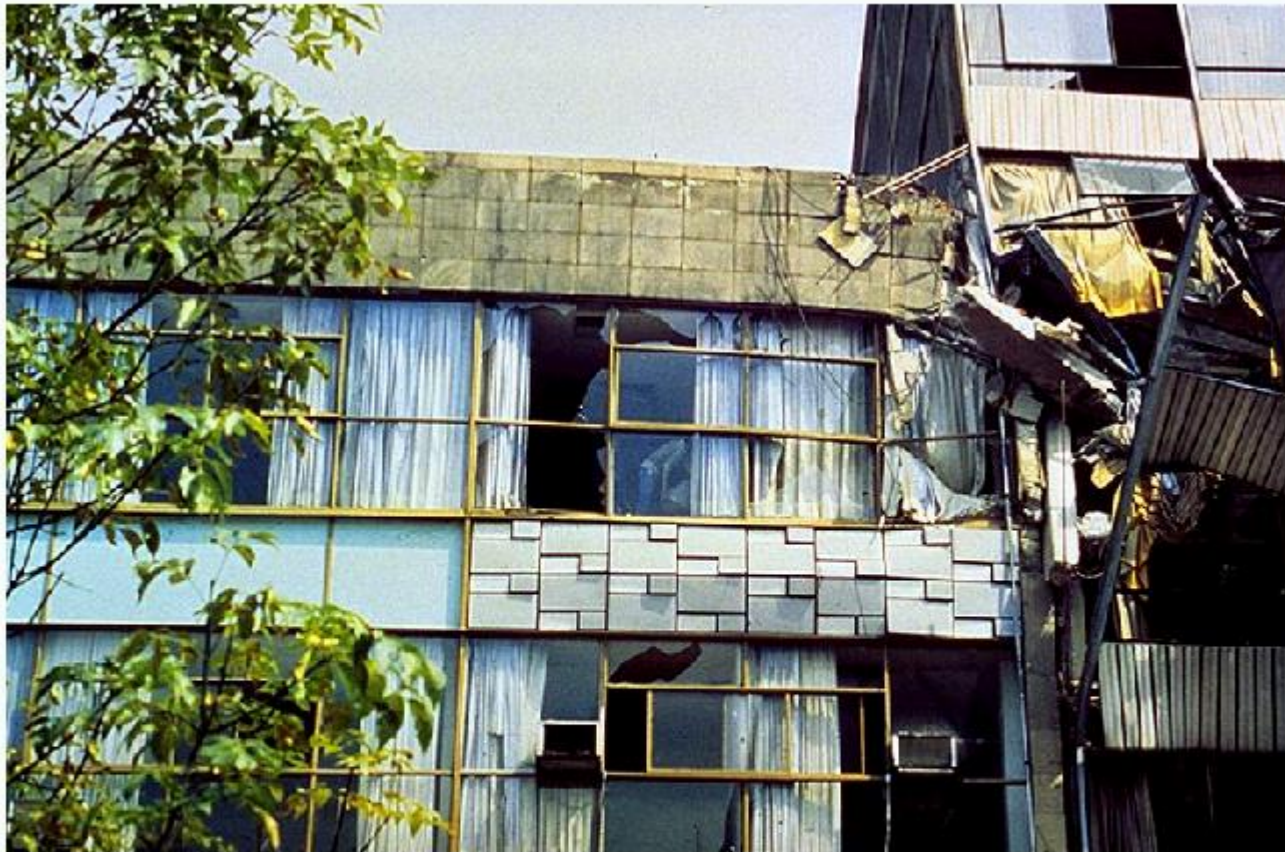
Pounding Damage

Damage caused by pounding results in intermediate floor collapse. Note that in spite of severe structural distortion, much glass is unbroken.

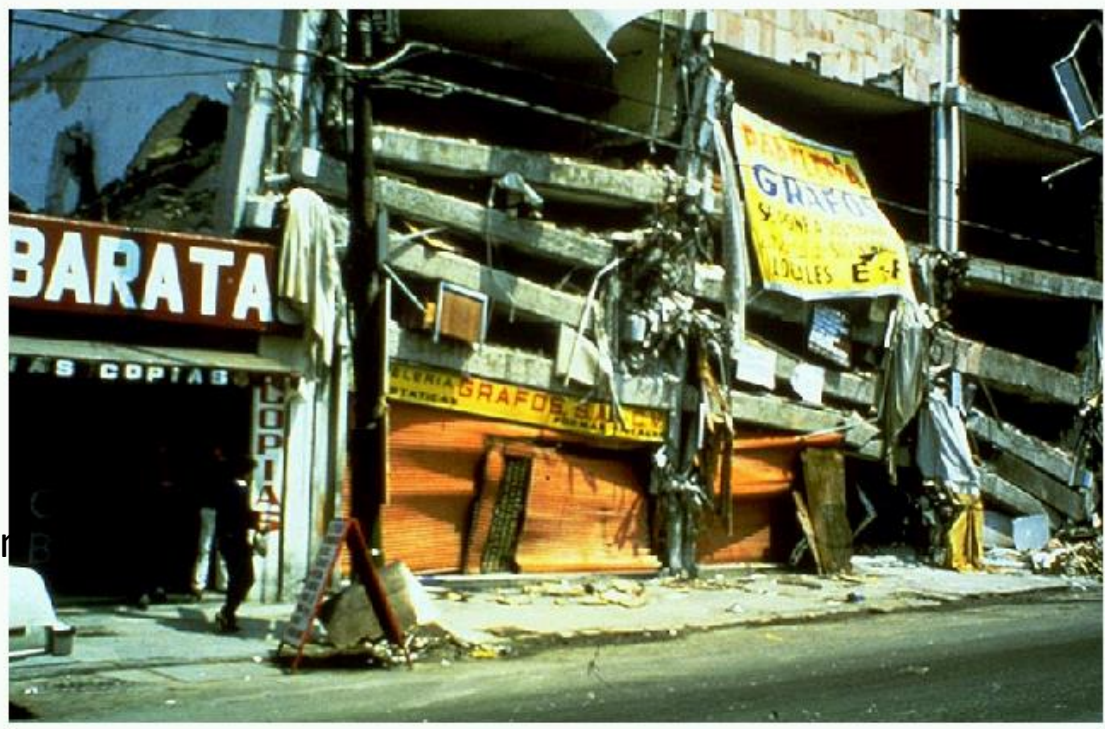
Lower Floor Collapse

Collapse of a number of lower floors of a commercial building. Upper floors remain intact. Note open first floors contrasted to upper floor with the consequent stiffness differential probably leading to the failure.

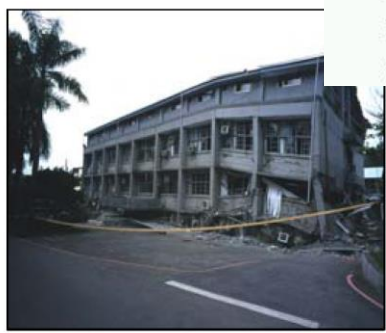
Fig. 7. Elevation of base floor, removal of partition wall, illegal penthouses on roof

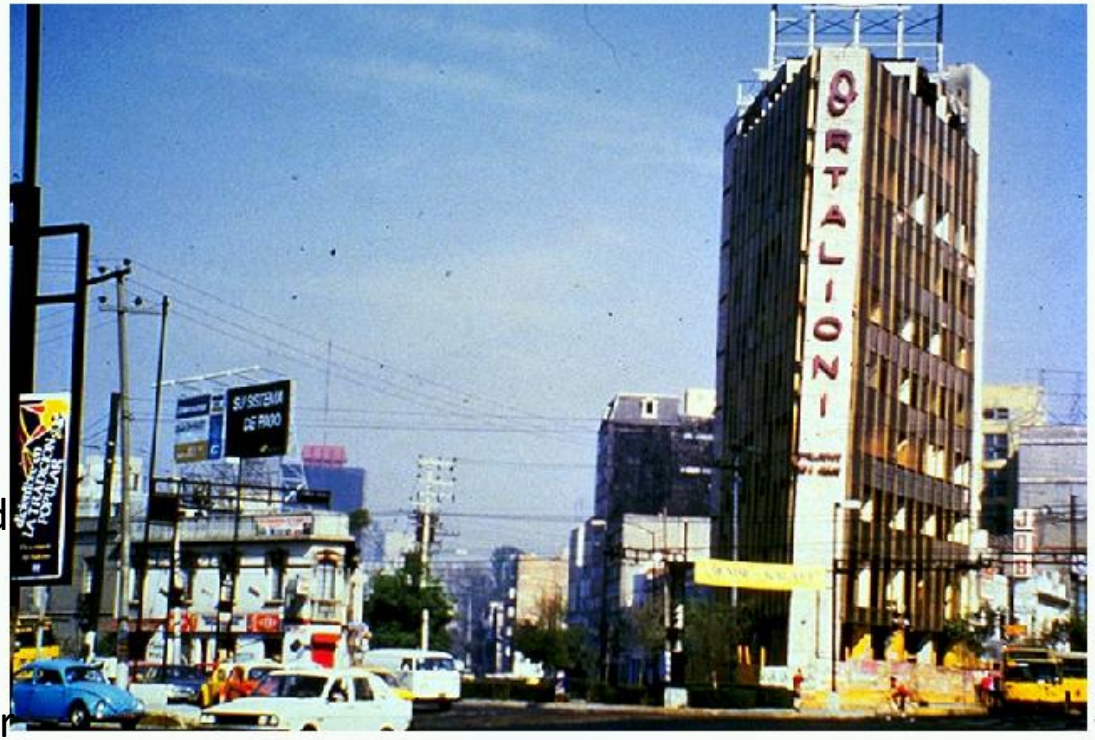
Building Distortion

- when torsion occurs in a plan, the deformation of corner columns is significantly greater than those of interior columns.
- In this case, three-dimensional dynamic analysis should be performed to consider the torsional effect.
- Shape of buildings is a crucial factor for earthquake safety

Severe distortion of building that is triangular in plan to fit the site requirement at a multiple street intersection. Form of building results in the torsional behavior shown.

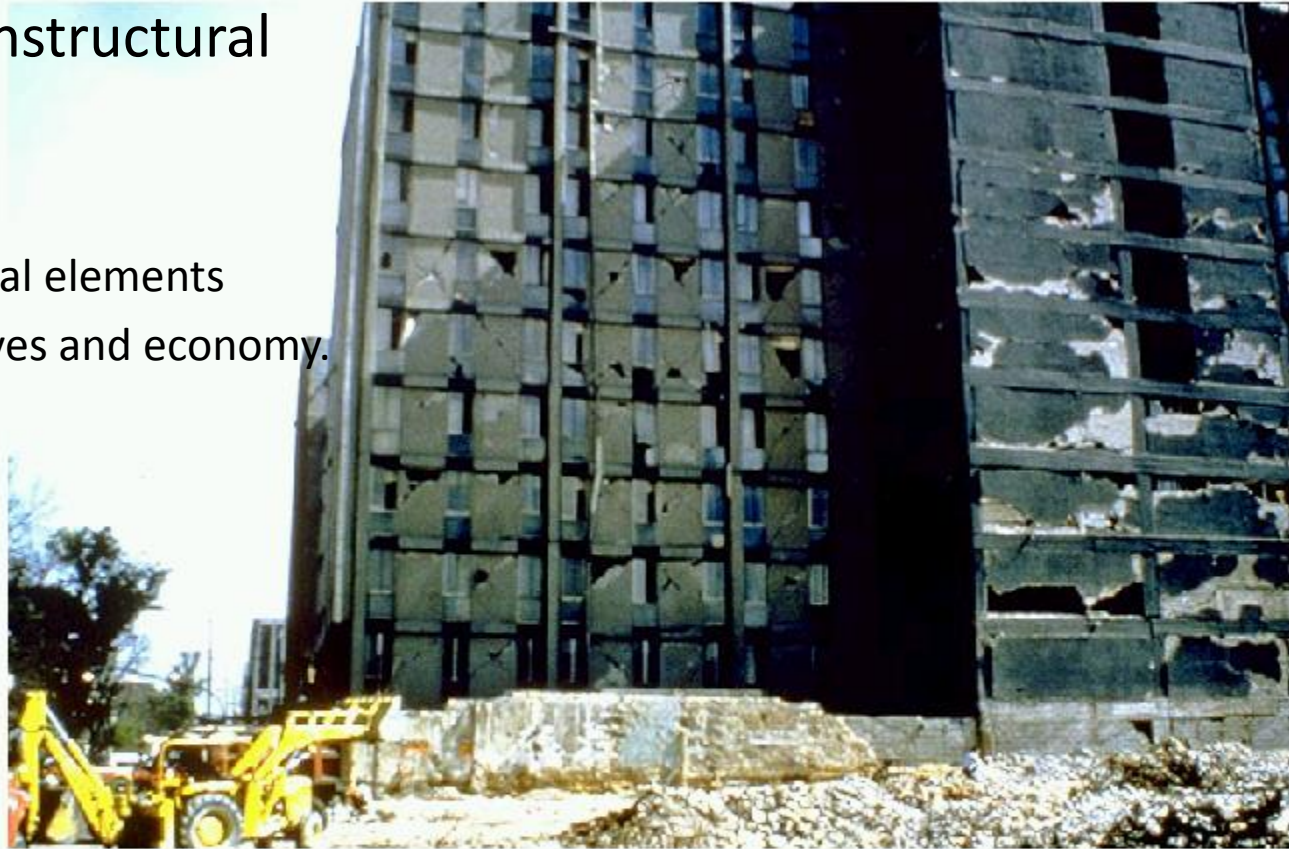
Infill Wall Damage

Typical patterns of damage in unreinforced masonry infill wall. Note damage concentration towards bottom of walls.

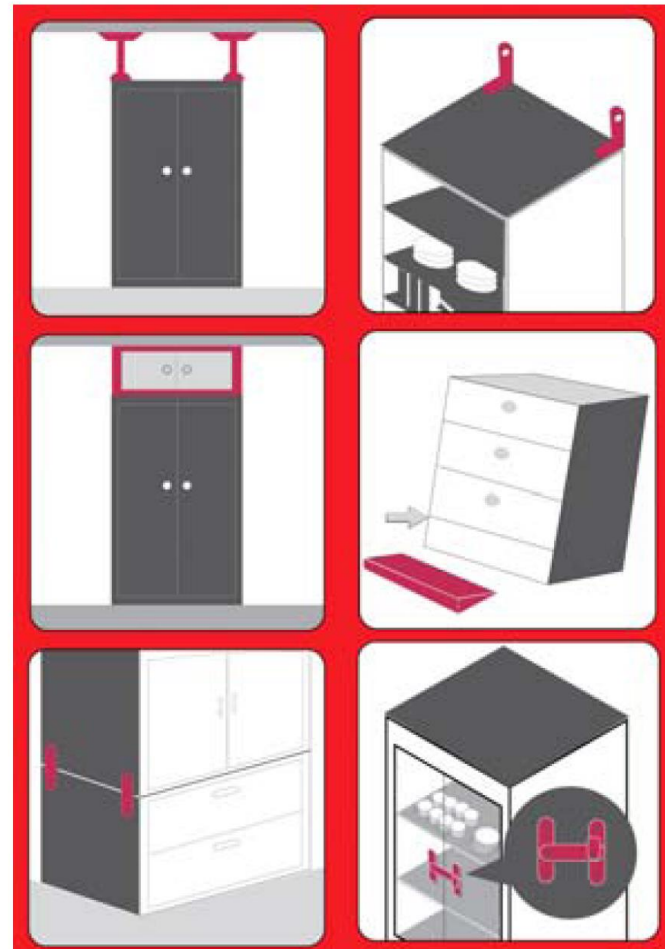
가구를 비롯한 비구조재의
적절한 고정이 필요

16. Prevent furniture from falling down during an earthquake

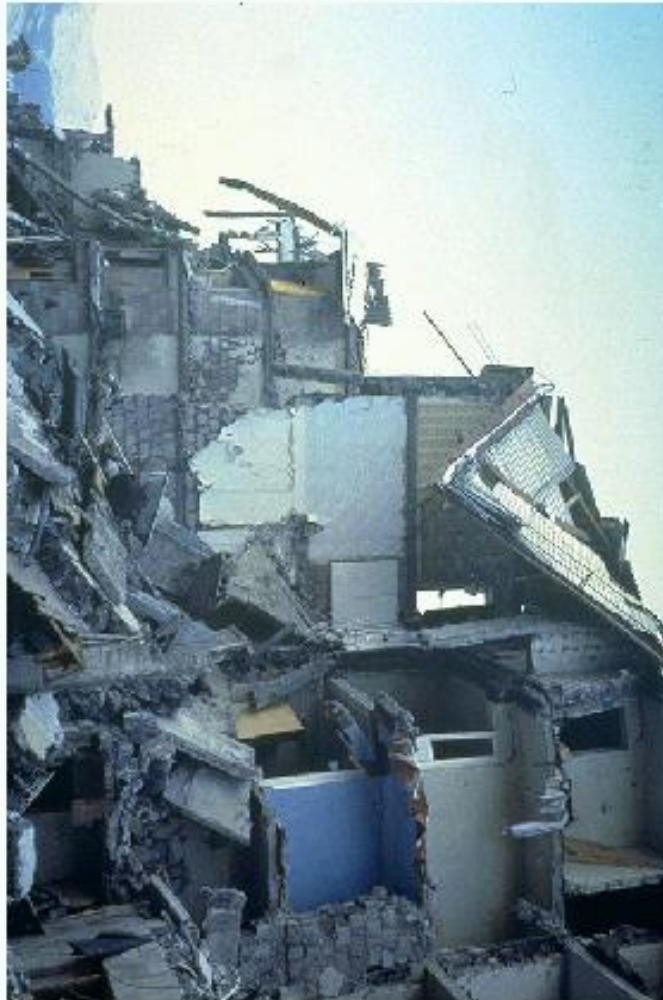
DAMAGE TO LOAD BEARING STONE MASONRY WALL BUILDING IN SPITAK

There are no ties between the floor planks and the wall. The ground shaking in the epicentral region was too great for this ineffective lateral force resisting system.

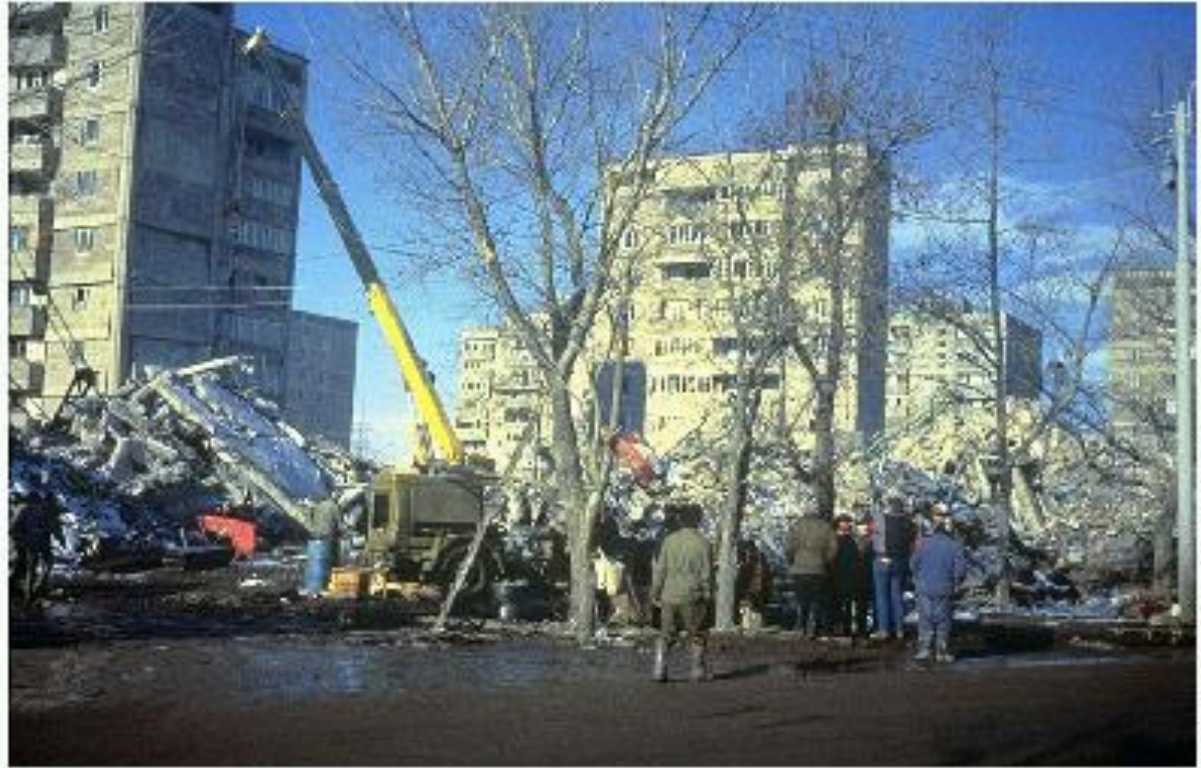
DAMAGE TO 9-STORY PRECAST CONCRETE FRAME BUILDINGS IN LENINAKAN

This slide shows collapsed and damaged nine-story precast concrete frame buildings in Leninakan. Poor diaphragm action due to lack of connections between the floor planks (flexicore precast floor panels) contributed to the failures.

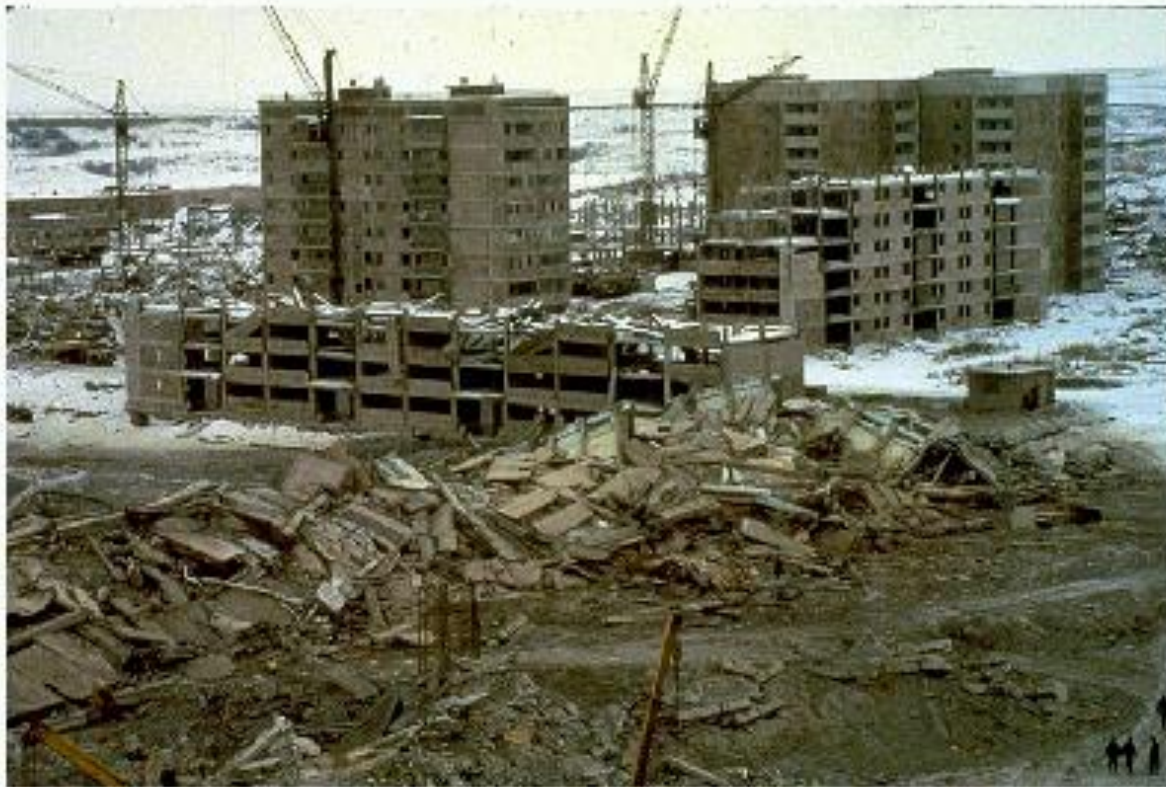
PRECAST CONCRETE PANEL BUILDINGS

In the Soviet design of precast concrete panel buildings, virtually every precast interior wall is used as a load-bearing element having shear capacity. This design gives a stiff, redundant structure. Floors and roofs are precast concrete planks, but with positive infrastructural connections between the various elements.

In this slide, taken at noon in Leninakan on December 27, the performance of precast frame-panel and precast panel buildings can be compared. Many precast frame-panel buildings in Leninakan collapsed and are shown in the foreground, including one under construction. Precast panel buildings, in contrast, performed very well and are shown standing in the background. The difference in performance is due to the basic differences in their design as well as possibly to specific characteristics of the ground motion. Site amplification in the 1.0 to 2.5 second band was found in the strong motion records of the aftershock sequence recorded in Leninakan may have generated a greater load on the concrete frame-panel buildings.

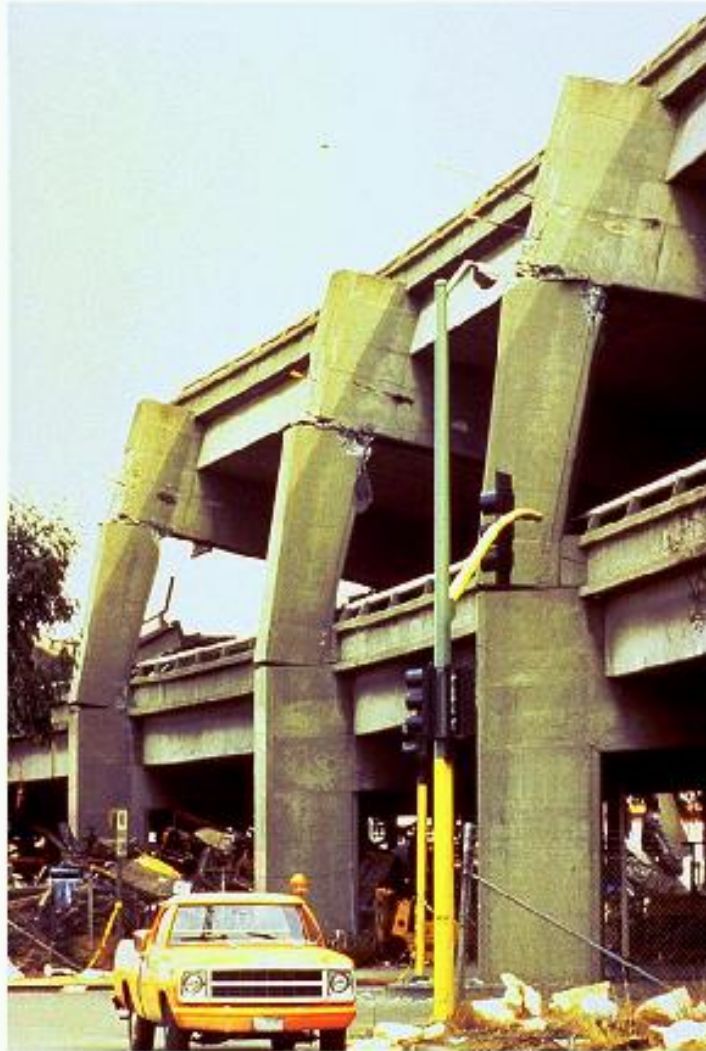
Detail of Failure: 1-880

A view looking north at the west side of three type 2 bents. These bents included prestressing of the upper girders. In this particular mode of failure, only the east columns of the upper frames failed.

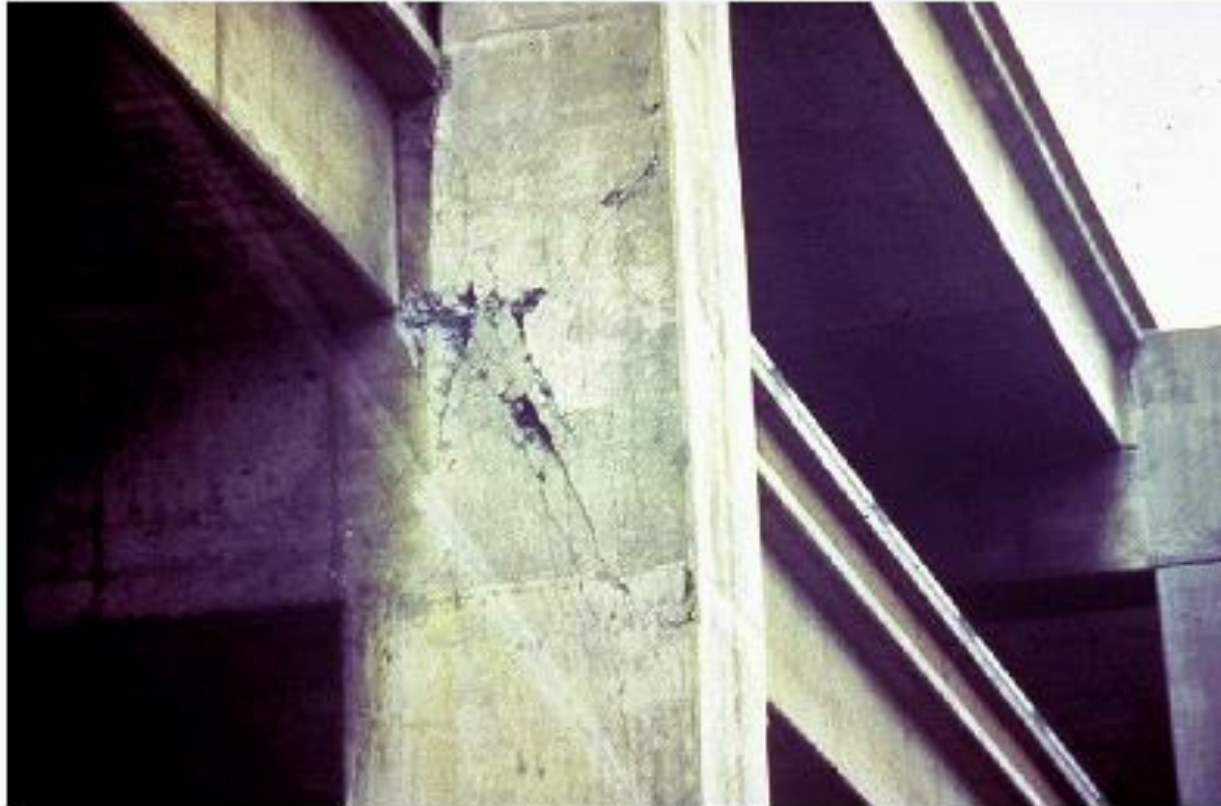
Close Up of Joint Failure: Embarcadero Freeway

The reasons for damage to the Embarcadero Freeway are likely the same as the reasons for the damage to I-880, namely: 1) the structure was built prior to the adoption of modern seismic design criteria, and 2) both locations experienced large ground displacements. The damage correlated with that portion of the Embarcadero Freeway where a transition in the bent configuration occurred.

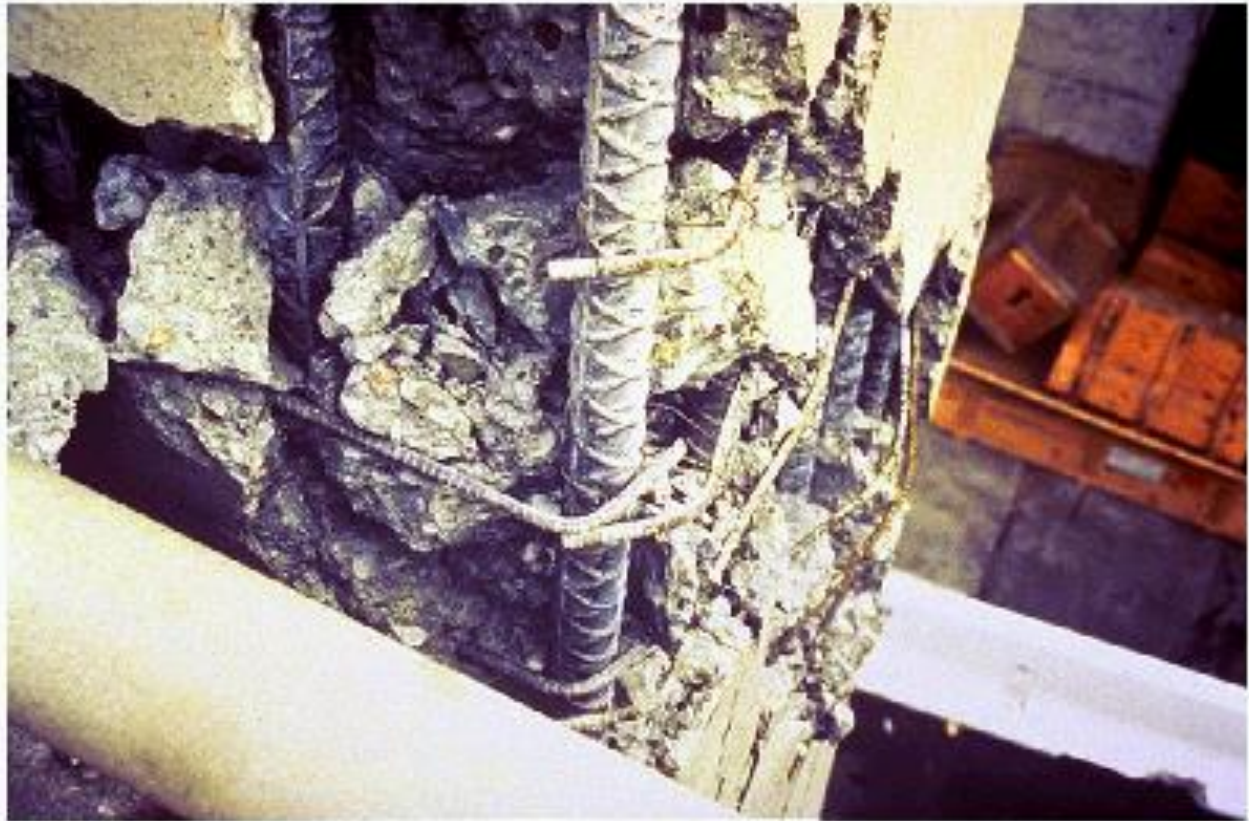
Reinforcing Details: I-280

A close-up view of reinforcing details of failure zone in bent 51. Note anchorage failure of ties.

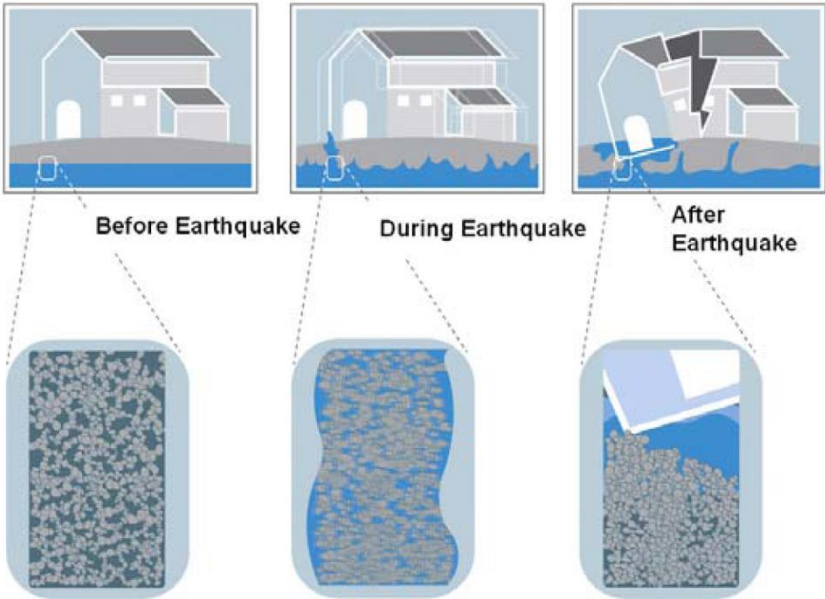
out the ground failure zone - erupting onto the Marina Green (Slide 12) and s, through cracks in garage and basement floors, and next to buildings (Slide it near Cervantes). At most locations, ejected sand was dark gray in color, edged from the Bay bottom; however, at a few locations, ejected material was characteristics of nearby dune sand (Slide 14, taken at Scott and North Point

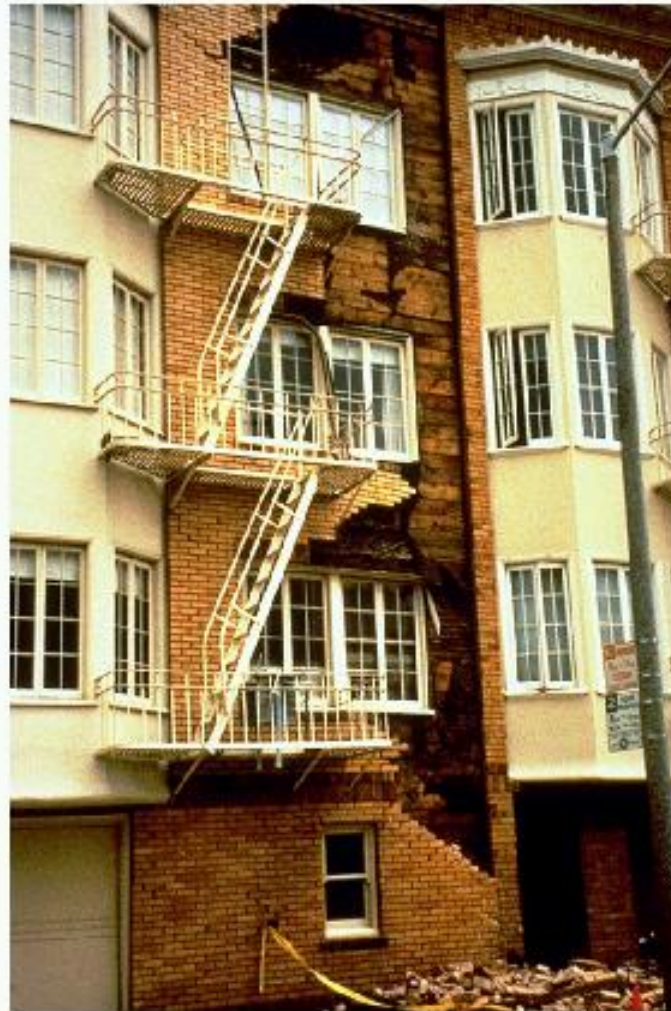
Brick Facade Collapse

While most of the buildings in the Marina district are wood-frame structures, many have an ornamental brick facade. During the strong ground shaking, quite a number of these facades became unattached from the building and crashed down onto the sidewalk or street.

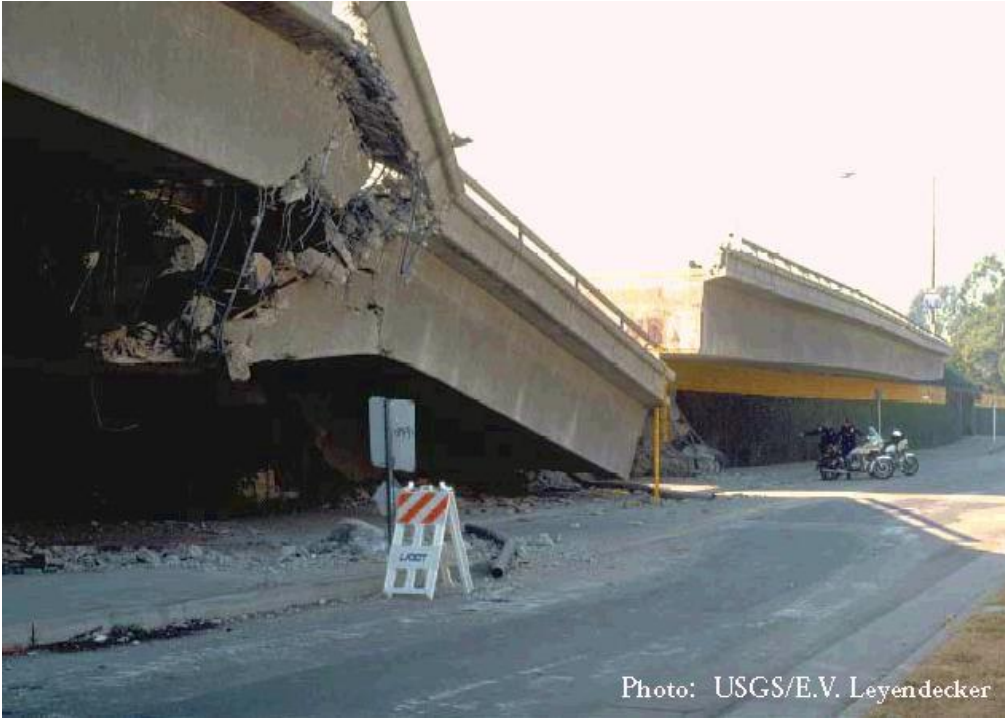
Failure of bridge columns caused by the lack of lateral reinforcement

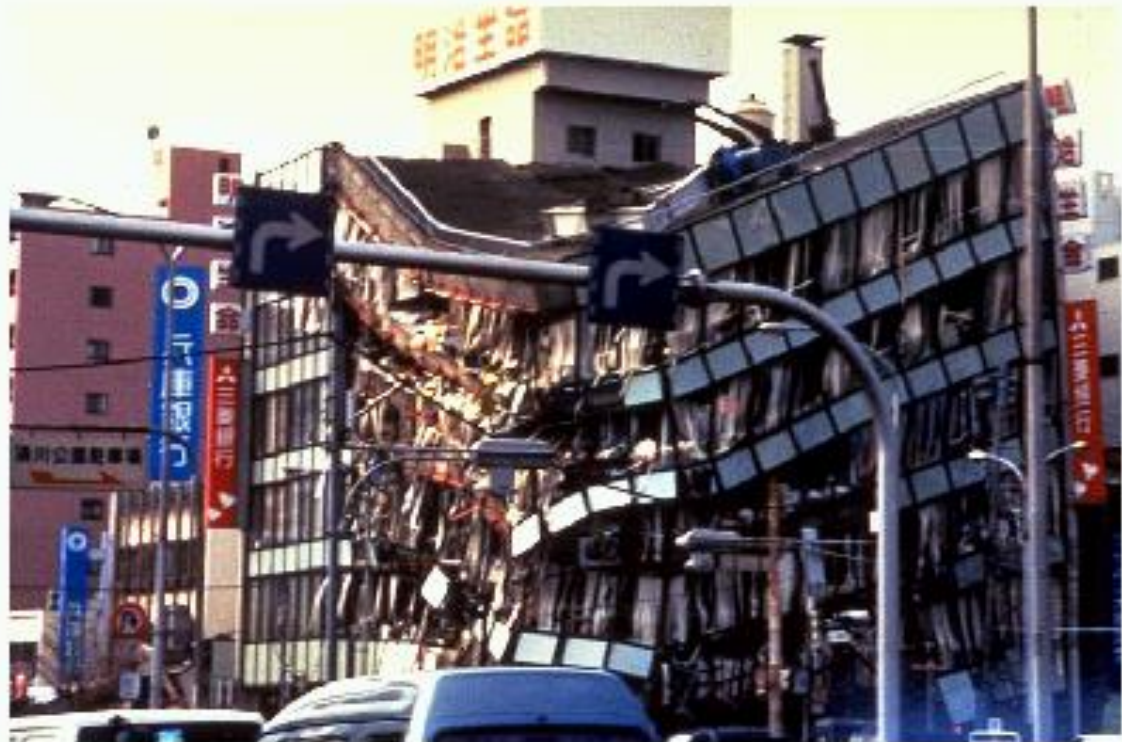
Slide 16-17:

A number of buildings built on city-block corners sustained partial collapse at the corner of the building, or failed completely.

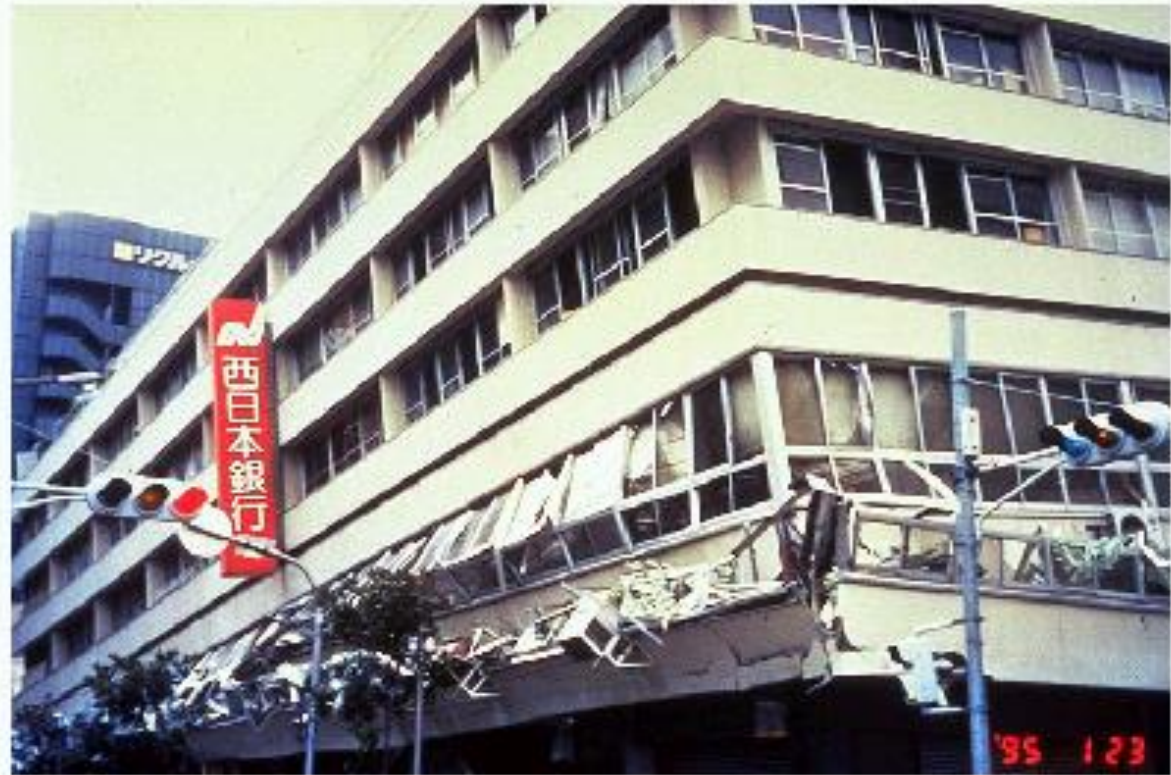
Slide 18-20:

Partial or full collapse of a single story in buildings was the common failure for most of the larger buildings. The particular story that sustained partial or full collapse varied from building to building. First-story failure was more common than mid-level or upper-story collapse.
