Overview of Earthquake Engineering

**Hong-Gun Park
Seoul National University**

1. Causes and damages
2. Principles of earthquake design
3. Design considerations
4. Earthquakes in Korean Peninsular

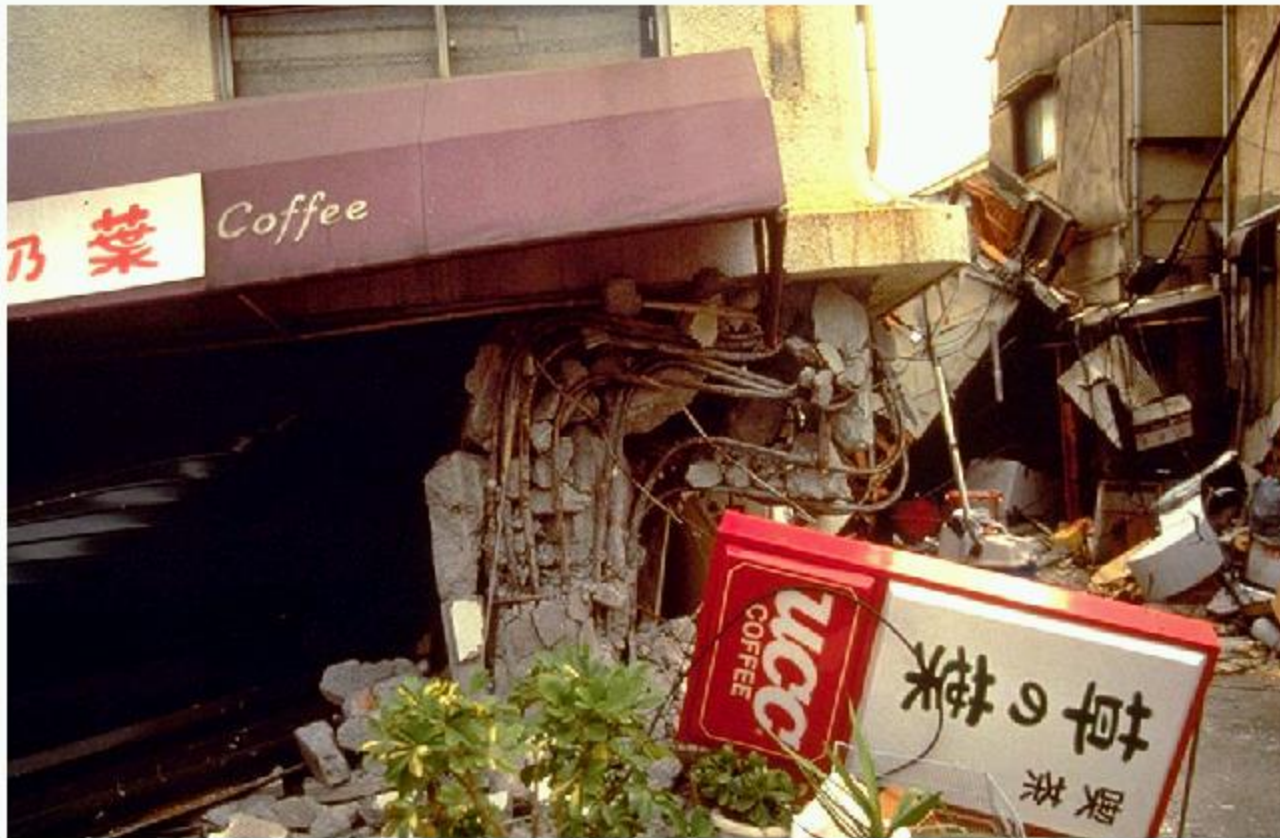
Pre-1971 Concrete Frame Buildings

Collapse of another soft first story non-ductile concrete frame.

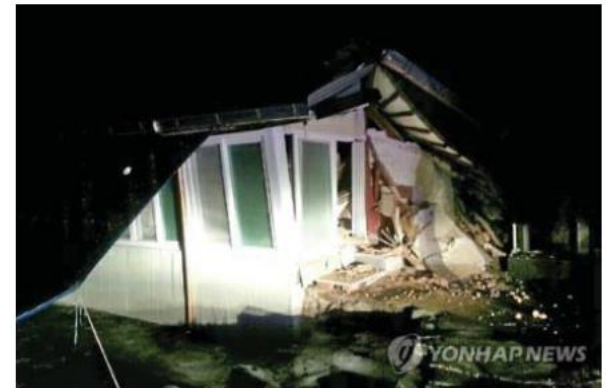
Failure in an already poor (non-engineered) construction

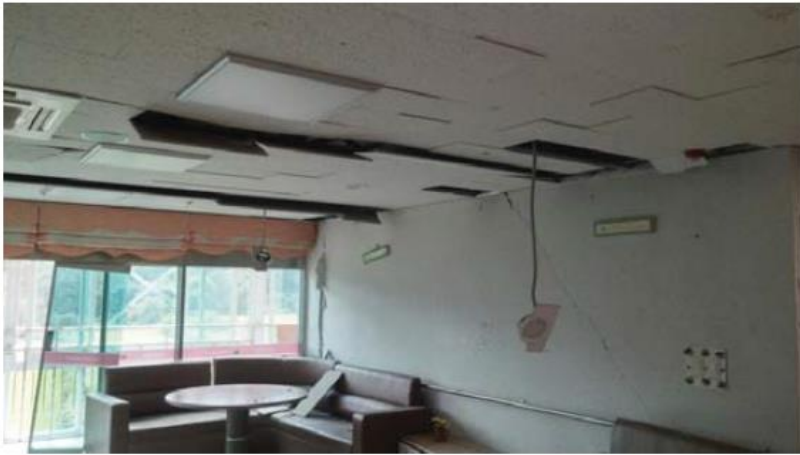
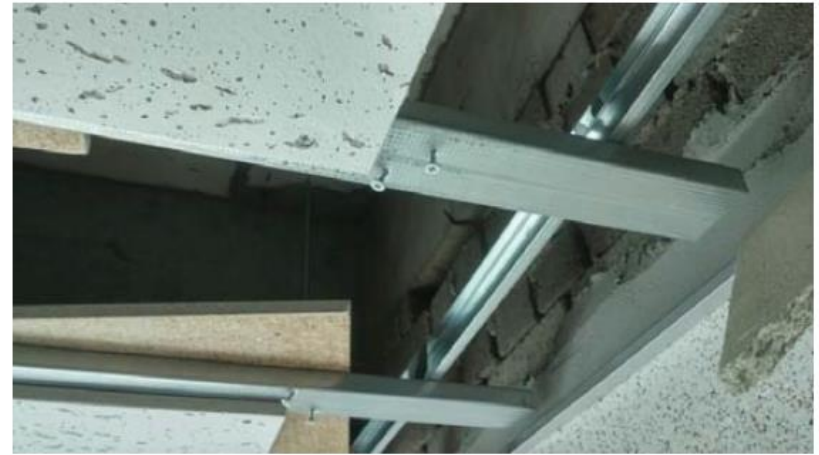
Damage observed in a 3-story RC Building (Ulju, Ulsan)_ ceiling and brick wall failure

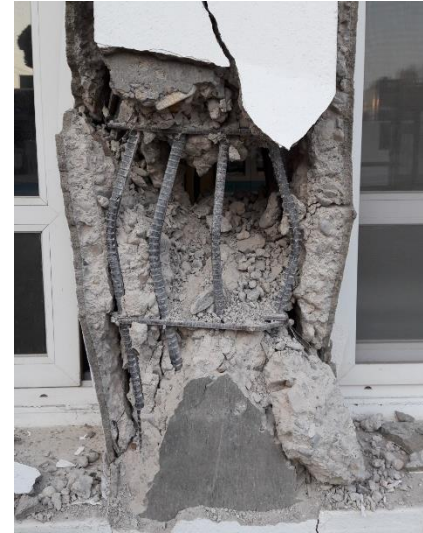
Heunghae Elementary School

**Short column effect
By masonry wall**

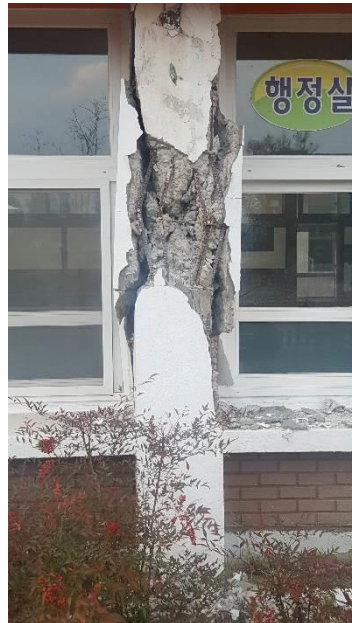
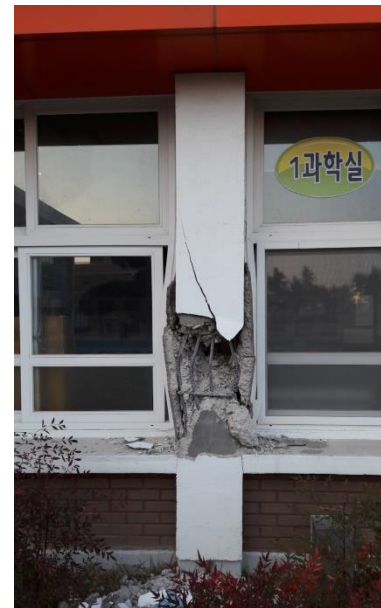
Piloti column

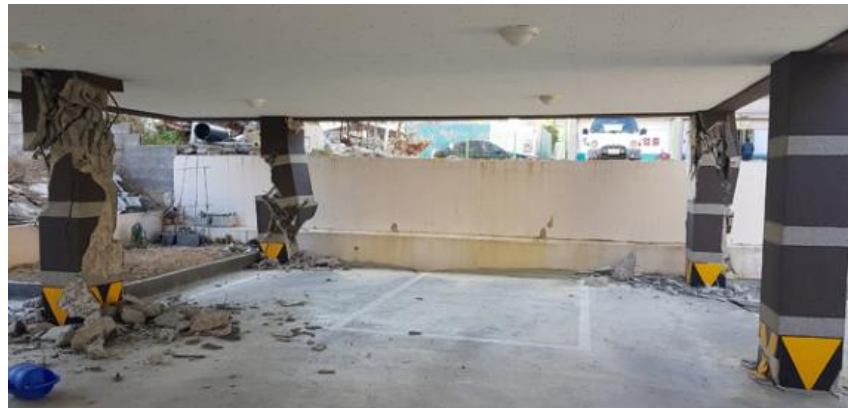
School damage

기둥, 내력벽 손상 / 피복탈락 및 균열

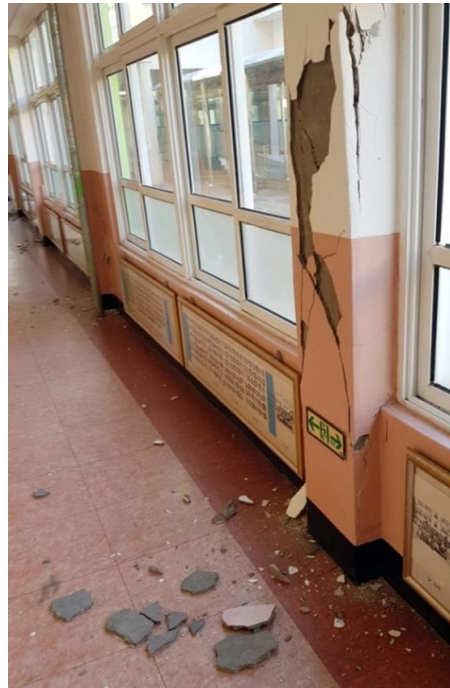
경북 포항 00초등학교

초등학교 지진 피해
(포항=연합뉴스) 15일 발생한 지진으로 경북 포항 한 초등학교 건물 기둥과 벽 일부가 금이 가거나 부서졌다.
2017.11.15 [독자 제공=연합뉴스]

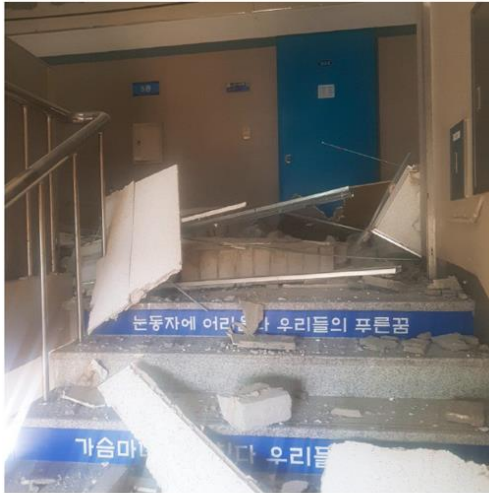
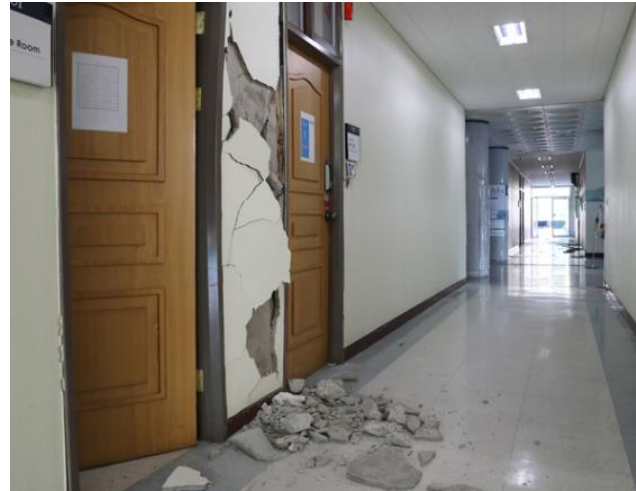
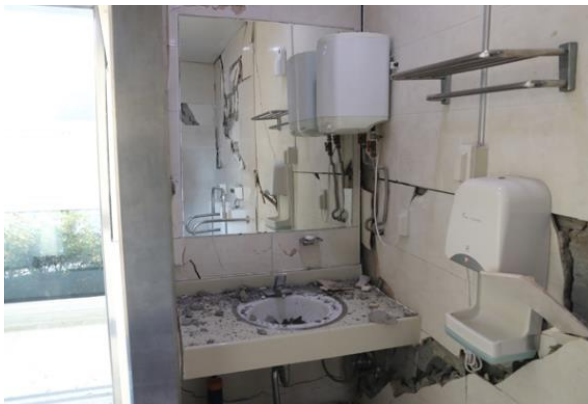
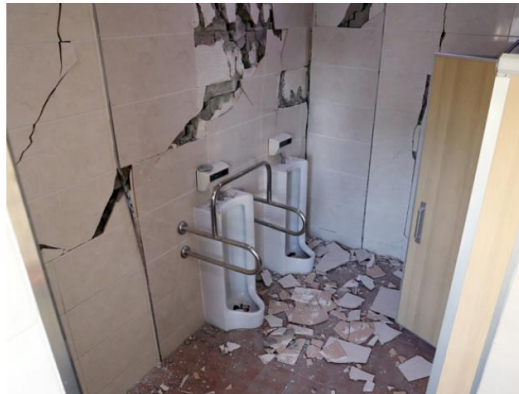
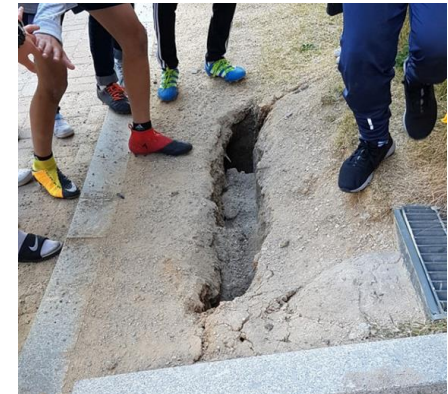
School damage

비구조재 손상 및 탈락 / 땅꺼짐 현상

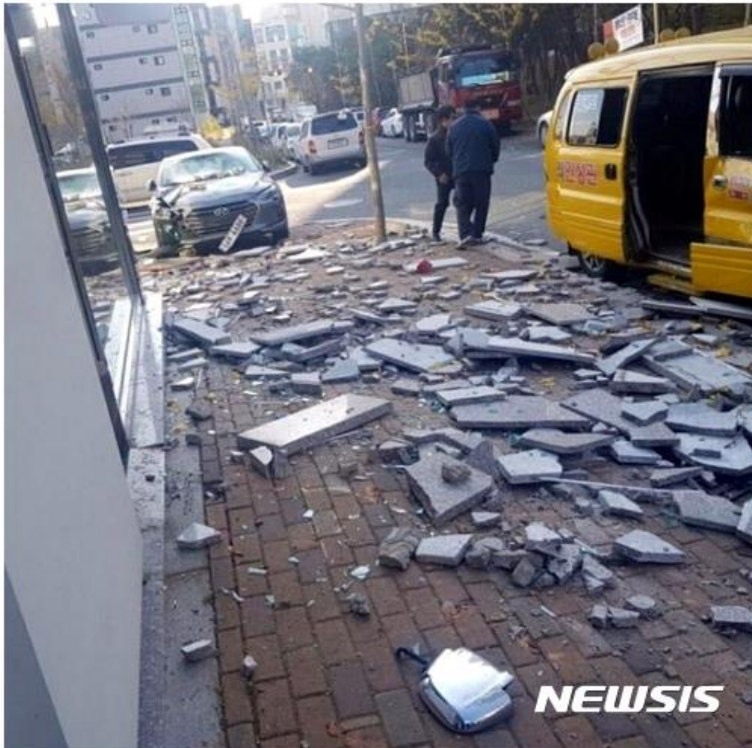
Non-structural damage

【포항=뉴스시스】박준 기자 = 15일 오후 2시29분께 경북 포항시 북구 북쪽 6km 지역에서 규모 5.5의 지진이 발생해 도로가 갈라지고 건물 외벽이 무너지는 등 피해가 속출했다. 2017.11.15june@newsis.com

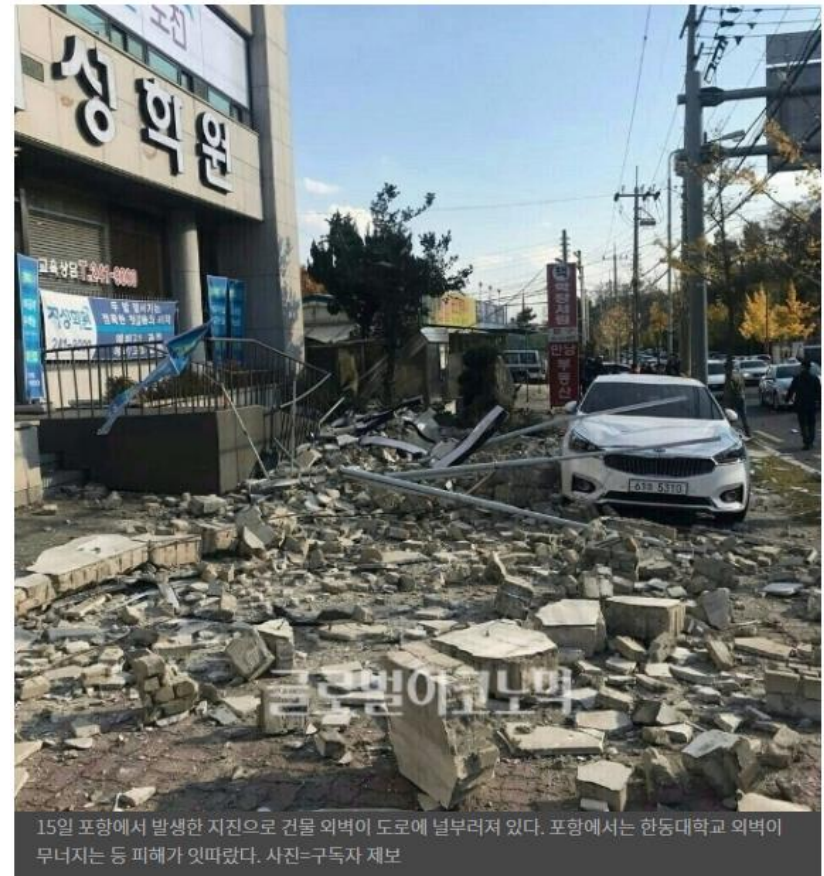
15일 포항에서 발생한 지진으로 건물 외벽이 도로에 널부러져 있다. 포항에서는 한동대학교 외벽이 무너지는 등 피해가 잇따랐다. 사진=구독자 제보
